Structural Stability Assessment Jeffrey Energy Center Inactive Bottom Ash Pond

Prepared for:
Westar Energy
Jeffrey Energy Center
St. Marys, Kansas

Prepared by:
APTIM Environmental & Infrastructure, Inc.

April 2018

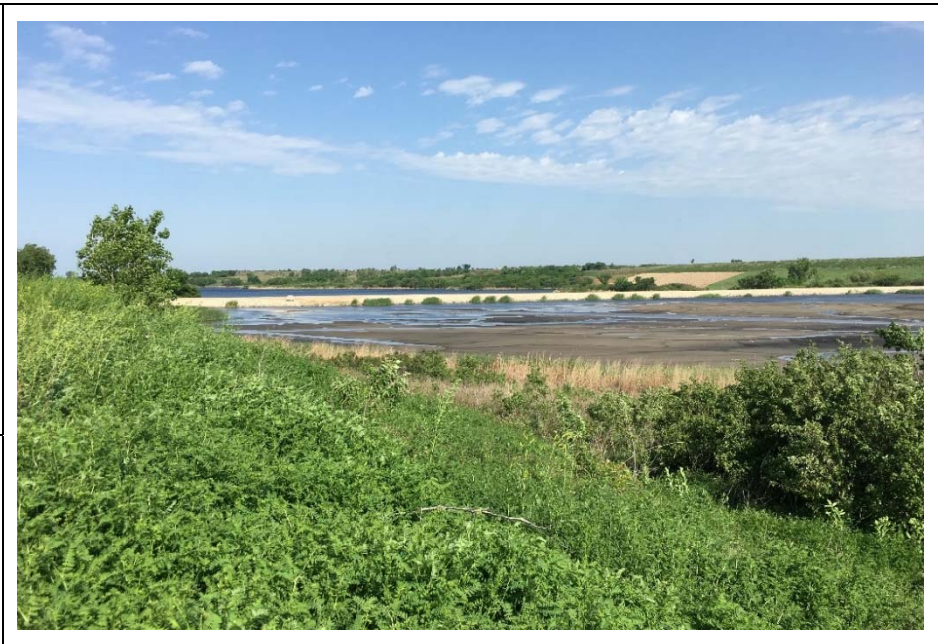
<p>Photograph No. 1</p> <p>Date: May 16, 2017</p> <p>Direction: Northwest</p>

The erosion protection on the south, east, and north slopes of the Pond consists of well-established vegetation. This includes tall grass, brush, bushes, and some small trees. See Photographs 1 and 2 in **Appendix A**.

<p>Description: Observing Bottom Ash Pond and the surrounding vegetation on the south slope.</p>

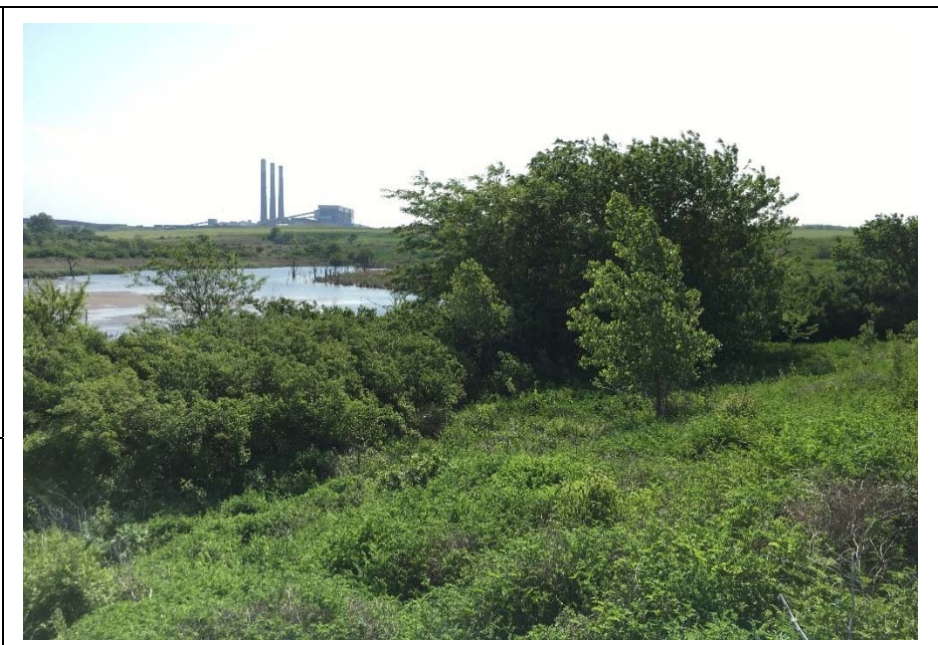
<p>Photograph No. 2</p> <p>Date: May 16, 2017</p> <p>Direction: Northeast</p>

<p>Description: Observing the eastern edge of the Bottom Ash Pond. Vegetation is well established.</p>

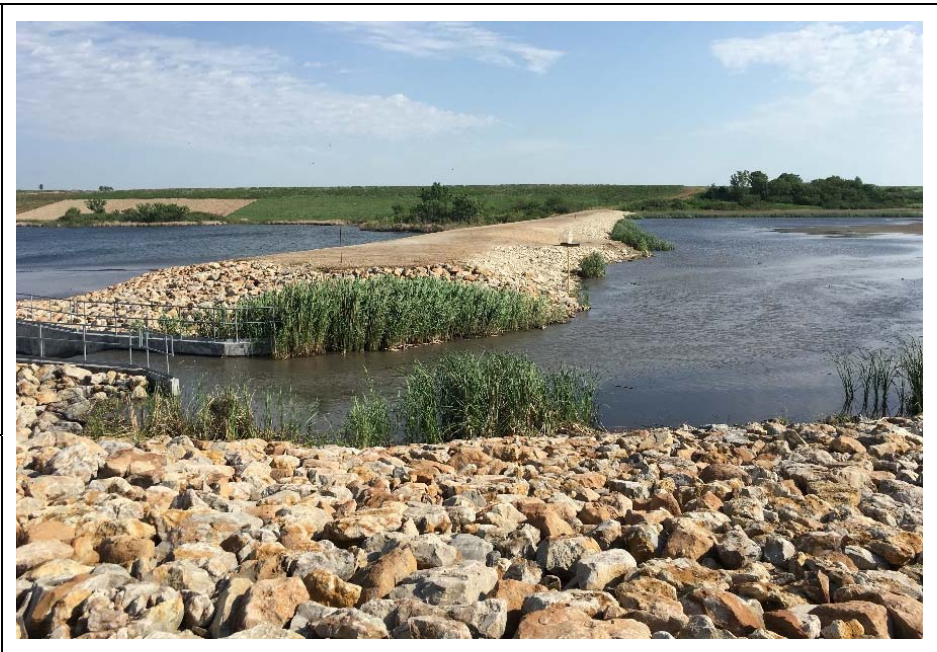
<p>Photograph No. 3</p> <p>Date: May 16, 2017</p> <p>Direction: North</p>

<p>Description: Looking at spillway and dam between the Bottom Ash Pond and Tower Hill Lake. Slopes are rip-rap lined. Some vegetation. No noticeable erosion.</p>

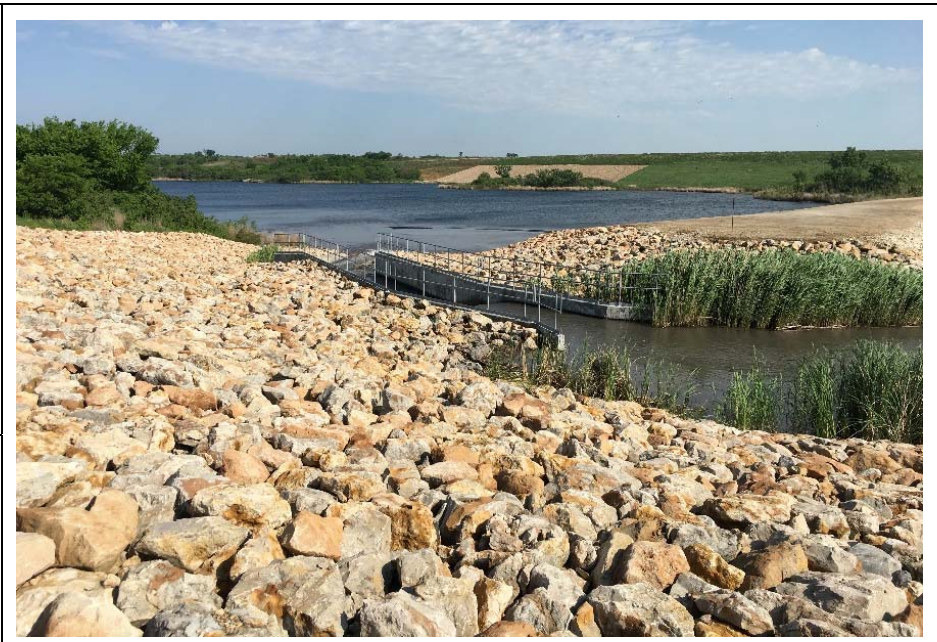
<p>Photograph No. 4</p> <p>Date: May 16, 2017</p> <p>Direction: Northwest</p>

<p>Description: Looking at spillway from Bottom Ash Pond to Tower Hill Lake. No evidence of erosion or malfunction.</p>

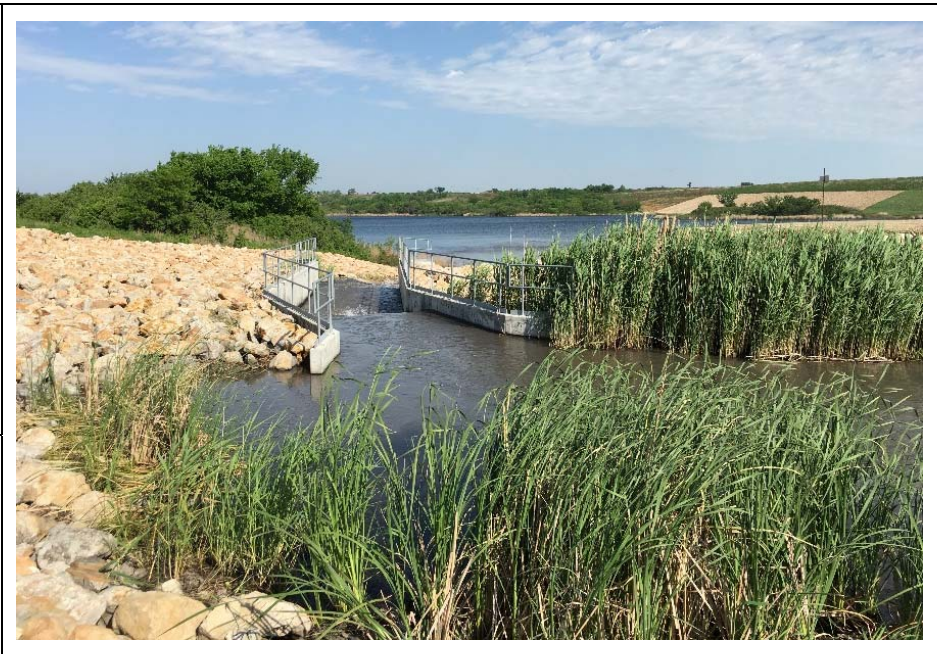
<p>Photograph No. 5</p> <p>Date: May 16, 2017</p> <p>Direction: Northwest</p>

<p>Description: Looking at spillway from Bottom Ash Pond to Tower Hill Lake. No evidence of erosion or malfunction. Some vegetation present.</p>

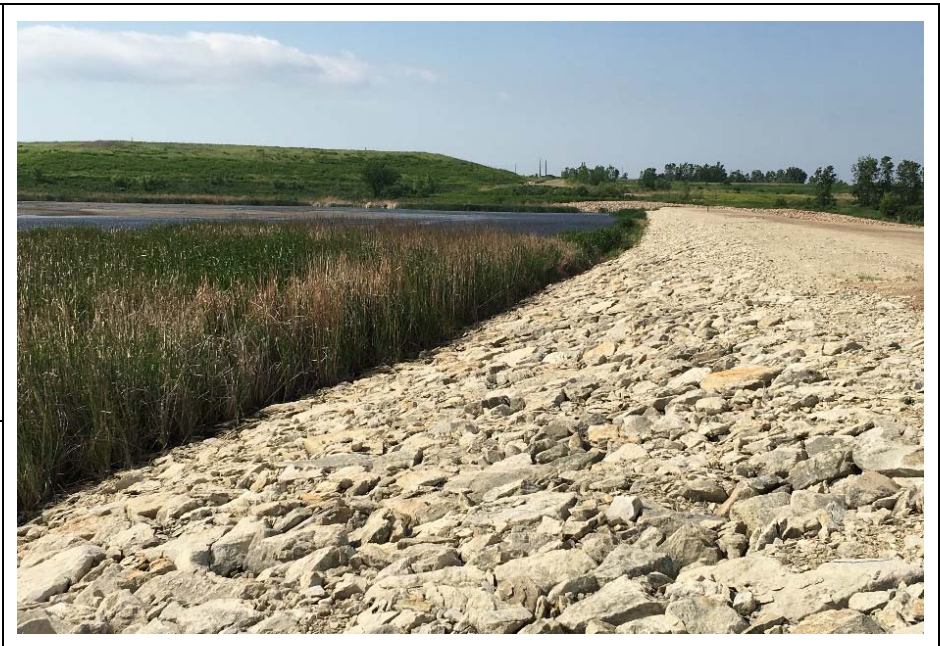
<p>Photograph No. 7</p> <p>Date: May 16, 2017</p> <p>Direction: Southwest</p>

<p>Description: Observing the upstream side of the dam separating the Bottom Ash Pond and Tower Hill Lake. No significant erosion. Established vegetation present.</p>

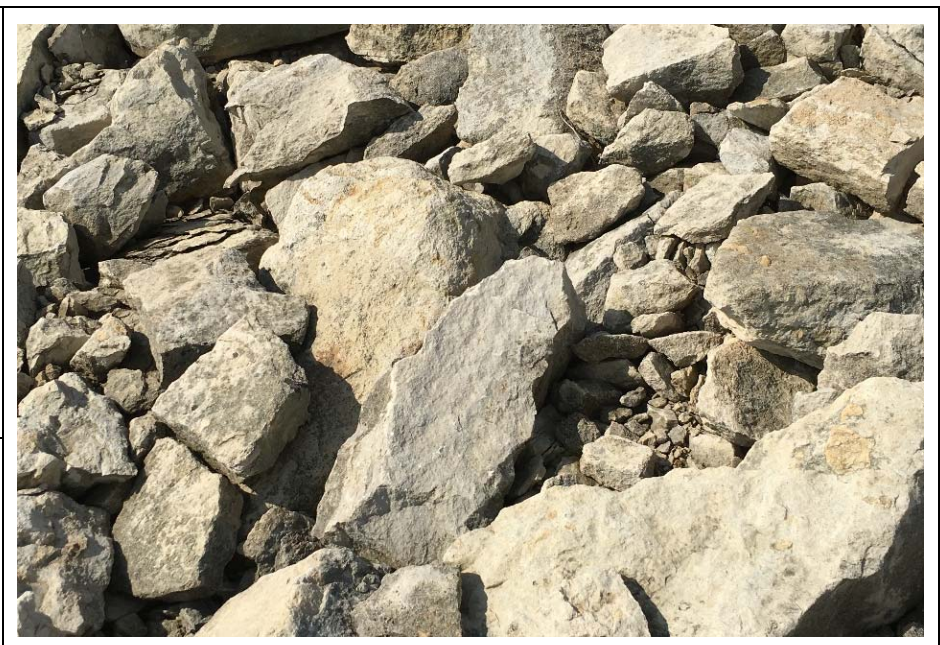
<p>Photograph No. 8</p> <p>Date: May 16, 2017</p> <p>Direction: -</p>

<p>Description: Observing rip-rap present on the upstream slope of the dam.</p>

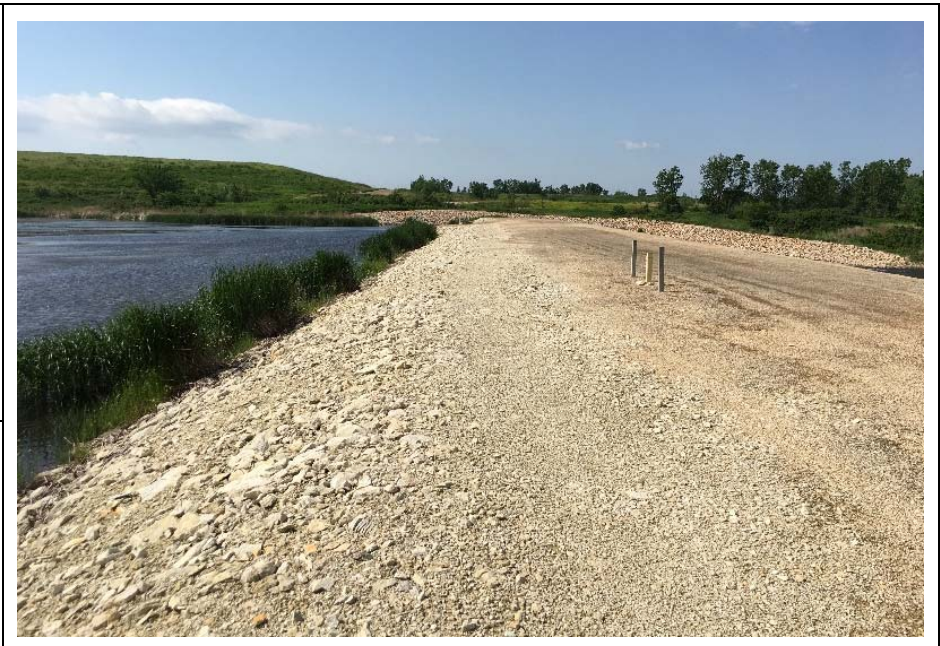
<p>Photograph No. 9</p> <p>Date: May 16, 2017</p> <p>Direction: Southwest</p>

<p>Description: Observing the dam separating the Bottom Ash Pond and Tower Hill Lake on the downstream slope. No significant erosion present. Established vegetation present.</p>

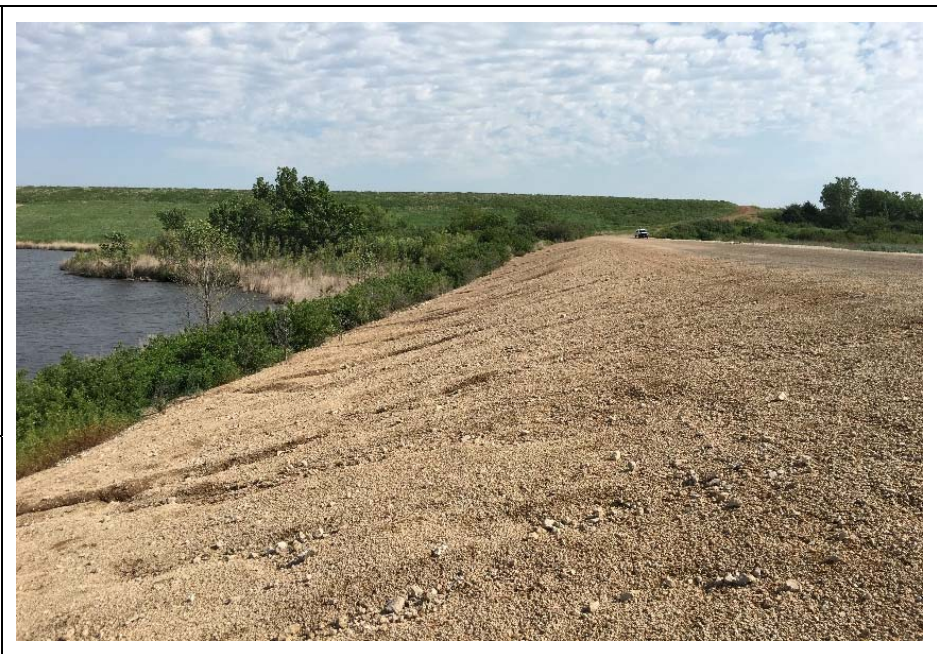
<p>Photograph No. 12</p> <p>Date: May 16, 2017</p> <p>Direction: Northeast</p>

areas of vegetation where the Pond Dam meets the surface of Tower Hill Lake. As previously mentioned, erosion rills are present on the downstream slope of the Pond Dam. Photographs 12 through 15 in **Appendix A** depict the observed erosion rills. The lack of other slope protection on the downstream slope does not appear to present a stability concern. Maintenance on the Pond Dam erosion rills will be addressed during the Pond closure activities. There was no evidence of any other deficiencies, including seeps, during the site visit.

<p>Description: Observing minor erosion of the dam separating the Bottom Ash Pond and Tower Hill Lake on the downstream slope. Established vegetation present.</p>

- Fill in and regrade the erosion rills on downstream slope of the Pond Dam as part of closure capping construction. Placement of rip-rap may be considered after filling and regrading to provide additional erosion protection;
- Continue to monitor and maintain rip-rap on the upstream slope;
- Continue proper management of the inflow control system and gradient flowing to the outlet structure; and
- Continue to monitor all conveyance features for signs of erosion, damage, obstructions, or malfunction.

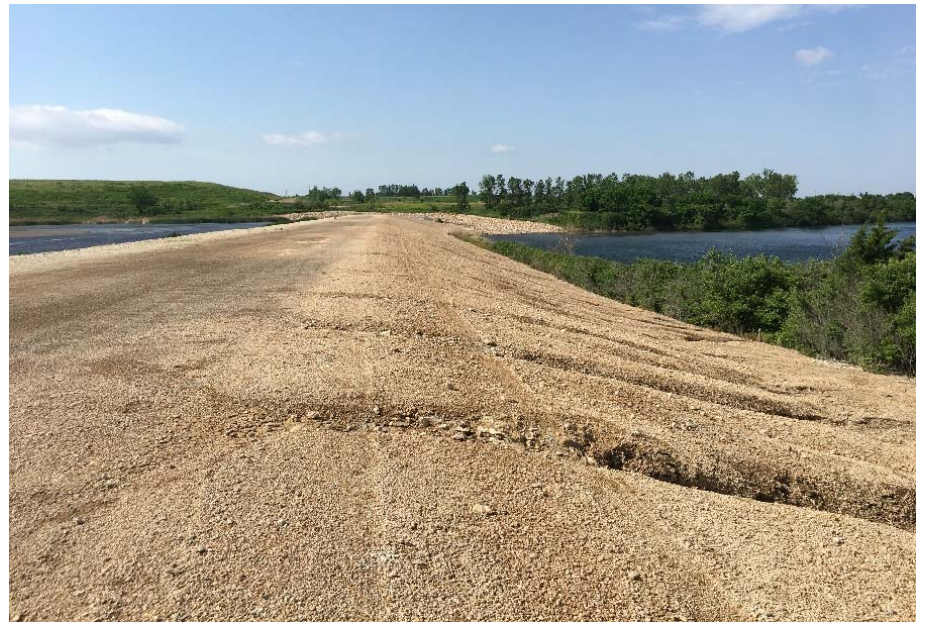
Photograph No. 15

Observing the dam that separates the Bottom Ash Pond from Tower Hill Lake. Erosion rills on downstream slope.
