15 January 2016
File No. 41938-008

Subject: Annual CCR Surface Impoundment PE Inspection
Area 1 Pond
Tecumseh Energy Center
Tecumseh, Kansas

**REPORT ON
INITIAL ANNUAL CCR SURFACE IMPOUNDMENT PE
INSPECTION
AREA 1 POND
TECUMSEH ENERGY CENTER
TECUMSEH, KANSAS**

for Westar Energy, Inc.
Tecumseh, Kansas

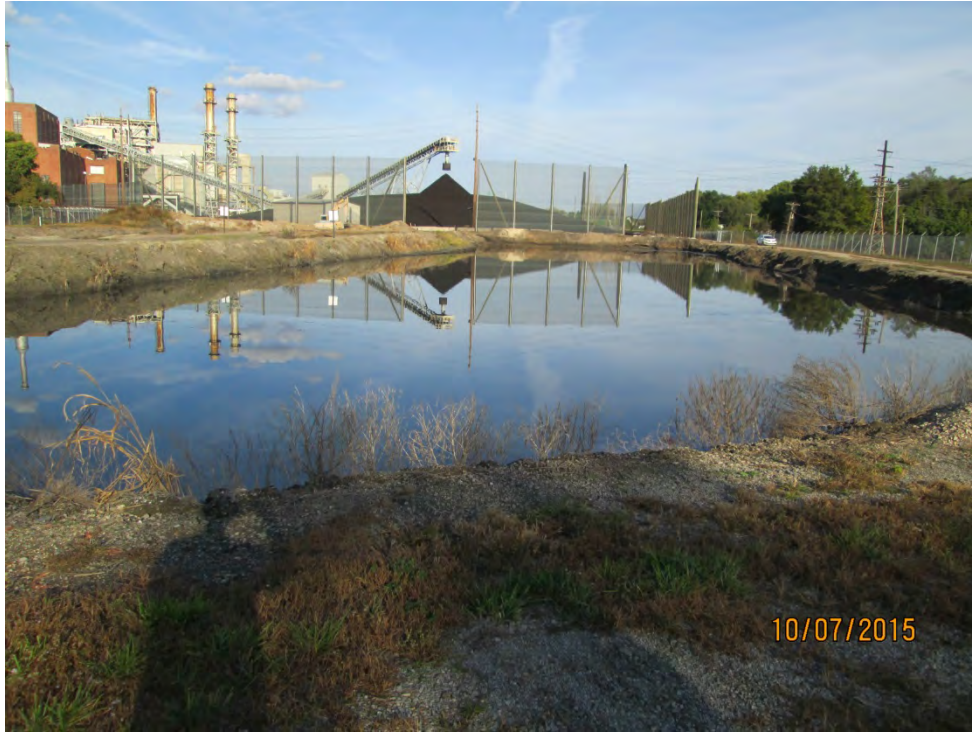
Photo No. 1
South Pond

At the time of the inspection, the north pond had been drained and the full height of the internal slope was visible. The south pond was filled with water with approximately 3 ft of the slope visible above the water surface (pond level at approximately El. 882). See Photos 1 through 4.

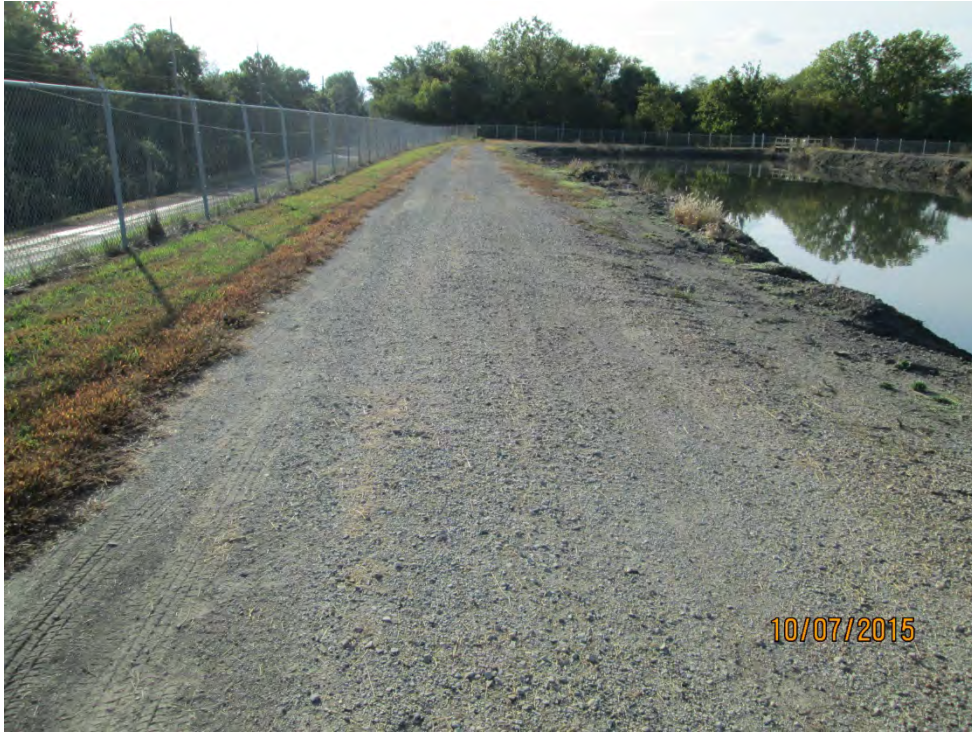
Photo No. 5
South Berm Crest

The berm crests are generally 18 to 25 ft in width and are gravel surfaced, providing access to service vehicles around the ponds. The surface is hard and capable of supporting vehicle traffic without significant rutting (Photos 5 and 6).

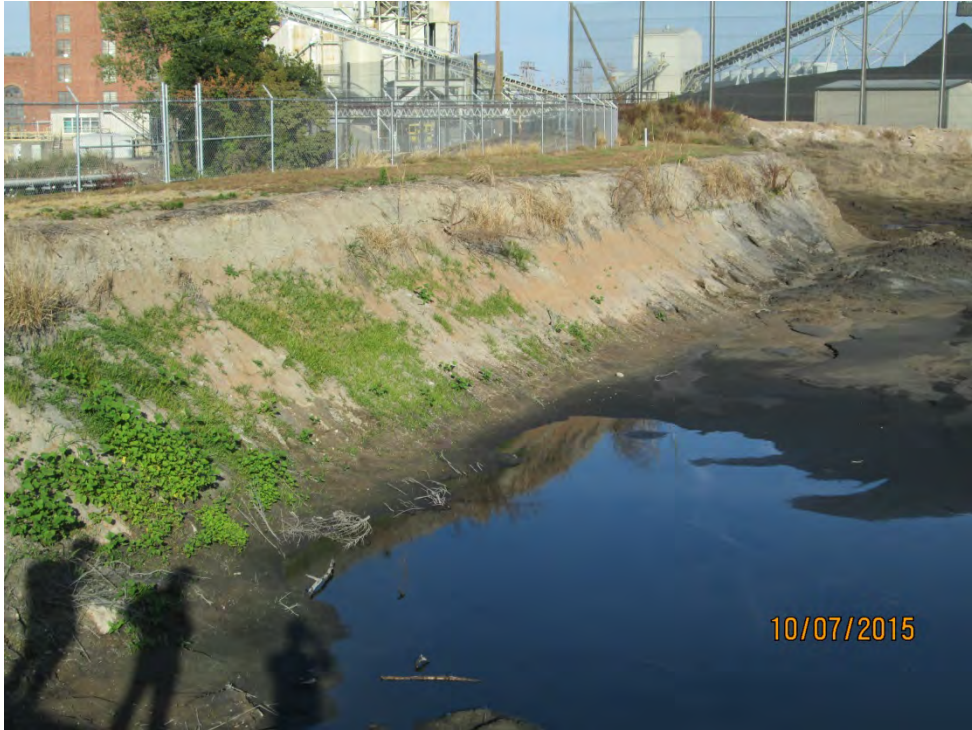
The upstream slopes are steep, ranging from nearly vertical to about 1H:1V. No slope protection is provided and there is little to no vegetation on the slopes. Despite having no protection, the slope appeared to be reasonably stable but exhibited some erosion from runoff (Photos 8 and 9).

Photo No. 9
North Berm Upstream Slope

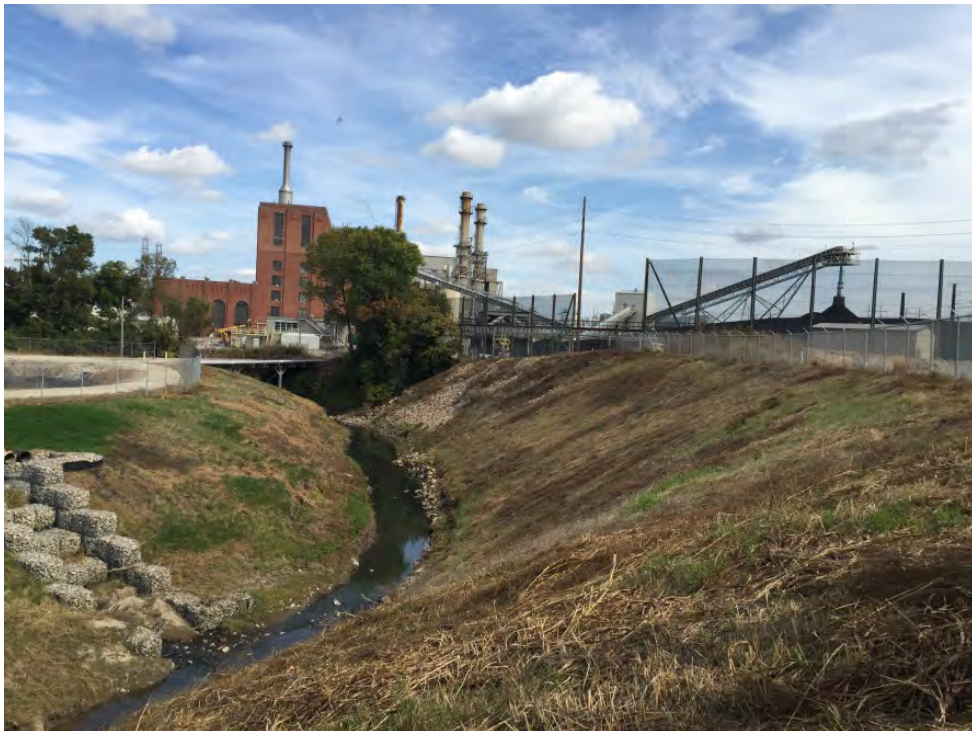
Photograph No. 10
North Berm Downstream Slope

The north and west downstream slopes are well protected against surface erosion by the heavy erosion control blankets placed during 2010 and 2012 construction activities, and by the vegetation that has

become established since construction (Photos 10 and 11). On the north downstream slope, a continuous cover of grass exists that was generally well maintained. On the west downstream slope, vegetation was less established resulting in some areas where the grass was dead. In addition, there were patches where the grass was up to 18 inches in height (Photo 12).

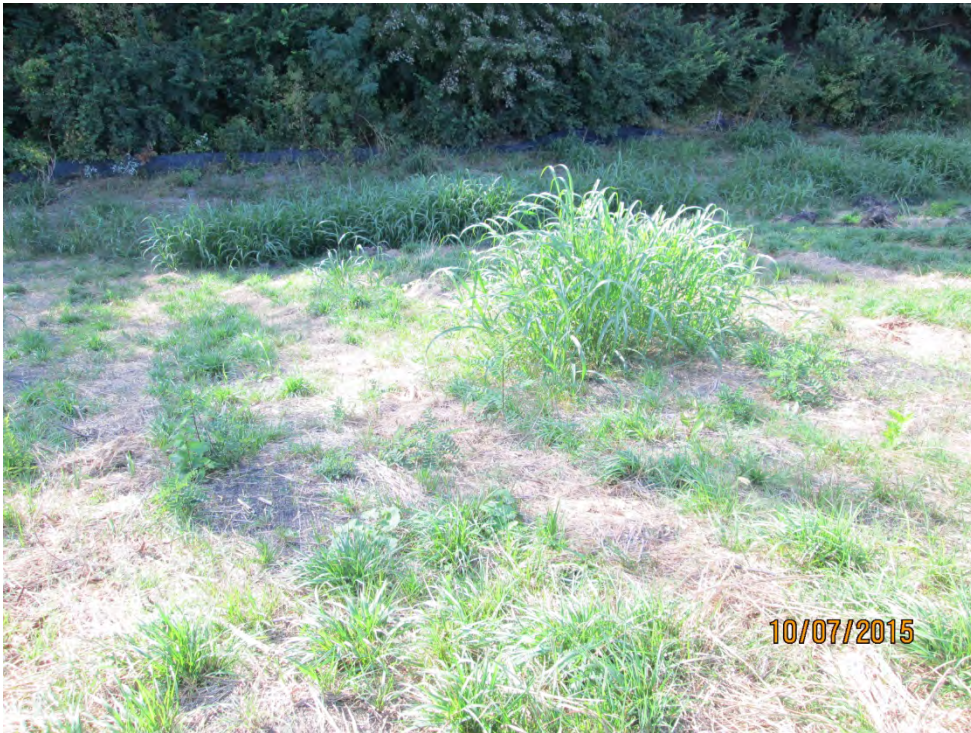
- On the west downstream slope, grass was up to 18 inches in height and patches exist where the grass is dead. On the south berm downstream slope, there are a number of patches (up to 30 ft x 30 ft in size) where the grass is dead.

Photo No. 12
Tall Grass and Dead Vegetation on West Downstream Slope

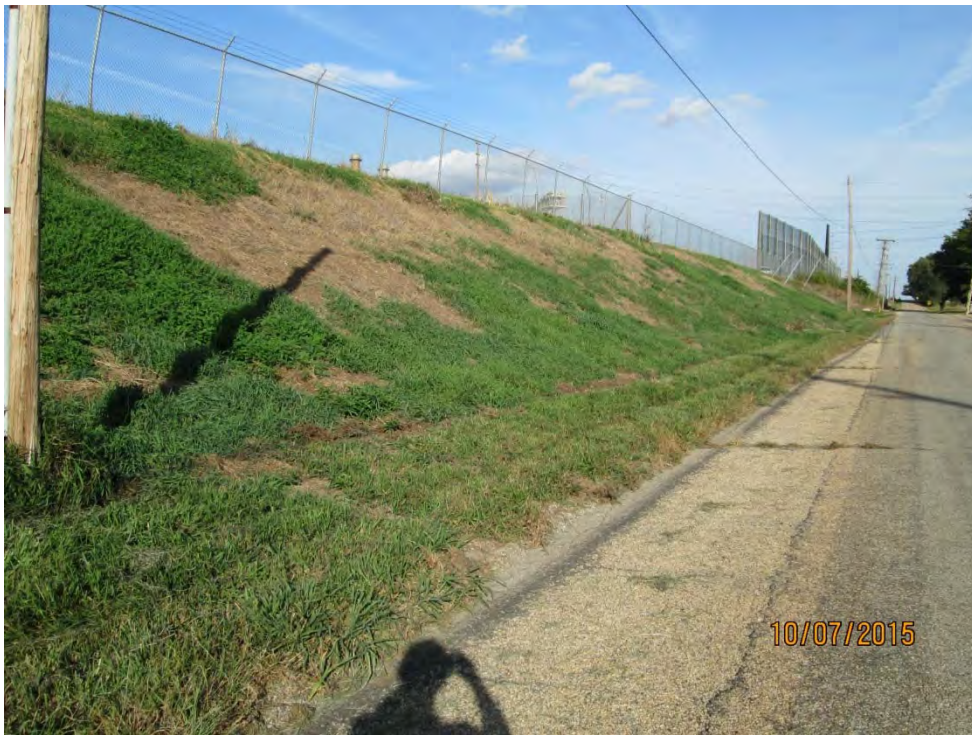
Photo No. 14
South Downstream Slope

The south berm downstream slope is generally vegetated with grass but there were a number of patches where the grass was dead (Photos 14 and 15). The dead patches were up to approximately 30 ft x 30 ft in size. Much of the slope was covered with pieces of woody vegetation that had recently been mowed. With the exception of one area as discussed below, the slope appeared to be stable with no significant erosion or signs of slope instability. A notable exception is a slough that exists on the slope approximately 50 ft west of the chain link gate on SE 2nd Street. Runoff from SE 2nd Street flows to an unlined drainage ditch at the toe of the south berm. Flow in the ditch has deepened the channel to the point that it caused a localized slump, approximately 5 ft x 5 ft in size on the slope (Photos 16 and 17).
