Annual Inspection Report Jeffrey Energy Center Bottom Ash Landfill

Westar Energy

Jeffrey Energy Center

January 2018

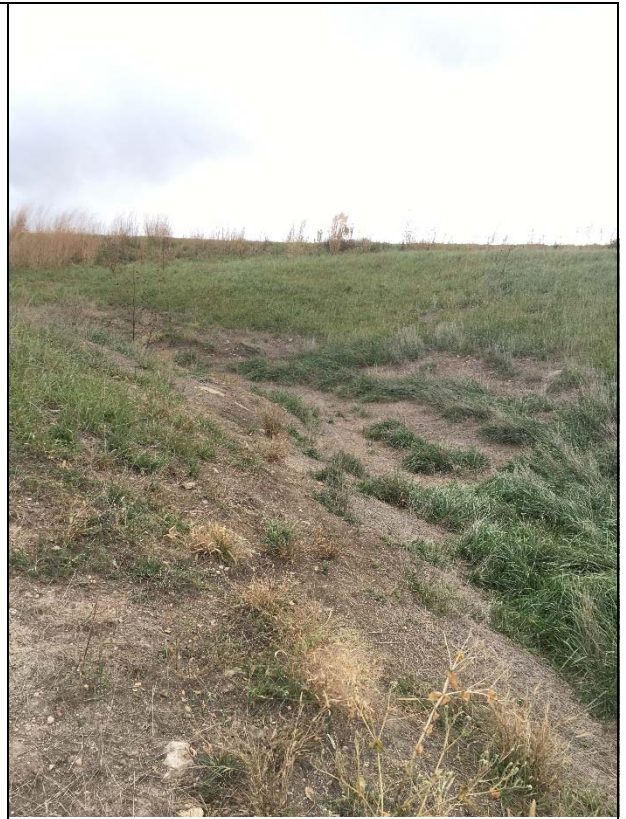
Photograph No. 1

Observing the run-on divergence channel. This channel was regraded since the previous inspection to improve stormwater flow around the Landfill. Vegetation is becoming established within the regrading area, but does not yet have full coverage.

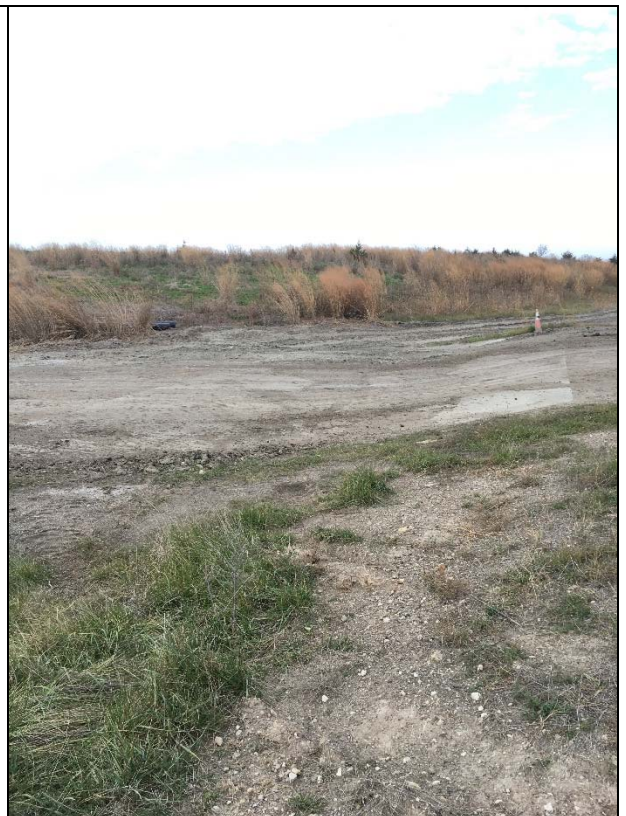
Photograph No. 2

Observing the low water stormwater channel road crossing that conveys water from the run-on divergence channel across the haul road. The channel is lined with concrete at the road crossing location. The recently regraded run-on divergence channel is shown in the foreground. Vegetation has not come fully established yet in the regrading area.

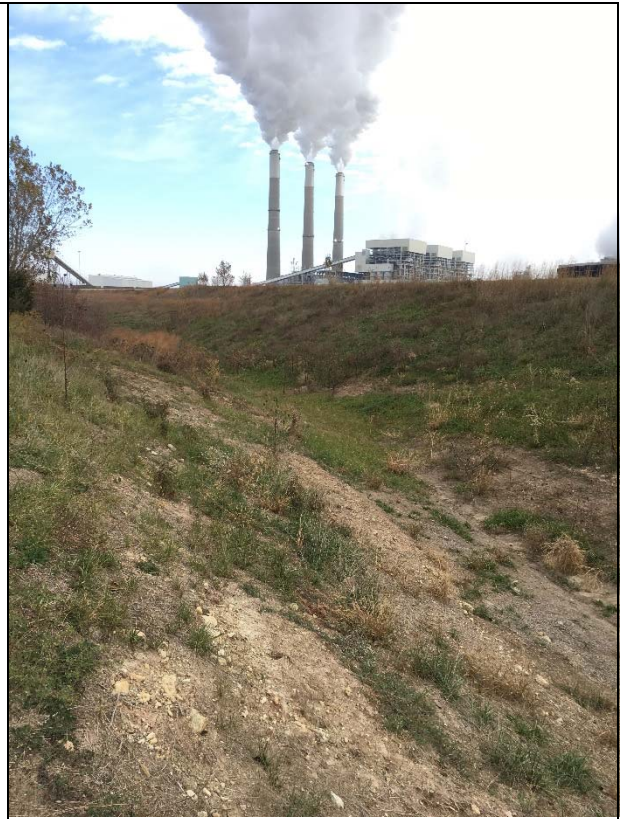
Photograph No. 3

Observing the run-on divergence channel. This channel has been regraded since the 2016 Annual Inspection to improve stormwater flow around the Landfill. Vegetation is becoming established within the regrading area, but does not yet have full coverage.

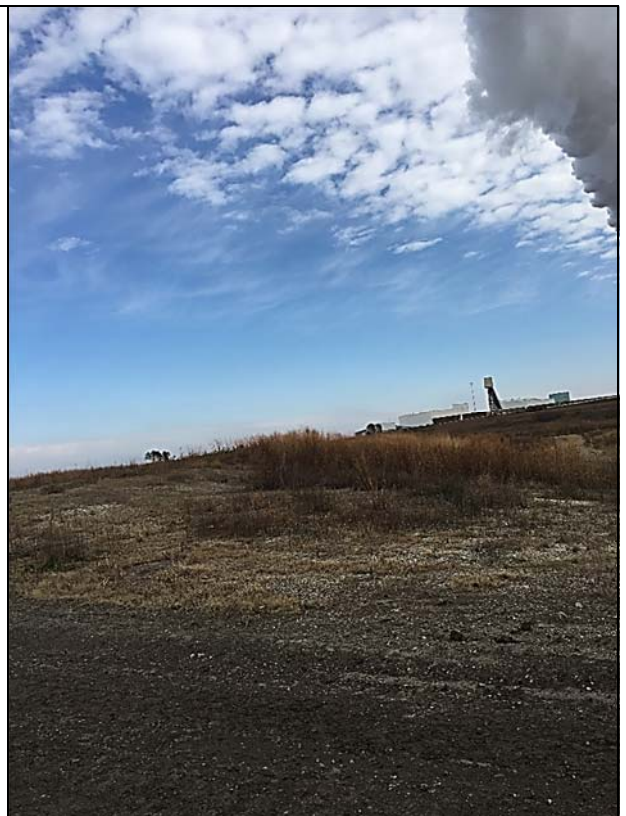
Photograph No. 4

Observing bottom ash within the Landfill. No cover soil has been placed. Some vegetation is growing within the bottom ash. It is anticipated that this area will be grubbed and graded before the final cover is added in the future.

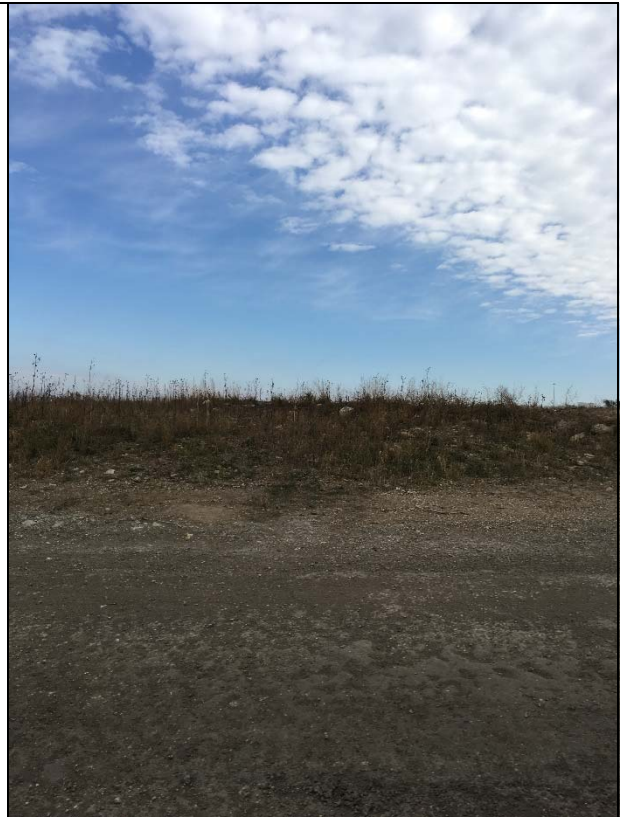
Photograph No. 5

Observing bottom ash within the Landfill. No cover soils have been placed. Some vegetation is growing within the bottom ash. It is anticipated that this area will be grubbed and graded before the final cover is added in the future.

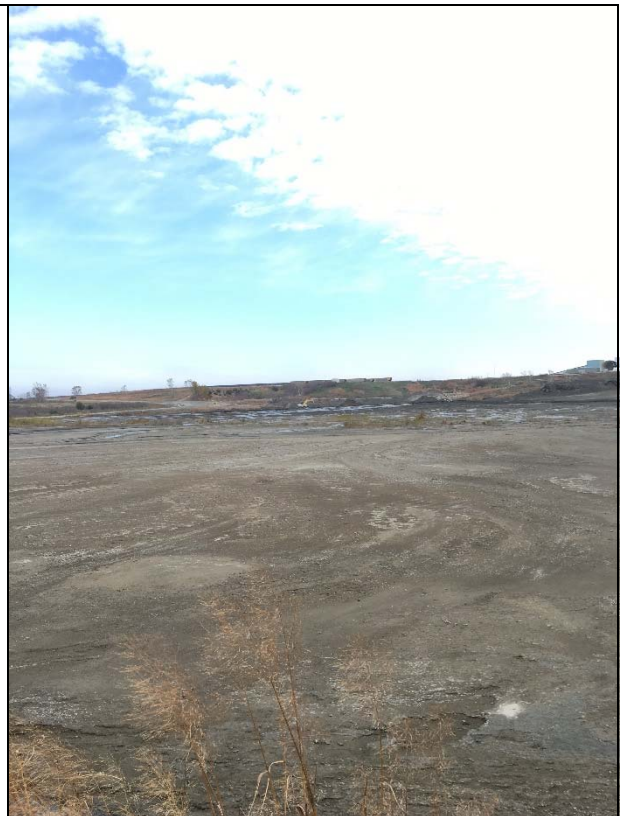
Photograph No. 6

Dried bottom ash is present within the Bottom Ash Surface Impoundment area.

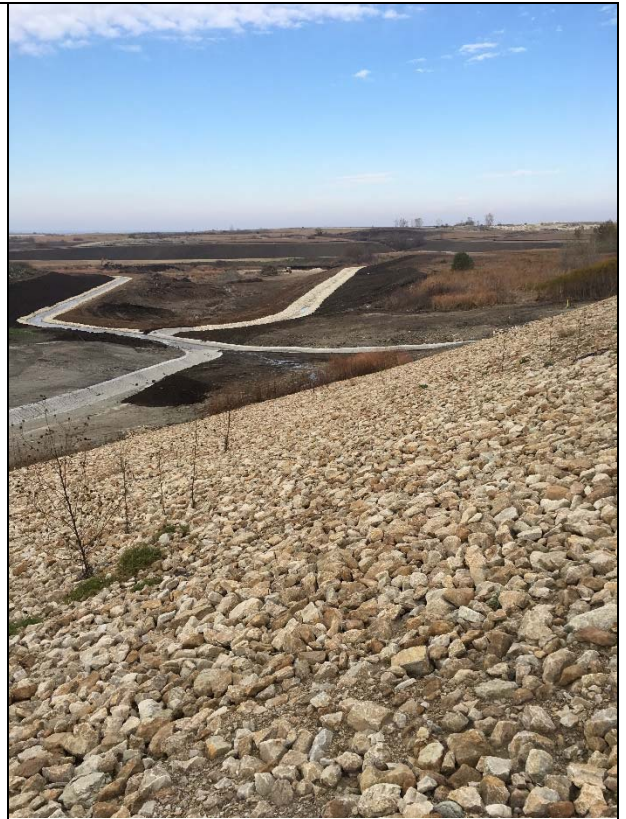
Photograph No. 7

Photograph shows rip-rap that has been placed on the Bottom Ash Area 1 outer berm/impoundment slope. The rip-rap was installed in 2016 to address seeps that were observed during the 2015 Annual Inspection. Rip-rap placement was ongoing at the time of the 2016 Annual Inspection. The rip-rap appears to be evenly installed with no evidence of migration. No seeps were observed from the wall. Some vegetation is present, but was largely dead due to routine herbicide spraying. The outer slope is in good condition with no stability or erosion issues.

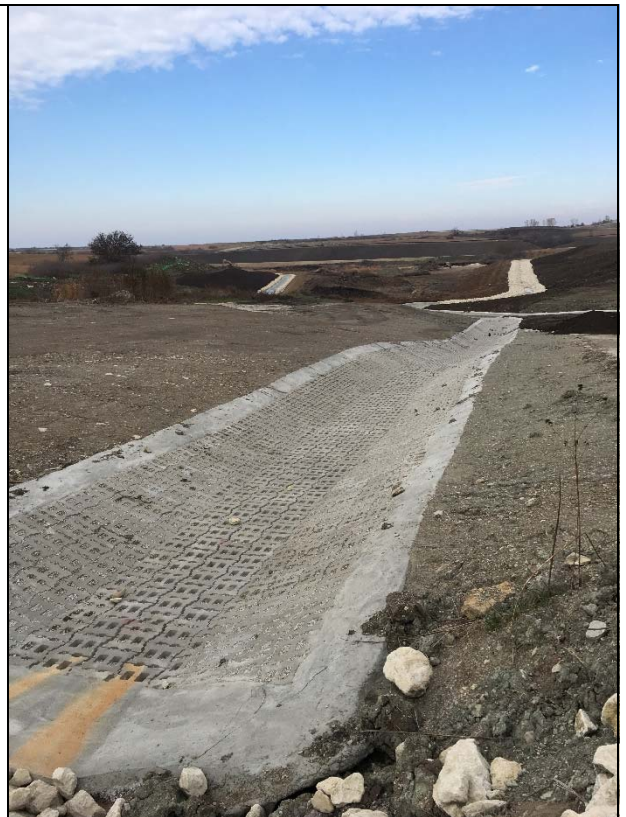
Photograph No. 8

Observing a newly lined stormwater channel at the base of the Bottom Ash Area 1. The channel is free of obstructions and appears in good condition.

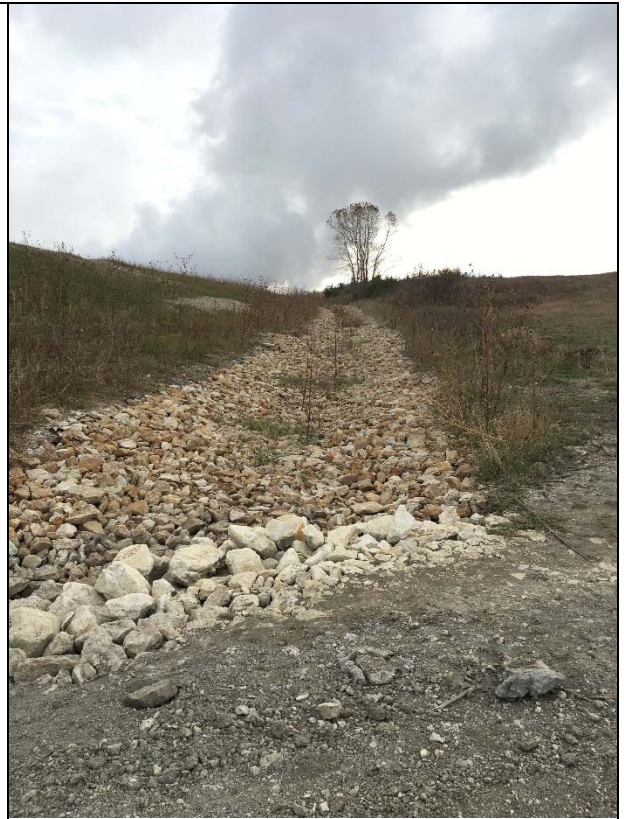
Photograph No. 9

Observing a rip-rap lined stormwater channel at the toe of the bottom ash within Bottom Ash Area 1. The channel is free of obstructions and appears in good condition.

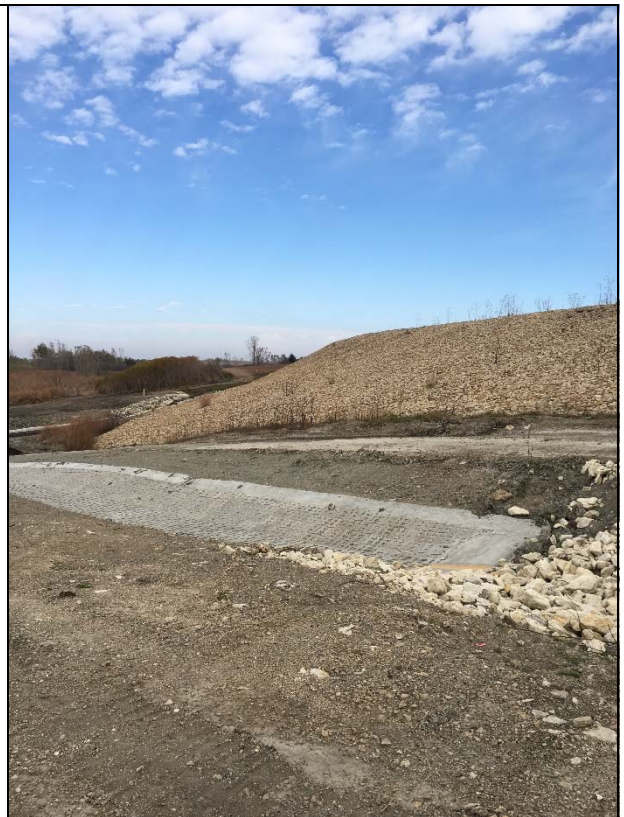
Photograph No. 10

Observing the ditch base of the Bottom Ash Area 1 berm/impoundment at the location where the ditch lining material changes from rip-rap to erosion control lining. The channels are free of obstructions and functioning as intended.

In the background, the outer slope of Bottom Ash Area 1 is shown. The rip-rap was installed in 2016 to address seeps. No seeps were observed from the wall. Some vegetation is present, but was largely dead due to routine herbicide spraying. The outer slope is in good condition with no stability or erosion issues.

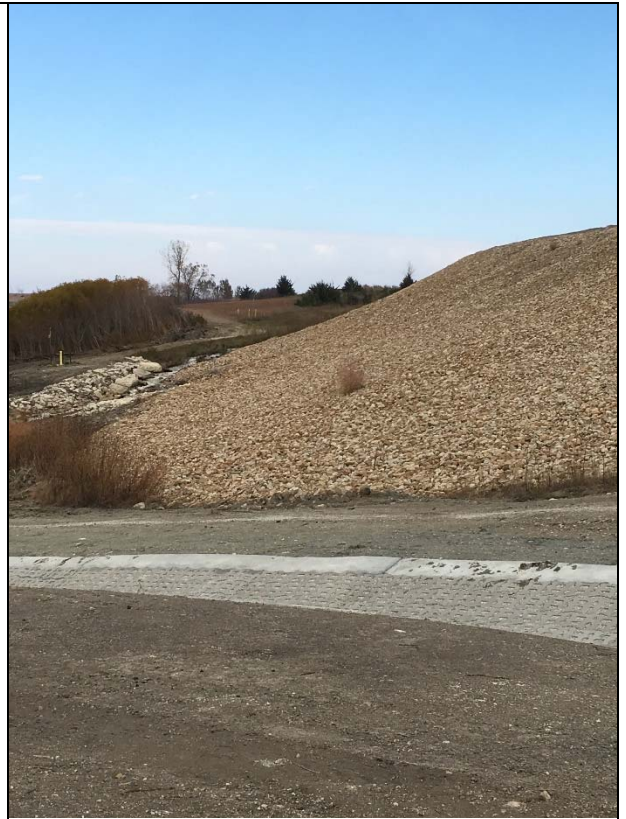
Photograph No. 11

The perimeter channel and outer slope of Bottom Ash Area 1 is shown. The rip-rap was installed in 2016 to address seeps. No seeps were observed from the wall. Some vegetation is present, but was largely dead due to routine herbicide spraying. The outer slope is in good condition with no stability or erosion issues.

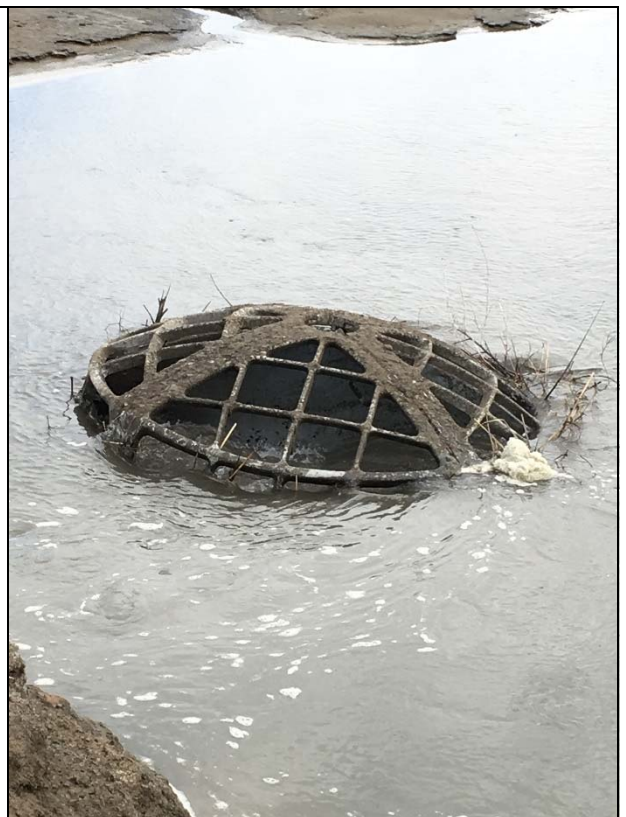
Photograph No. 12

Observing the inlet of the outlet standpipe structure of the Bottom Ash Area 1. The structure is working as intended.

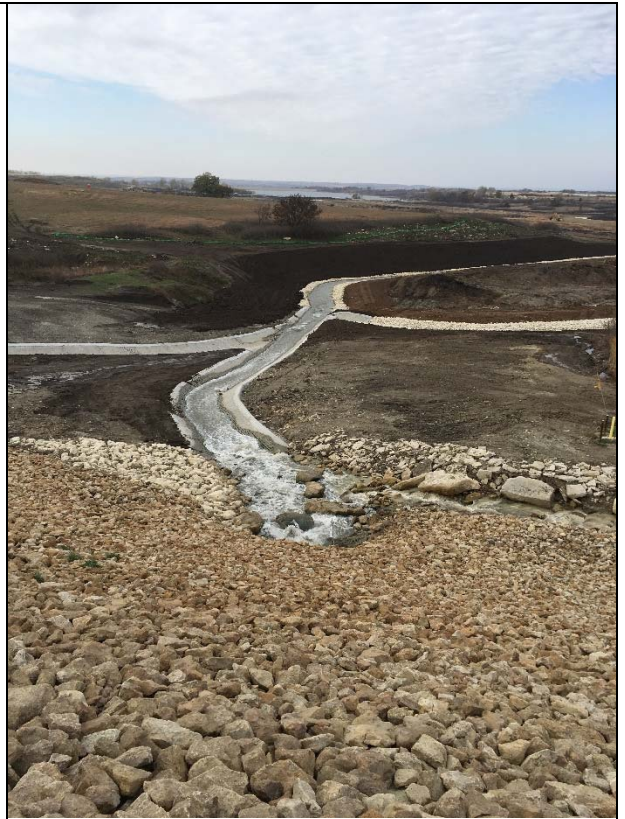
Photograph No. 13

Observing the bottom ash outlet (center). The outlet structure and channel leading to the outlet are functioning as intended.

- Continue to monitor and maintain rip-rap at the base of the outlet pipe of the Bottom Ash Area Surface Impoundment (see Photograph 13 in **Appendix A**).
- Continue to monitor erosion controls and vegetative cover in line with the routine inspections.
- Continue proper management of the active Landfill areas.
- Continue to monitor all stormwater conveyance features for signs of erosion or malfunction in line with the routine inspections.

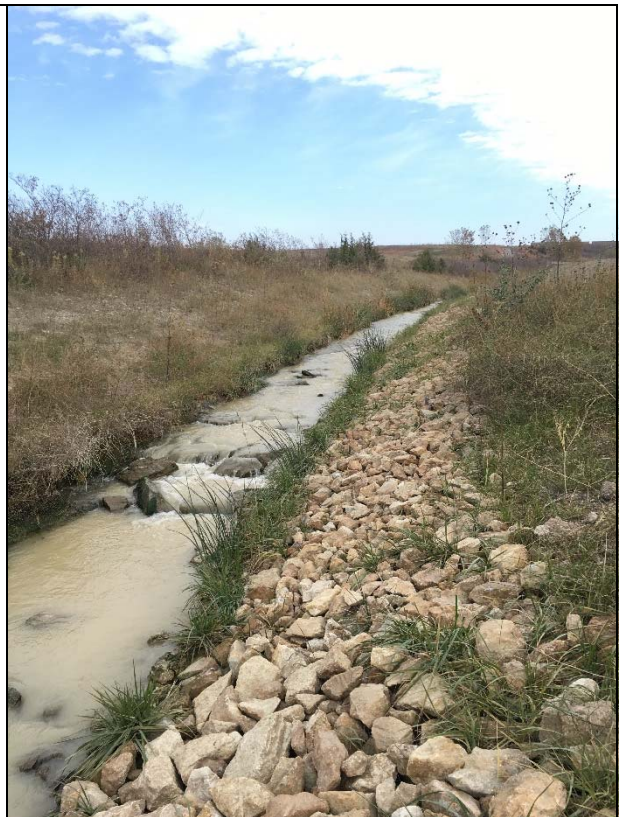
Photograph No. 14

Observing the stormwater run-on divergence channel. This channel captures stormwater and plant process water that would run onto Bottom Ash Area 1 and directs it around the toe of slope to the west. There are no signs of erosion. The channel is functioning as intended.

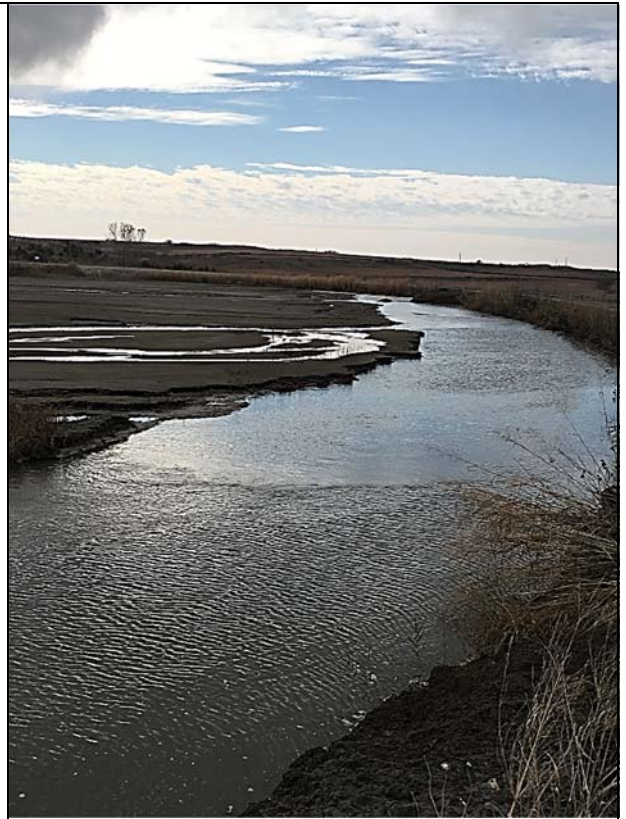
Photograph No. 15

Observing the Bottom Ash Surface Impoundment within Bottom Ash Area 1. Vegetation is present on the sideslopes.

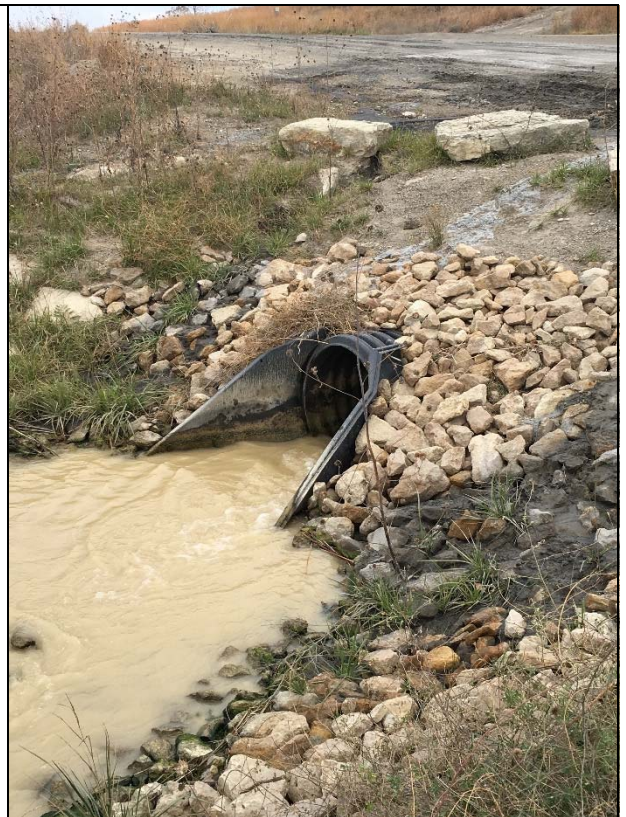
Photograph No. 16

Observing the outlet of an in-line culvert at an access road crossing of the stormwater run-on divergence channel. No evidence of erosion or distress. The culvert showed no signs of buckling or crushing and is functioning as intended. No flow obstructions were observed.

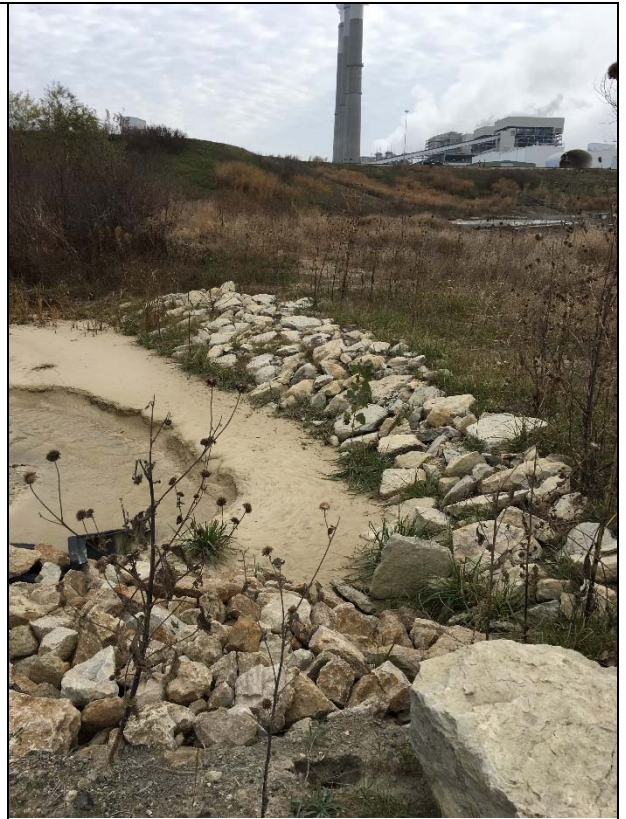
Photograph No. 17

Observing the inlet of the in-line culvert at an access road crossing of the stormwater run-on divergence channel. Functioning as intended.
