# Annual Inspection Report Jeffrey Energy Center Bottom Ash Area Surface Impoundment

Westar Energy

Jeffrey Energy Center

January 2017

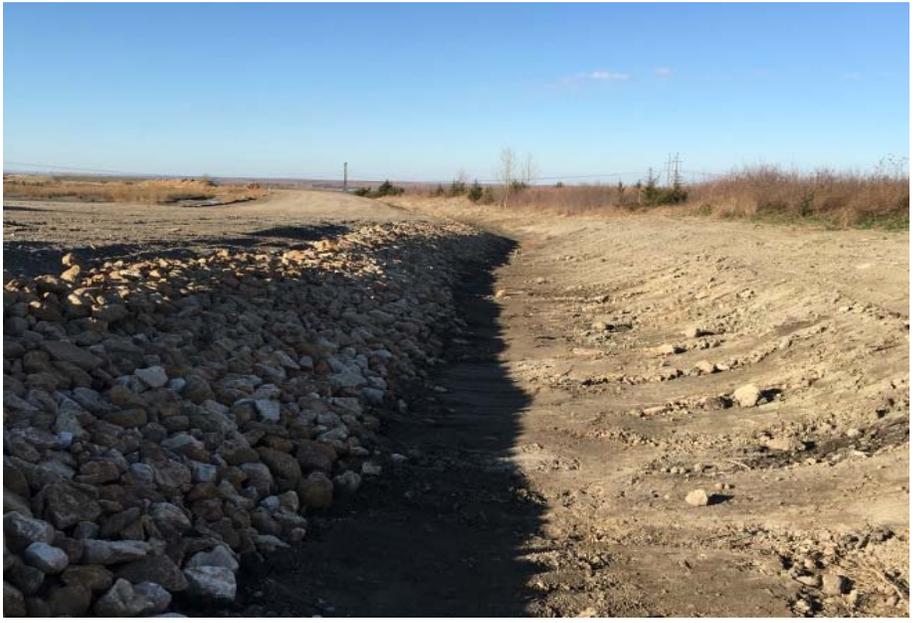
<p><b>Photograph No. 3</b></p> <p><b>Date:</b> November 29, 2016</p> <p><b>Direction:</b> Southwest</p>

<p><b>Description:</b> Non-contact drainage channel with riprap-lined interior slope to address erosion observed during 2015 inspection. Will be seeded and/or lined prior to accepting flow.</p>

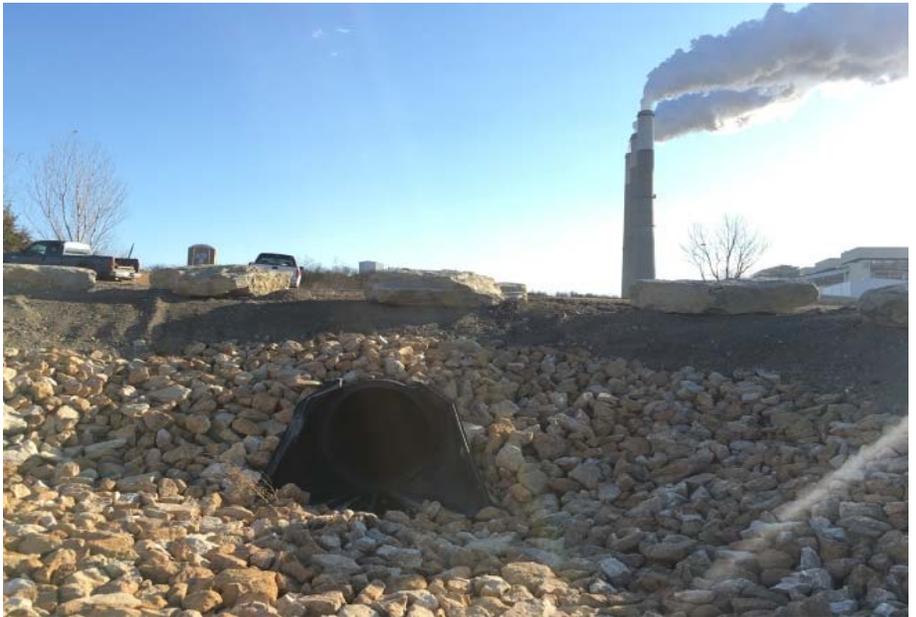
<p><b>Photograph No. 4</b></p> <p><b>Date:</b> November 29, 2016</p> <p><b>Direction:</b> Northeast</p>

<p><b>Description:</b> Looking up-slope of channel at access road crossing. No evidence of erosion or distress.</p>

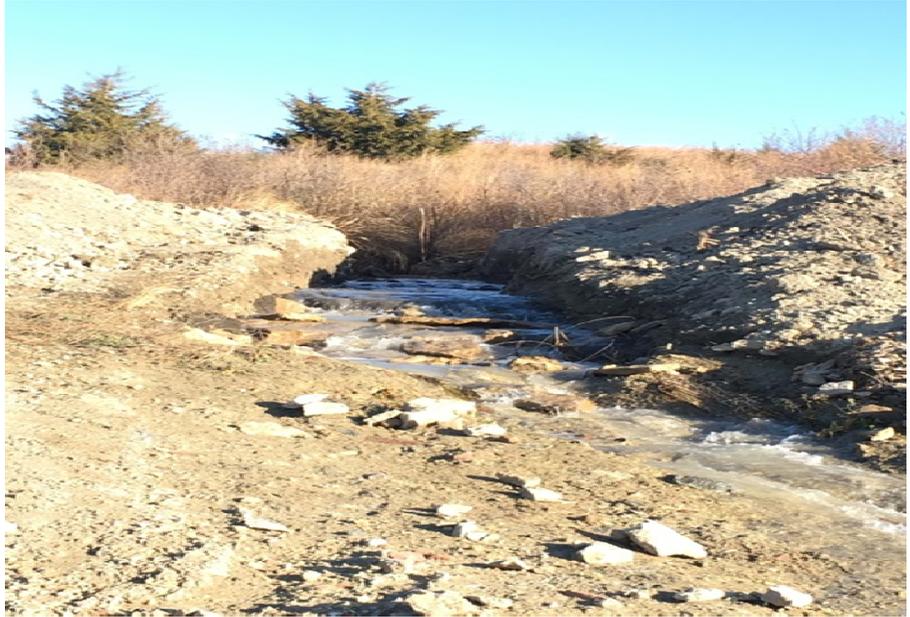
<p><b>Photograph No. 5</b></p> <p><b>Date:</b> November 29, 2016</p> <p><b>Direction:</b> North</p>

<p><b>Description:</b> Looking up-slope at temporary channel used during construction. No evidence of erosion or distress.</p>

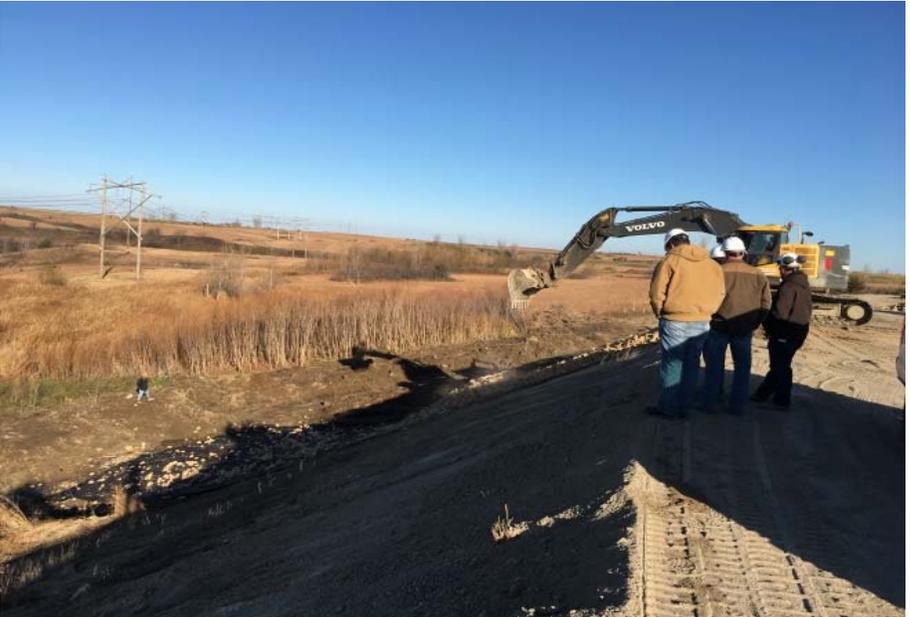
<p><b>Photograph No. 6</b></p> <p><b>Date:</b> November 29, 2016</p> <p><b>Direction:</b> Northwest</p>

<p><b>Description:</b> Observing a backhoe placing and compacting riprap to address seepage erosion observed during 2015 inspection.</p>

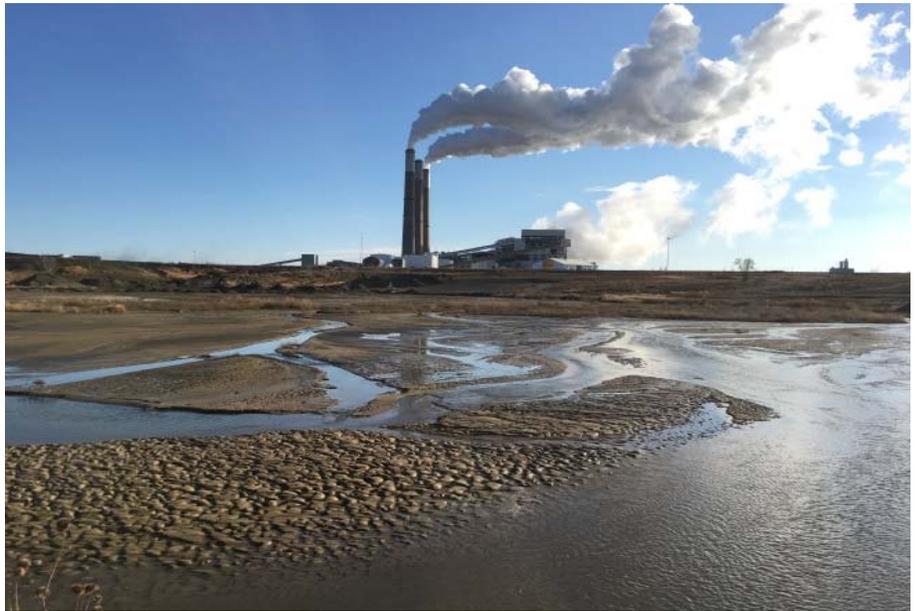
<p><b>Photograph No. 7</b></p> <p><b>Date:</b> November 29, 2016</p> <p><b>Direction:</b> Northeast</p>

<p><b>Description:</b> Observing process water collection within the surface impoundment. No evidence of malfunction.</p>

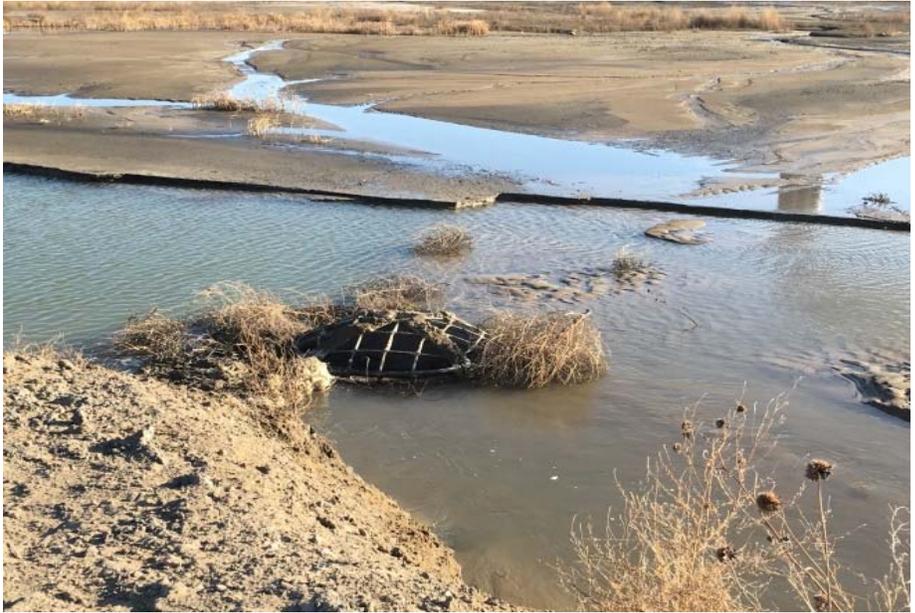
<p><b>Photograph No. 8</b></p> <p><b>Date:</b> November 29, 2016</p> <p><b>Direction:</b> Northeast</p>

<p><b>Description:</b> Observing the repaired outlet pipe structure of the surface impoundment to address damage observed during 2015 inspection.</p>

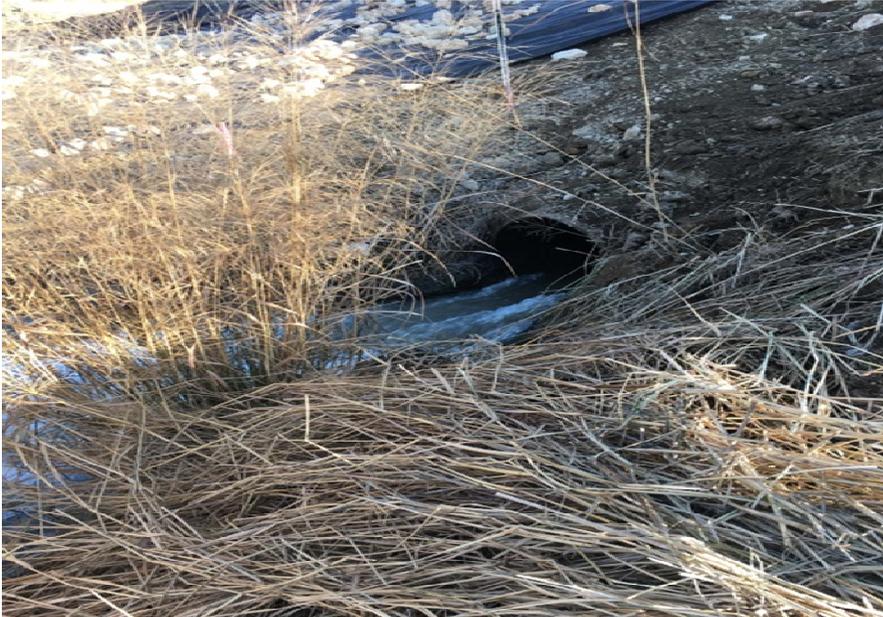
<p><b>Photograph No. 9</b></p> <p><b>Date:</b> November 29, 2016</p> <p><b>Direction:</b> East</p>

<p><b>Description:</b> Observing outlet pipe structure at the toe of the surface impoundment slope. Erosion stabilization controls are recommended at this outlet.</p>

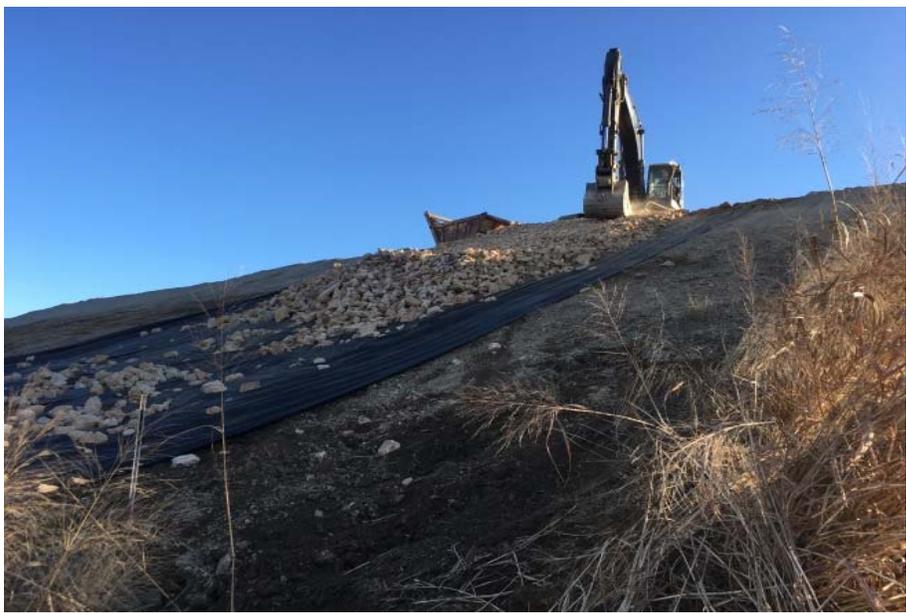
<p><b>Photograph No. 10</b></p> <p><b>Date:</b> November 29, 2016</p> <p><b>Direction:</b> Northeast</p>

<p><b>Description:</b> Observing a backhoe placing and compacting riprap to address seepage erosion observed during 2015 inspection.</p>

- ❑ Erosion areas that were identified have been stabilized with vegetation or riprap. See Photograph 13.
- ❑ The vertical riser intake pipe has been repaired. All vegetated side slopes have been properly cut and maintained. See Photograph 8.
- ❑ The north perimeter channel has been redesigned with riprap to minimize the potential for erosion along the perimeter berm toe of slope. See Photograph 3.
- ❑ Seepage erosion on the downstream slope of the west perimeter berm has been repaired with a riprap stabilized flow path to direct seepage in a non-erosive manner. See Photograph 10.

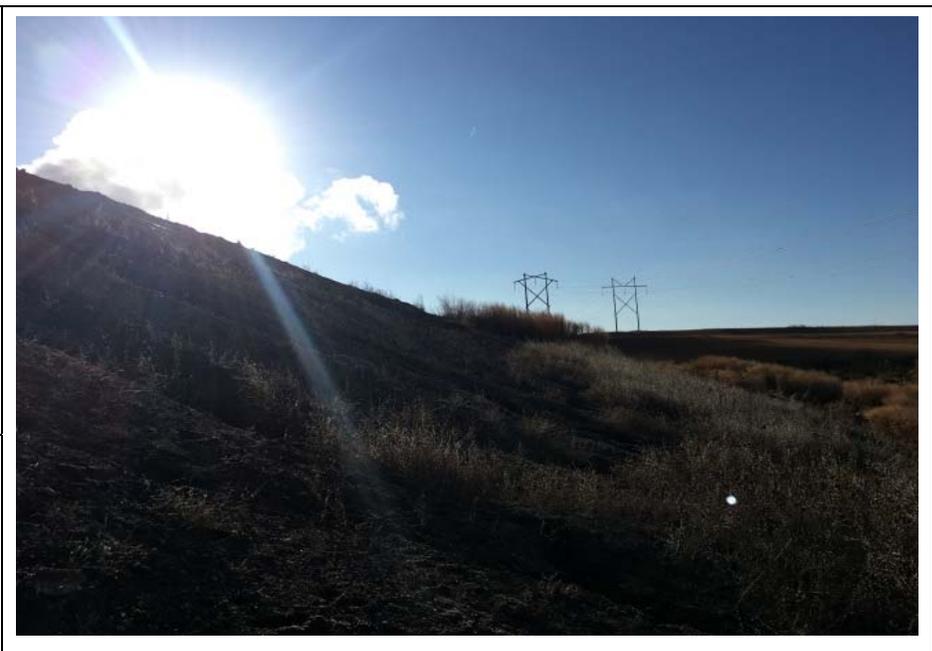
<p><b>Photograph No. 11</b></p> <p><b>Date:</b> November 29, 2016</p> <p><b>Direction:</b> Southeast</p>

<p><b>Description:</b> Observing the landfill perimeter berm slopes and non-contact stormwater ditch. Vegetation is well-established and maintained. No evidence of erosion or sloughing.</p>

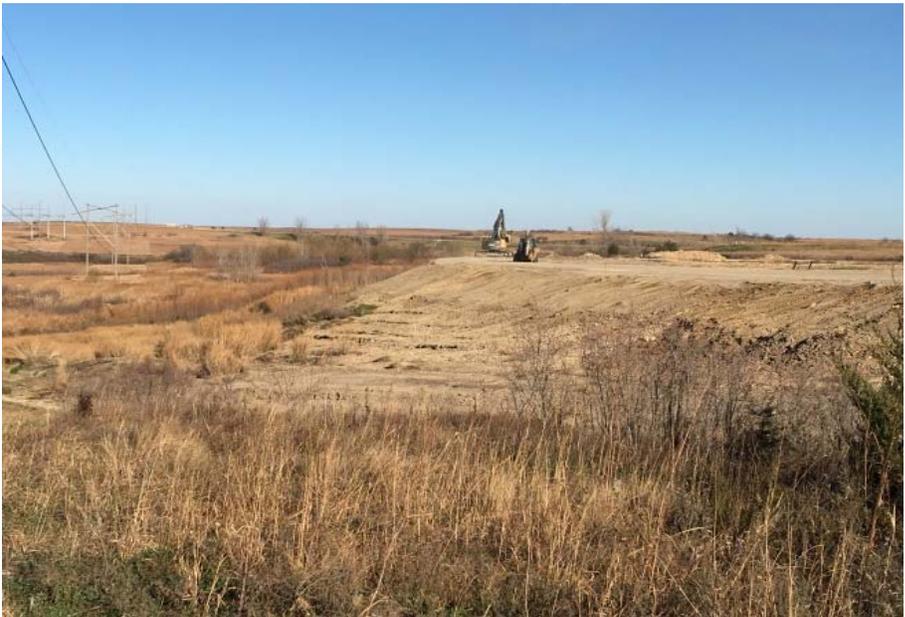
<p><b>Photograph No. 13</b></p> <p><b>Date:</b> November 29, 2016</p> <p><b>Direction:</b> North</p>

A wide-angle photograph showing a large, flat, sandy area under a clear blue sky. In the distance, a yellow excavator is visible on the sand. The foreground is filled with tall, dry, golden-brown grasses. Power lines are visible on the left side of the frame.
<p><b>Description:</b> Overview of the Bottom Ash Area 1 surface impoundment.</p>

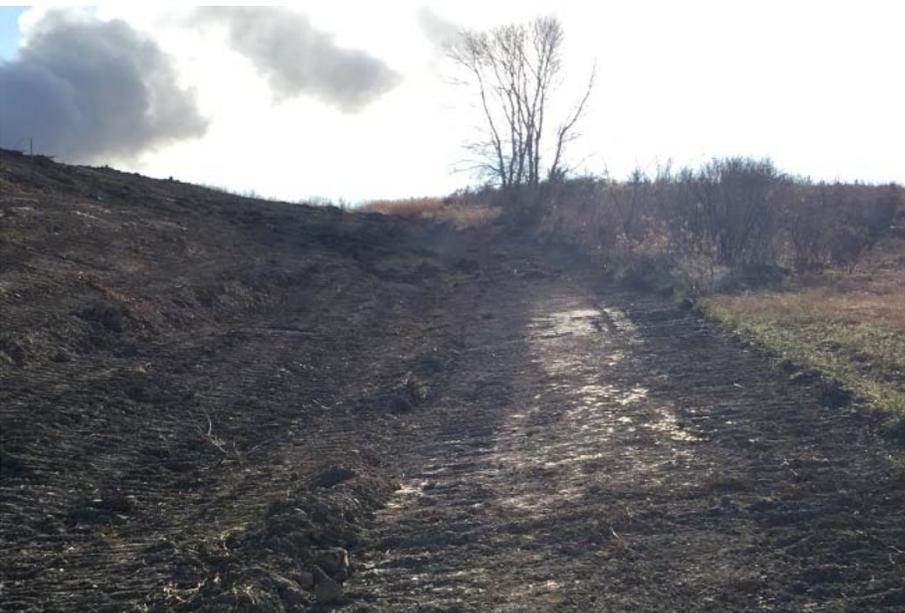
<p><b>Photograph No. 14</b></p> <p><b>Date:</b> November 29, 2016</p> <p><b>Direction:</b> Southeast</p>

A photograph of a newly constructed stormwater ditch. The ditch is a narrow, dark channel cut into the earth, running from the foreground towards the background. The surrounding area is a mix of dark soil and sparse, dry vegetation. The sky is overcast with grey clouds.
<p><b>Description:</b> Observing newly constructed non-contact stormwater ditch along western perimeter.</p>

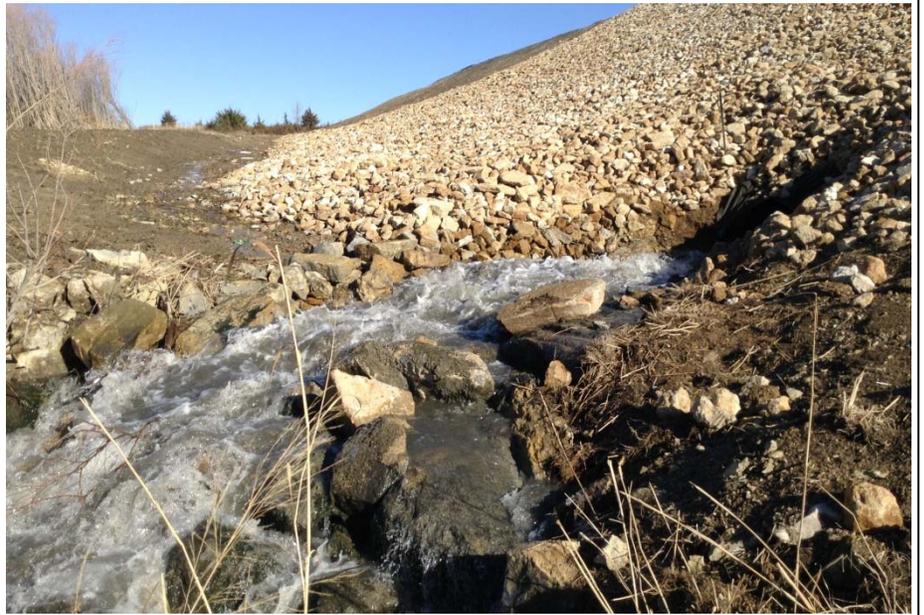
**Photograph No. 15**

During the on-site inspection, slope appearance, slope stability, and overall site conditions were assessed. No erosion or sloughing was observed along the Surface Impoundment perimeter berm. Minor erosion was observed at the Bottom Ash Area Surface Impoundment discharge location on the west side of the berm. Following the annual inspection, rip-rap has been placed at this discharge location to minimize the potential for erosion. Photograph 9 depicts the discharge location during the annual inspection. Photograph 15 depicts the rip-rap that has been placed at the discharge location.

Observing erosion repaired with rip-rap at Bottom Ash discharge location.

- Continue to monitor and maintain rip-rap at the base of the outlet pipe of the Bottom Ash Area Surface Impoundment (see Photograph 15).
- Continue to monitor erosion controls and vegetative cover in line with the weekly inspections.
- Continue proper management of the inflow control system and gradient flowing to the outlet structure.
- Continue to monitor all conveyance features for signs of erosion, damage, obstructions, or malfunction in line with the weekly inspections
