Annual Inspection Report Jeffrey Energy Center Bottom Ash Area Surface Impoundment

Prepared for:
Westar Energy
Jeffrey Energy Center
St. Marys, Kansas

Prepared by:
APTIM Environmental & Infrastructure, Inc.

January 2018

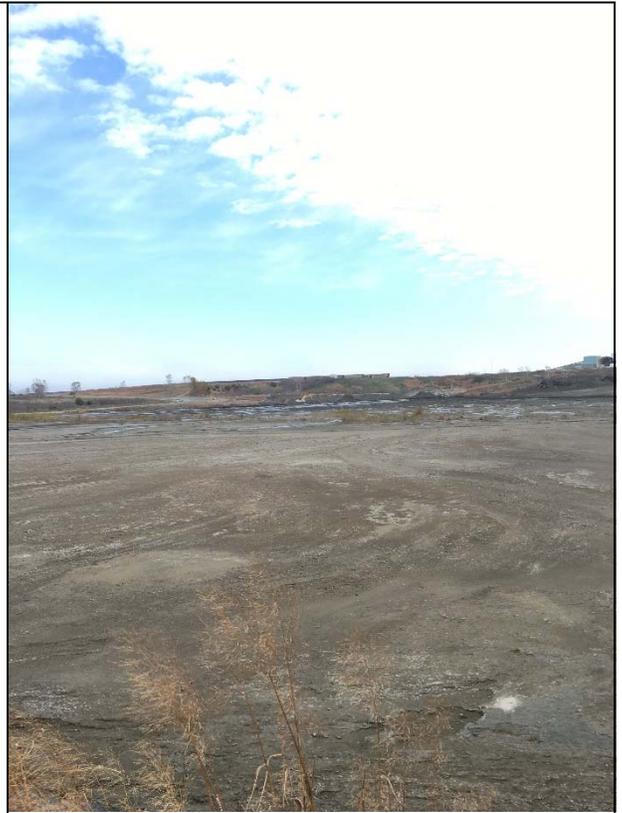
Photograph No. 1

At the time of inspection, there was little to no water in the Surface Impoundment (see Photo No. 1 in **Appendix A**). There is a small channel running through the Surface Impoundment which is where most of the water is stored (see Photograph No. 10 in **Appendix A**). It can be seen in Photograph No. 7 that the water is at the elevation of the outlet in the Surface Impoundment, which is approximately at 1239.25 ft mean sea level (MSL).

Dried bottom ash is present within the Bottom Ash Surface Impoundment area.

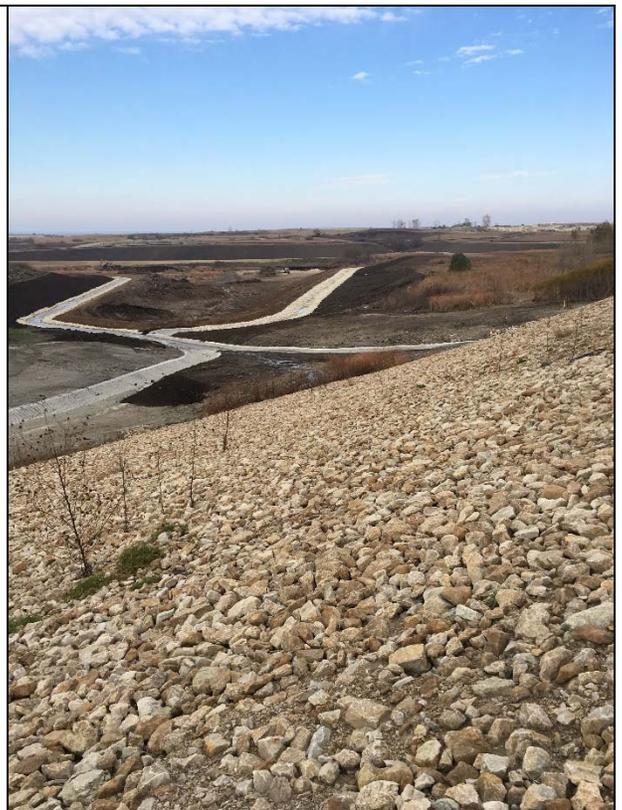
Photograph No. 2

Photograph shows rip-rap that has been placed on the Bottom Ash Area 1 outer berm/impoundment slope. The rip-rap was installed in 2016 to address seeps that were observed during the 2015 Annual Inspection. Rip-rap placement was ongoing at the time of the 2016 Annual Inspection. The rip-rap appears to be evenly installed with no evidence of migration. No seeps were observed from the wall. Some vegetation is present, but was largely dead due to routine herbicide spraying. The outer slope is in good condition with no stability or erosion issues.

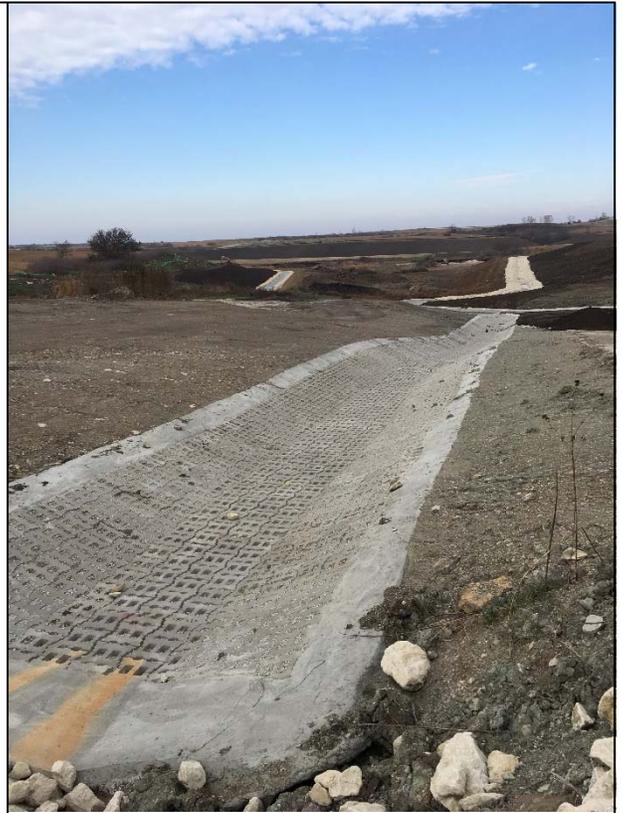
Photograph No. 3

Observing a newly lined stormwater channel at the base of the Bottom Ash Area 1. The channel is free of obstructions and appears in good condition.

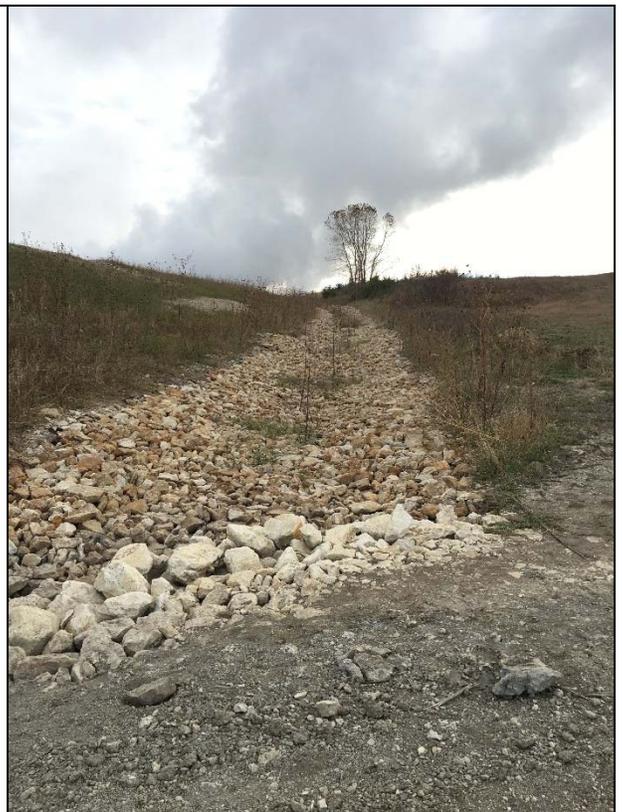
Photograph No. 4

Observing a rip-rap lined stormwater channel at the toe of the bottom ash within Bottom Ash Area 1. The channel is free of obstructions and appears in good condition.

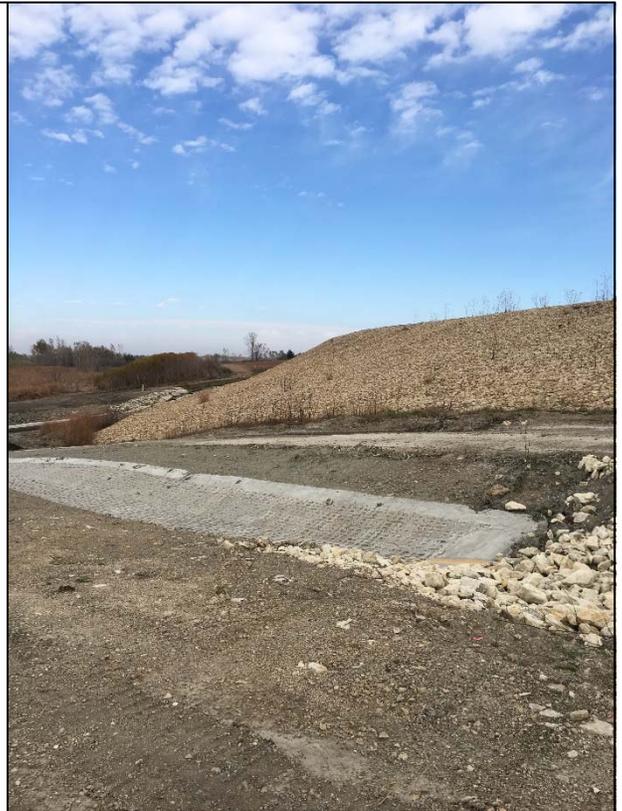
Photograph No. 5

Observing the ditch base of the Bottom Ash Area 1 berm/impoundment at the location where the ditch lining material changes from rip-rap to erosion control lining. The channels are free of obstructions and functioning as intended.

In the background, the outer slope of Bottom Ash Area 1 is shown. The rip-rap was installed in 2016 to address seeps. No seeps were observed from the wall. Some vegetation is present, but was largely dead due to routine herbicide spraying. The outer slope is in good condition with no stability or erosion issues.

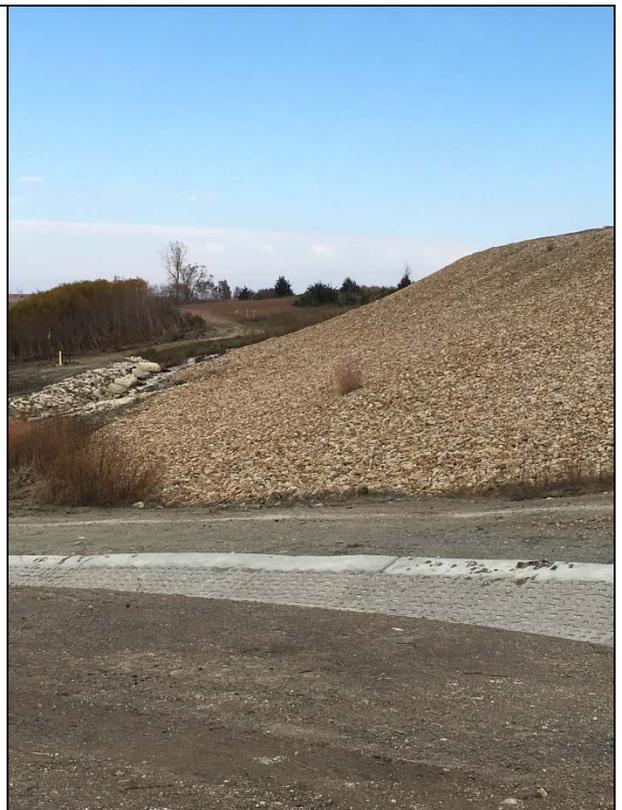
Photograph No. 6

The perimeter channel and outer slope of Bottom Ash Area 1 is shown. The rip-rap was installed in 2016 to address seeps. No seeps were observed from the wall. Some vegetation is present, but was largely dead due to routine herbicide spraying. The outer slope is in good condition with no stability or erosion issues.

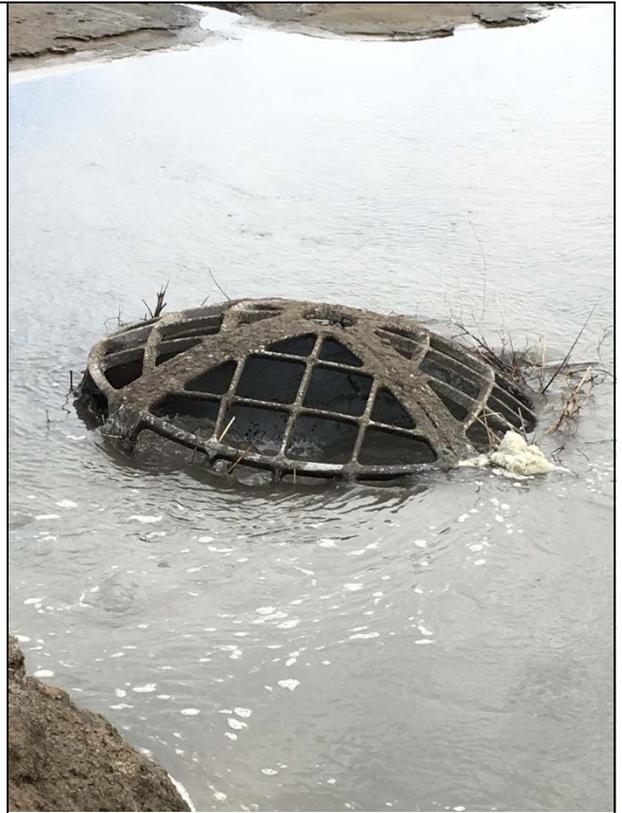
Photograph No. 7

Observing the inlet of the outlet standpipe structure of the Bottom Ash Area 1. The structure is working as intended.

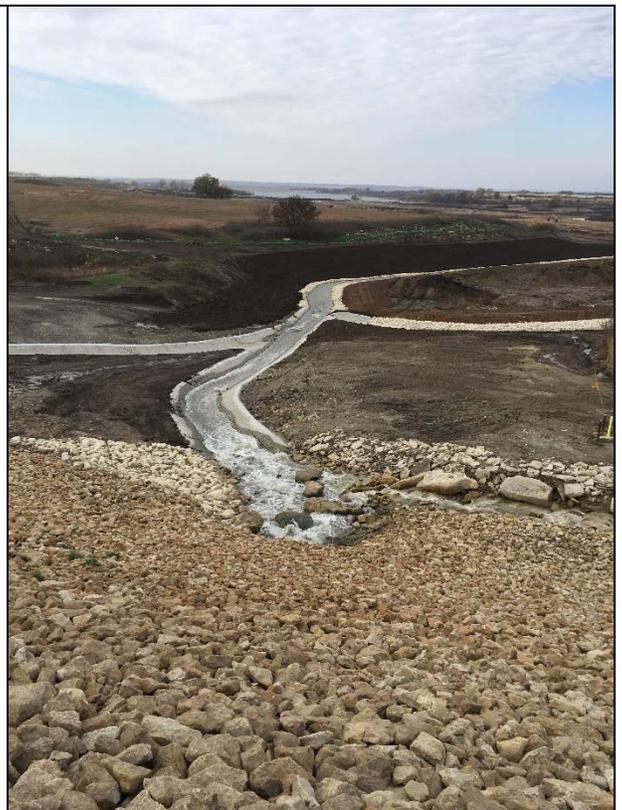
Photograph No. 8

Observing the bottom ash outlet (center). The outlet structure and channel leading to the outlet are functioning as intended.

- Continue to monitor and maintain rip-rap at the base of the outlet pipe of the Surface Impoundment (see Photograph 8 in **Appendix A**).
- Continue to monitor erosion controls and vegetative cover in line with the required inspections.
- Continue proper management of the inflow control system and gradient flowing to the outlet structure.
- Continue to monitor all conveyance features for signs of erosion, damage, obstructions, or malfunction in line with the required inspections

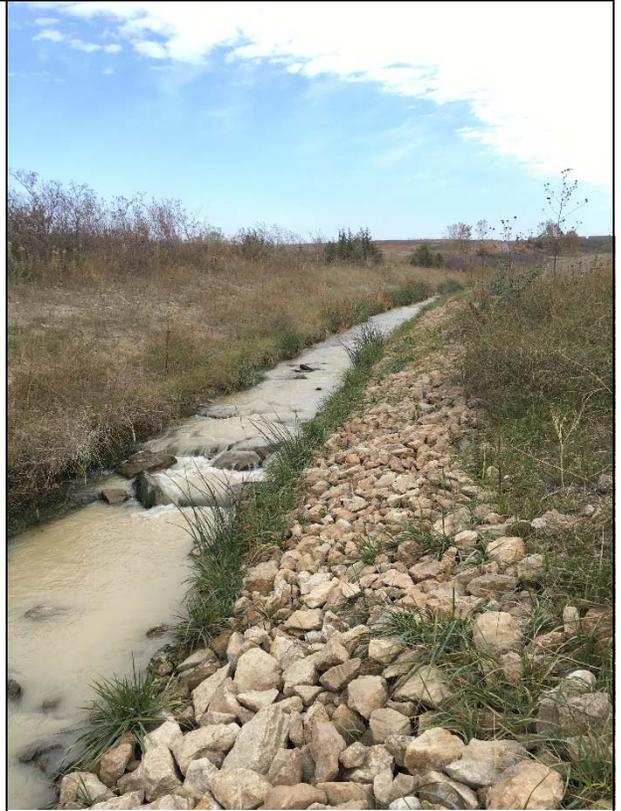
Photograph No. 9

Observing the stormwater run-on divergence channel. This channel captures stormwater and plant process water that would run onto Bottom Ash Area 1 and directs it around the toe of slope to the west. There are no signs of erosion. The channel is functioning as intended.

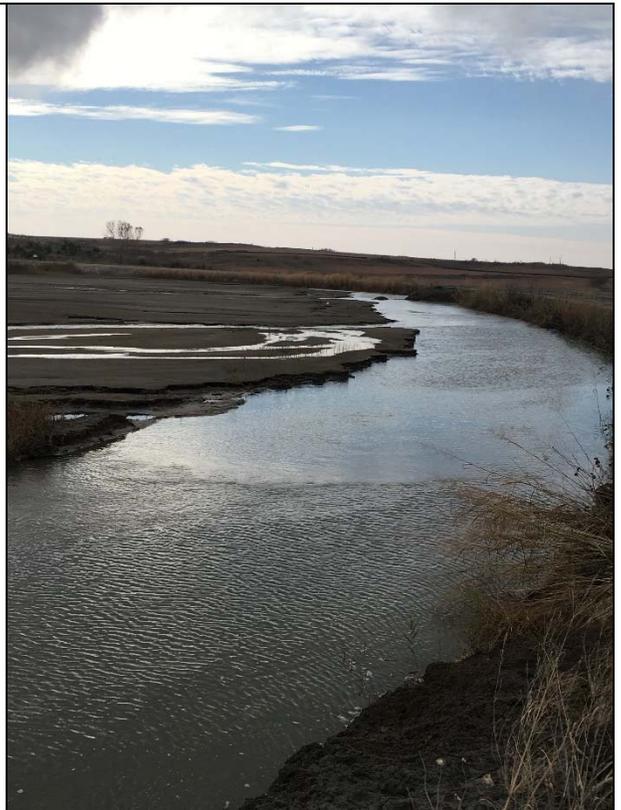
Photograph No. 10

Observing the Bottom Ash Surface Impoundment within Bottom Ash Area 1. Vegetation is present on the sideslopes.

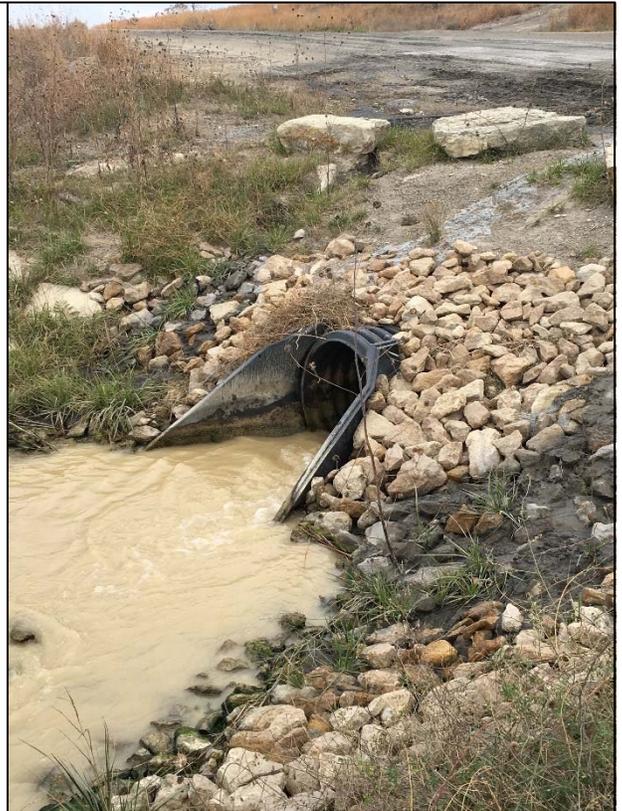
Photograph No. 11

Observing the outlet of an in-line culvert at an access road crossing of the stormwater run-on divergence channel. No evidence of erosion or distress. The culvert showed no signs of buckling or crushing and is functioning as intended. No flow obstructions were observed.

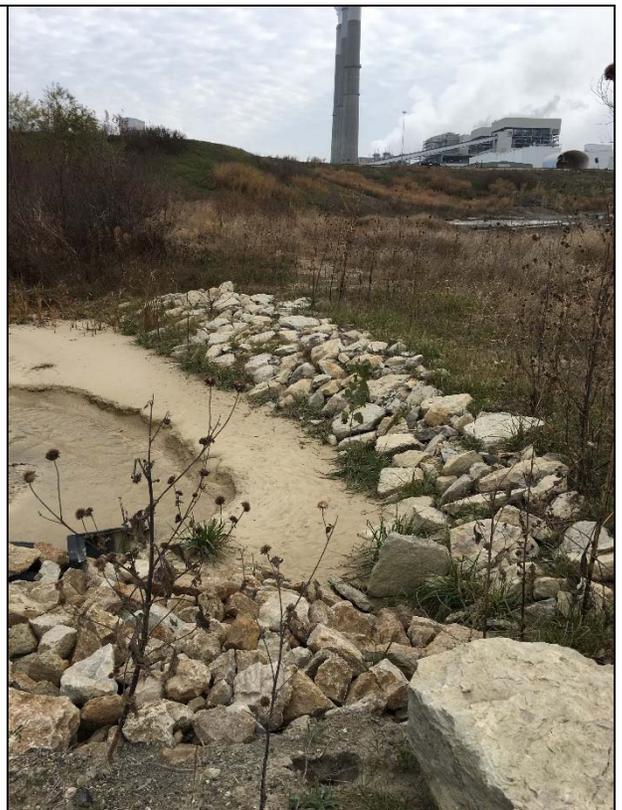
Photograph No. 12

Observing the inlet of the in-line culvert at an access road crossing of the stormwater run-on divergence channel. Functioning as intended.
