Annual Inspection Report Jeffrey Energy Center Flue Gas Desulfurization (FGD) Landfill

Westar Energy

Jeffrey Energy Center

January 2017

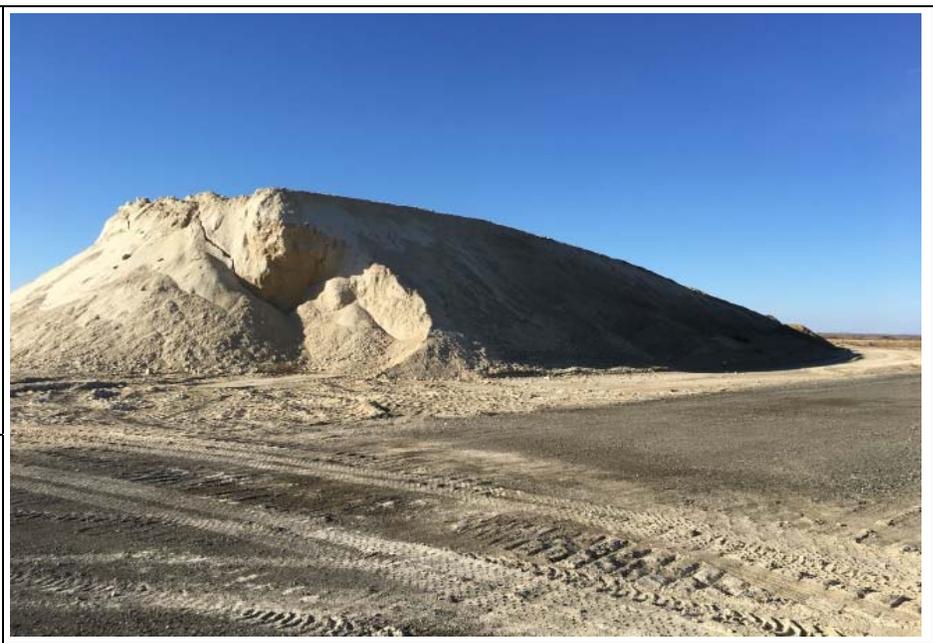
<p>Photograph No. 1</p> <p>Date: November 29, 2016</p> <p>Direction: Northwest</p>

<p>Description: Observing the FGD beneficial use pile. No evidence of erosion or sloughing. No dust is being generated, despite windy conditions.</p>

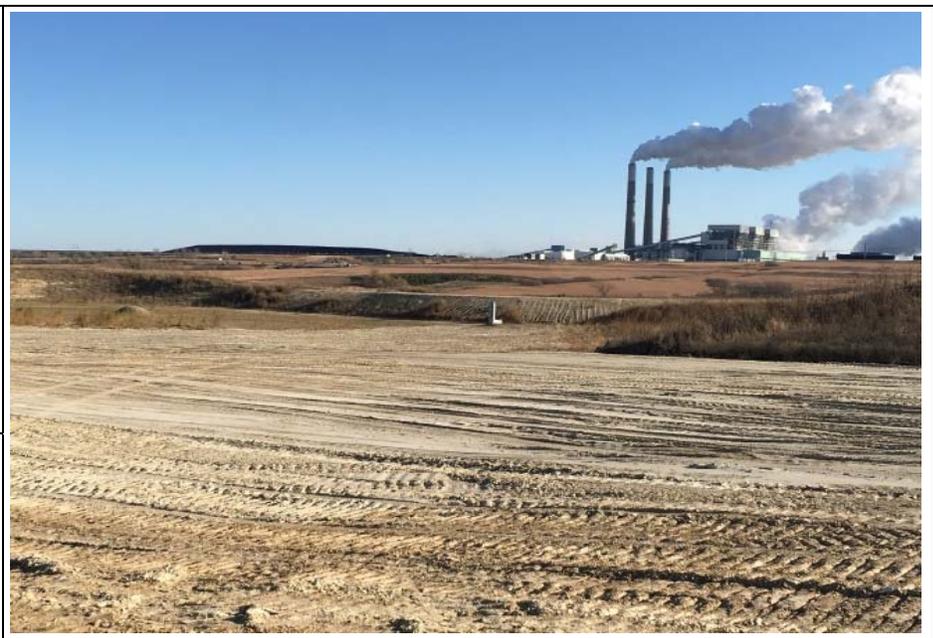
<p>Photograph No. 2</p> <p>Date: November 29, 2016</p> <p>Direction: Northwest</p>

<p>Description: Observing the recently graded FGD active area and wick drain pipe. No dust is being generated, despite windy conditions.</p>

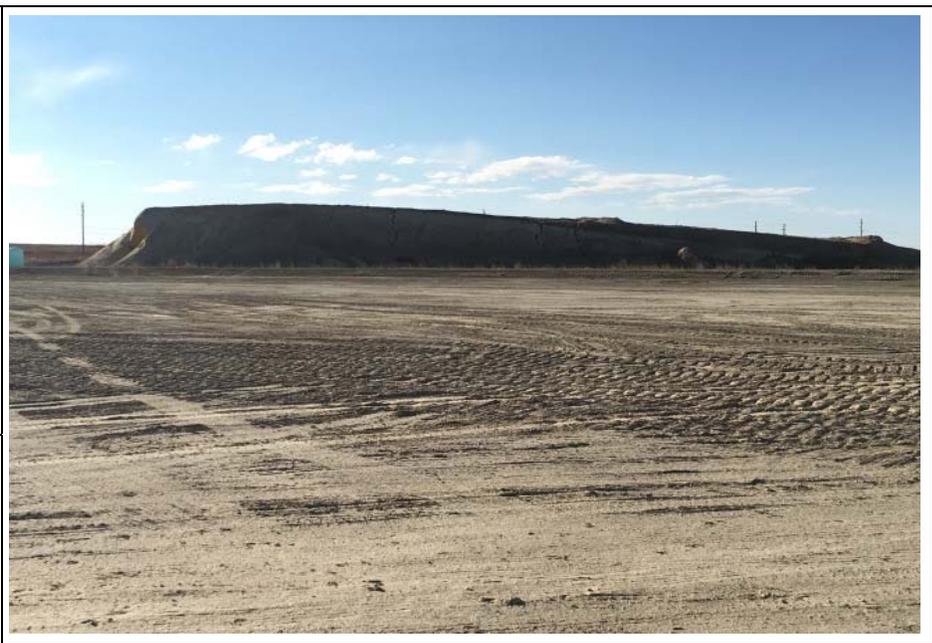
<p>Photograph No. 3</p> <p>Date: November 29, 2016</p> <p>Direction: South</p>

<p>Description: Observing the FGD beneficial use pile. No evidence of erosion or sloughing. No dust is being generated, despite windy conditions.</p>

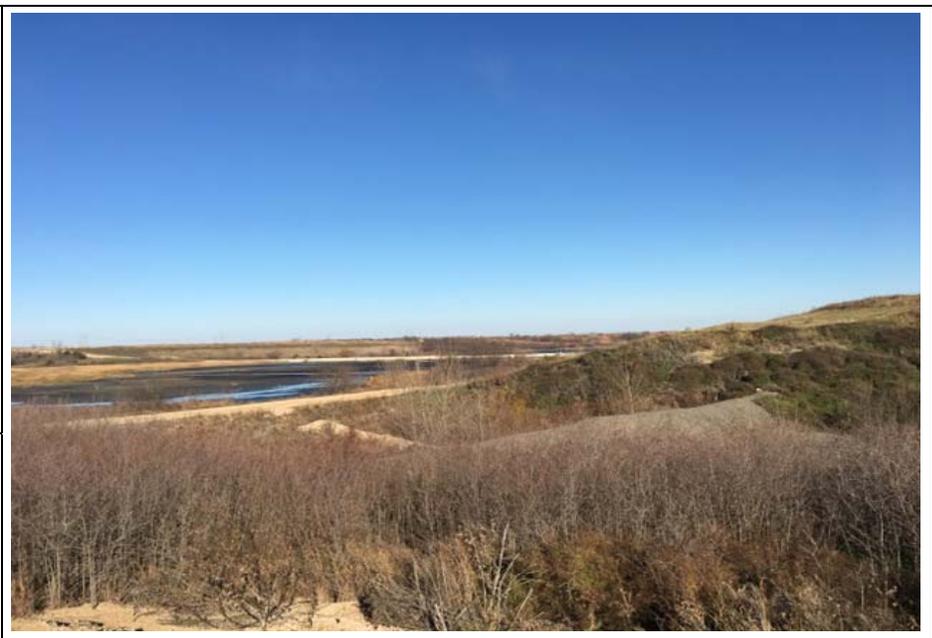
<p>Photograph No. 4</p> <p>Date: November 29, 2016</p> <p>Direction: North</p>

<p>Description: Observing check dams in non-contact stormwater ditch. No evidence of erosion or instability.</p>

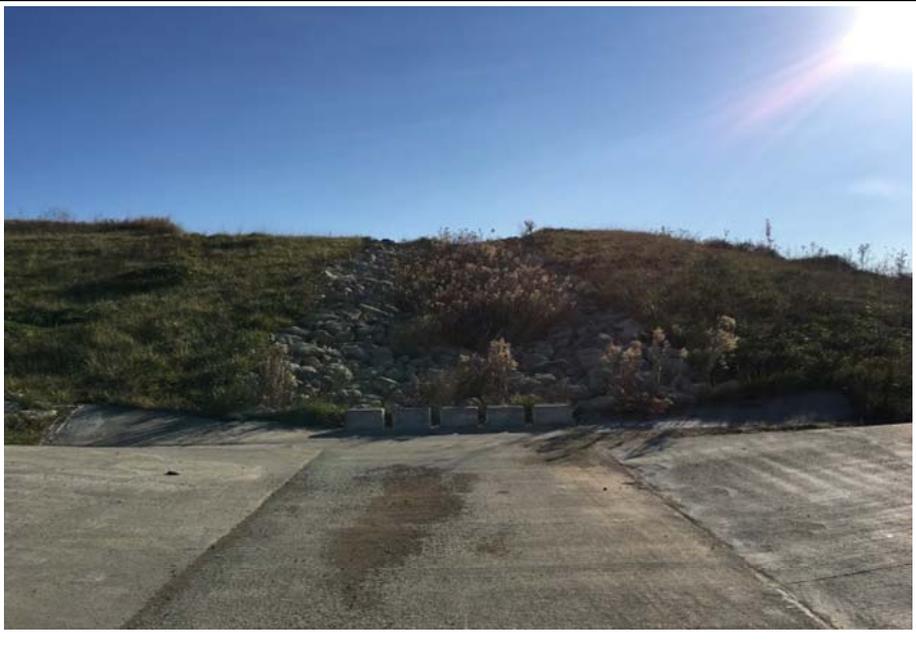
<p>Photograph No. 7</p> <p>Date: November 29, 2016</p> <p>Direction: South</p>

<p>Description: Observing a letdown ditch and concrete road crossing. No evidence of erosion or malfunction. Vegetation should be removed to prevent flow obstructions.</p>

- Remove vegetation in riprap lined letdown channels to prevent flow obstructions (see Photograph 7).
- Place riprap at drainage ditch inlet to pipes under perimeter road to prevent scour (see Photograph 11).
- Continue to monitor erosion controls and vegetative cover in line with weekly inspections.
- Continue proper management of the active landfill areas.
- Continue to monitor all stormwater conveyance features for signs of erosion or malfunction in line with weekly inspections.

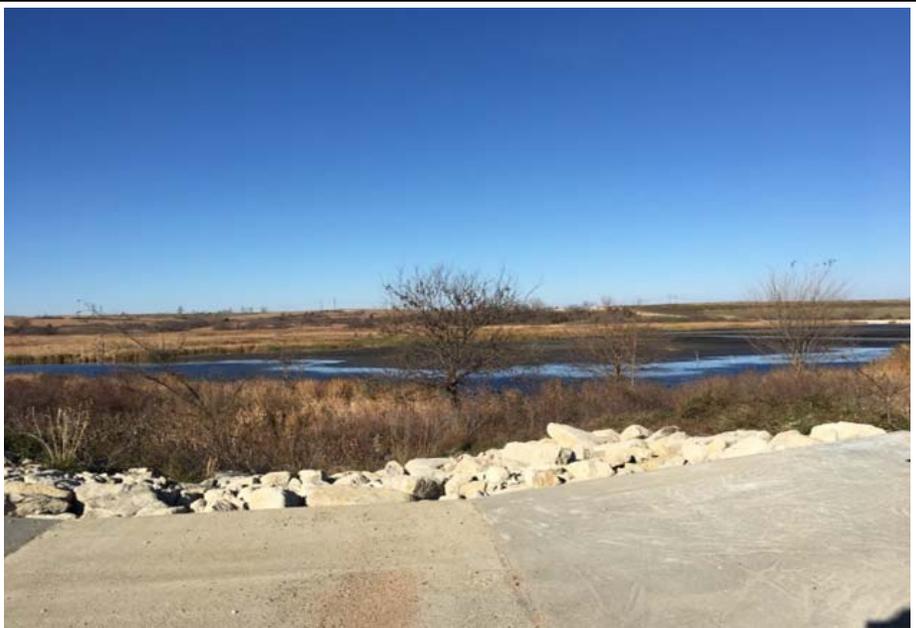
<p>Photograph No. 8</p> <p>Date: November 29, 2016</p> <p>Direction: North</p>

<p>Description: Observing stabilized slope, opposite of the letdown ditch section.</p>

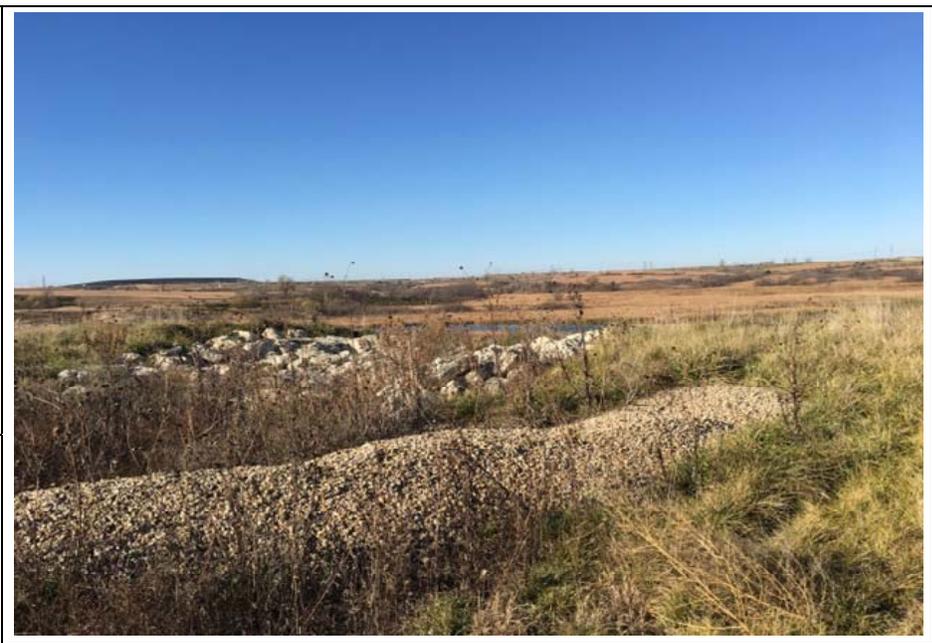
<p>Photograph No. 9</p> <p>Date: November 29, 2016</p> <p>Direction: Northeast</p>

<p>Description: Observing a gravel check dam along non-contact water stormwater ditch. No evidence of erosion or sloughing along drainage way.</p>

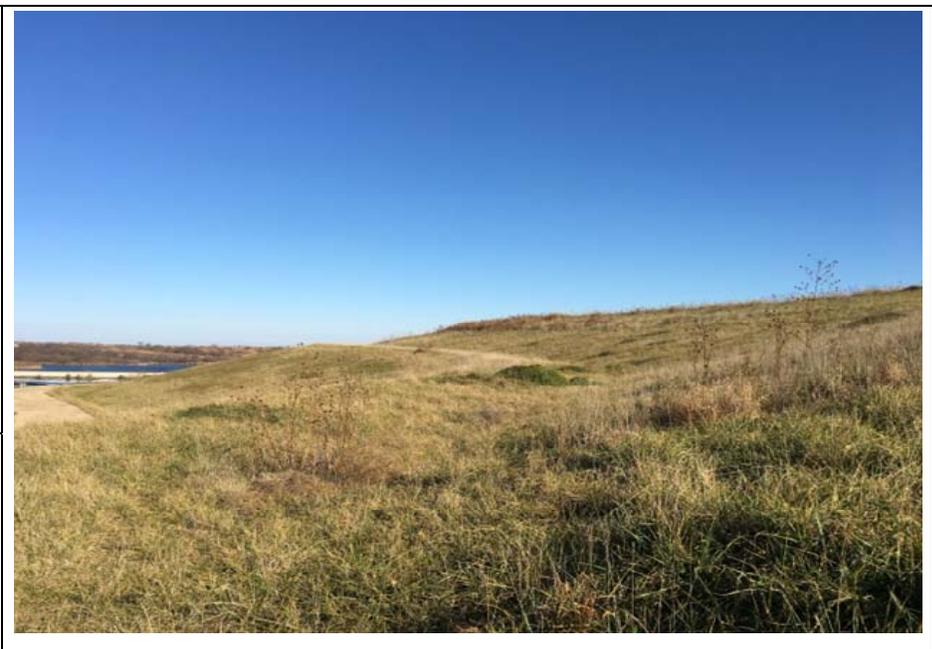
<p>Photograph No. 10</p> <p>Date: November 29, 2016</p> <p>Direction: Northeast</p>

<p>Description: Observing stabilized non-contact stormwater ditch. Vegetation is well-established and maintained. No evidence of erosion or malfunction.</p>

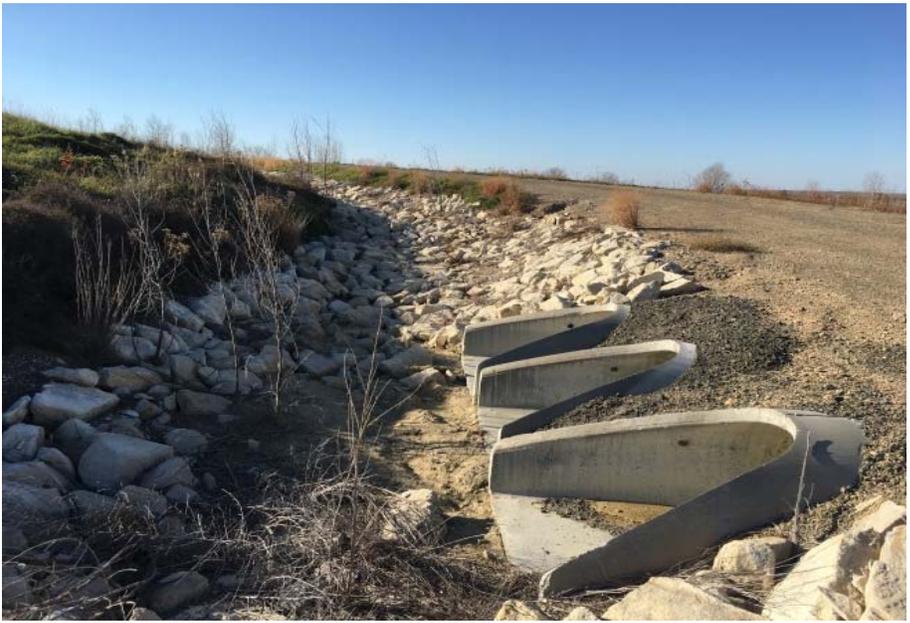
<p>Photograph No. 11</p> <p>Date: November 29, 2016</p> <p>Direction: Southwest</p>

A photograph showing a stormwater ditch with a riprap lining. Several concrete culverts are visible, some partially buried or damaged. The ditch is situated on a grassy slope under a clear blue sky.
<p>Description: Observing perimeter stormwater ditch and road culverts. No evidence of erosion. Additional riprap should be placed at inlet location to prevent scour.</p>

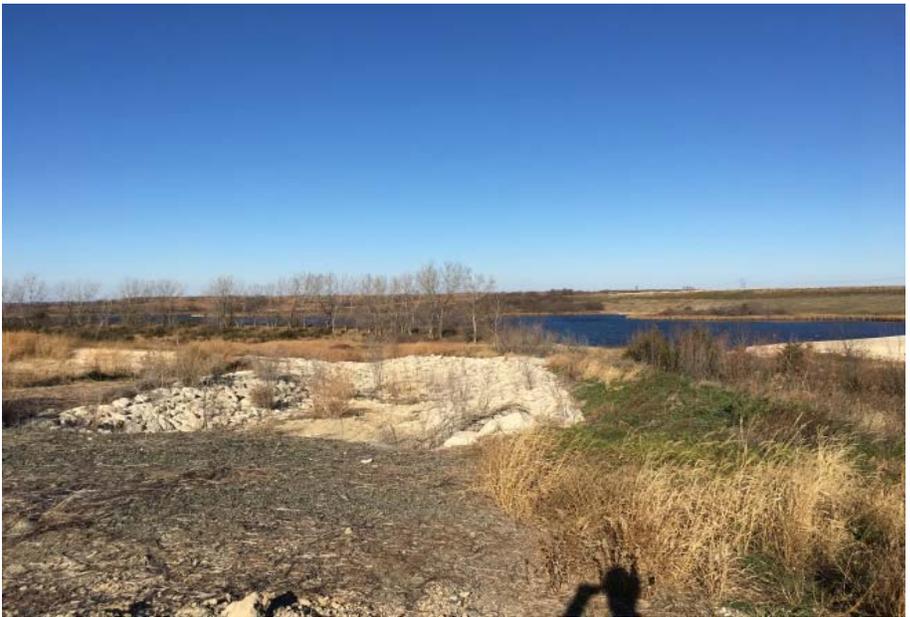
<p>Photograph No. 12</p> <p>Date: November 29, 2016</p> <p>Direction: West</p>

A wide-angle photograph showing a landscape view of a road culvert outlet. The outlet is stabilized with riprap and is situated on a grassy slope. In the background, there is a large body of water under a clear blue sky.
<p>Description: Observing the outlets of the road culverts. Outlets are stabilized and protected by riprap.</p>

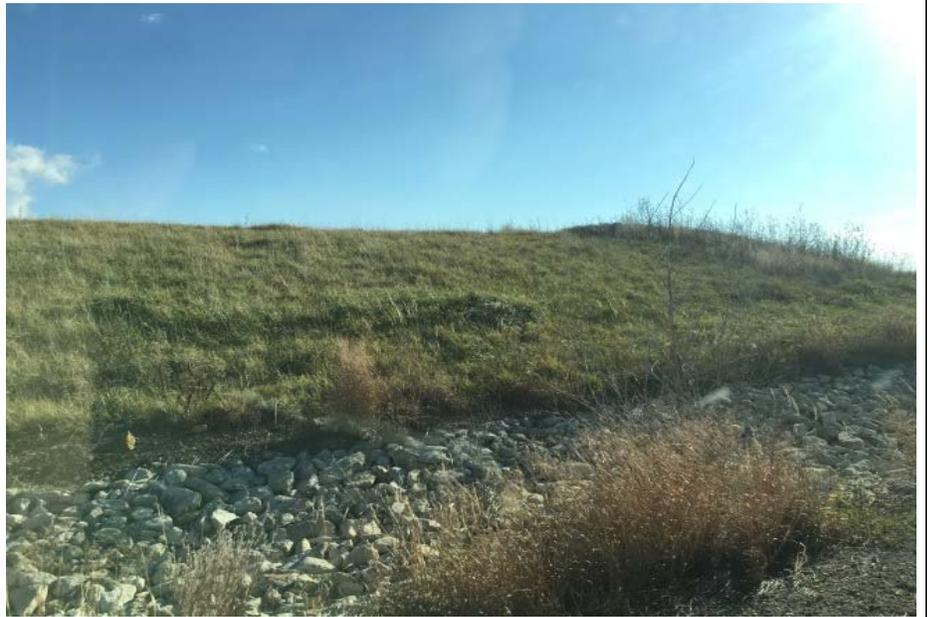
Photograph No. 13

Perimeter stormwater ditch lined with riprap and final cover area of Phase I. Vegetation is well-established and maintained. No evidence of erosion or malfunction.
