# Annual Inspection Report Tecumseh Energy Center Bottom Ash Surface Impoundments

Westar Energy

Tecumseh Energy Center

January 2017

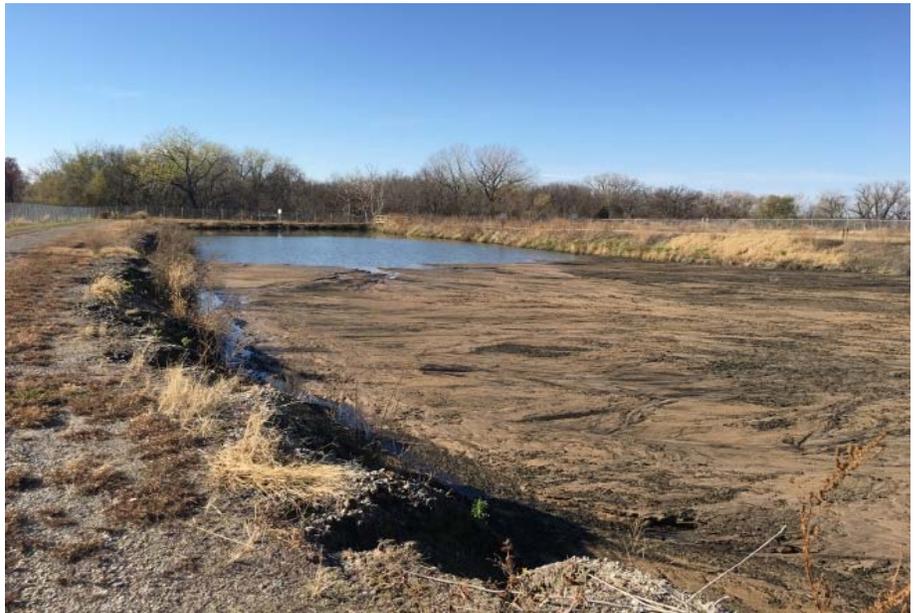
<p><b>Photograph No. 1</b></p> <p><b>Date:</b> November 28, 2016</p> <p><b>Direction:</b> West</p>

<p><b>Description:</b> Overview of South Pond. Minor erosion gullies on inside slope, but is not causing malfunction or impacting stability.</p>

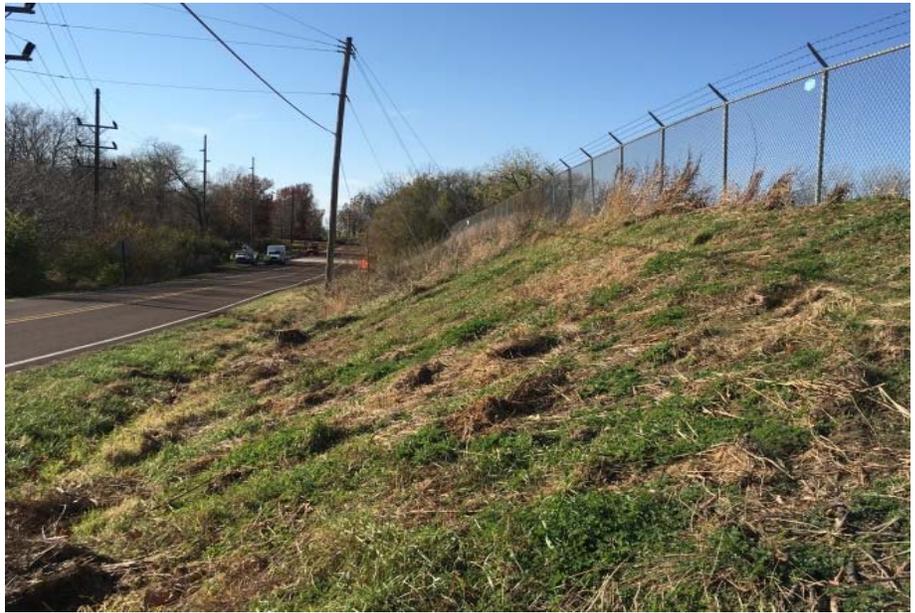
<p><b>Photograph No. 2</b></p> <p><b>Date:</b> November 28, 2016</p> <p><b>Direction:</b> West</p>

At the time of this inspection, there were no significant signs of distress or malfunction that would indicate actual or potential structural weakness at the Surface Impoundments. Minor observations include the channel incising of the SE 2<sup>nd</sup> Street drainage channel, which should be stabilized. There was no indication that existing conditions at the Surface Impoundments have disrupted or have the potential to disrupt safety or operations. Weekly inspections are utilized to document any signs of distress, malfunction, or disruption and resolve the issues immediately.

<p><b>Description:</b> South berm of South Pond along SE 2<sup>nd</sup> St. Steep slopes. Vegetation appears to have improved since 2015 inspection. Drainage channel at toe appears to be incising into berm.</p>

- Install rip-rap at the base of the drainage ditch of SE 2<sup>nd</sup> Street to minimize the potential for erosion or sloughing.
- Continue to monitor erosion controls and vegetative cover in line with the weekly inspections.
- Continue proper management of the inflow control system and outlet structure.
- Continue to monitor all conveyance features for signs of erosion, damage, obstructions, or malfunction in line with the weekly inspections.

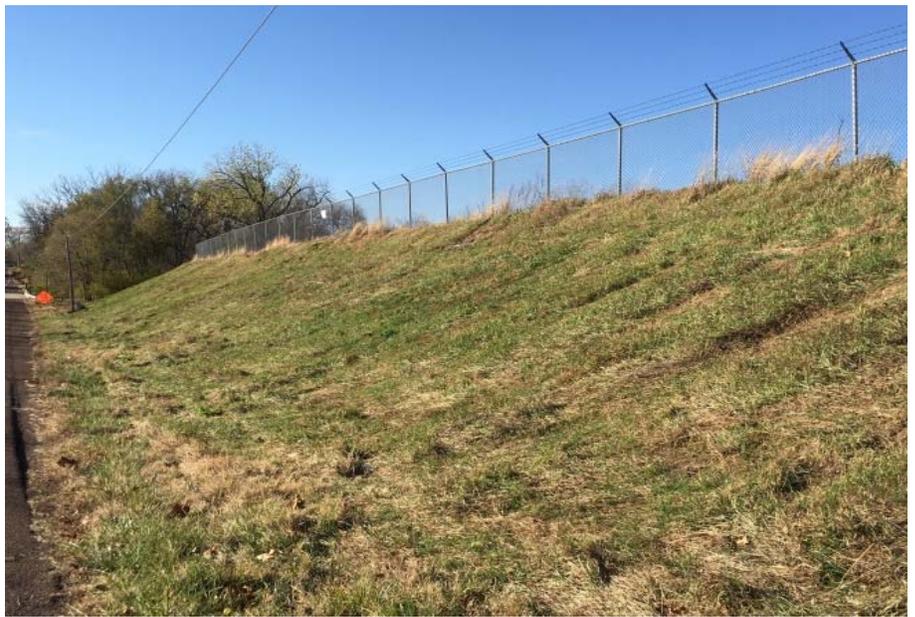
<p><b>Photograph No. 3</b></p> <p><b>Date:</b> November 28, 2016</p> <p><b>Direction:</b> West</p>

<p><b>Description:</b> South berm of South Pond along SE 2<sup>nd</sup> St. Steep slopes. Vegetation appears to have improved since 2015 inspection. Drainage channel at toe appears to be incising into berm.</p>

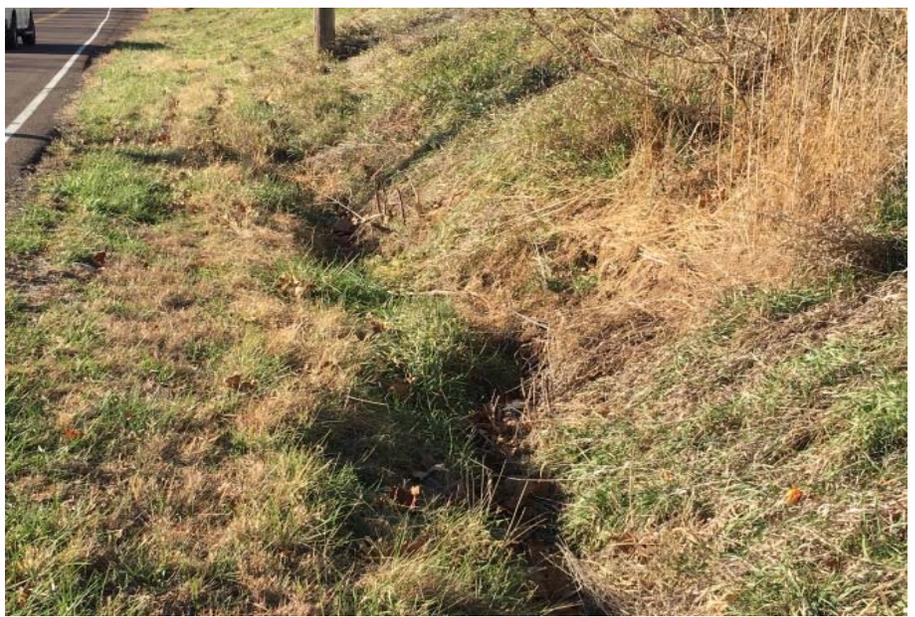
<p><b>Photograph No. 4</b></p> <p><b>Date:</b> November 28, 2016</p> <p><b>Direction:</b> West</p>

<p><b>Description:</b> Observing the drainage channel along toe of slope of south berm. Evidence of erosion along drainageway.</p>

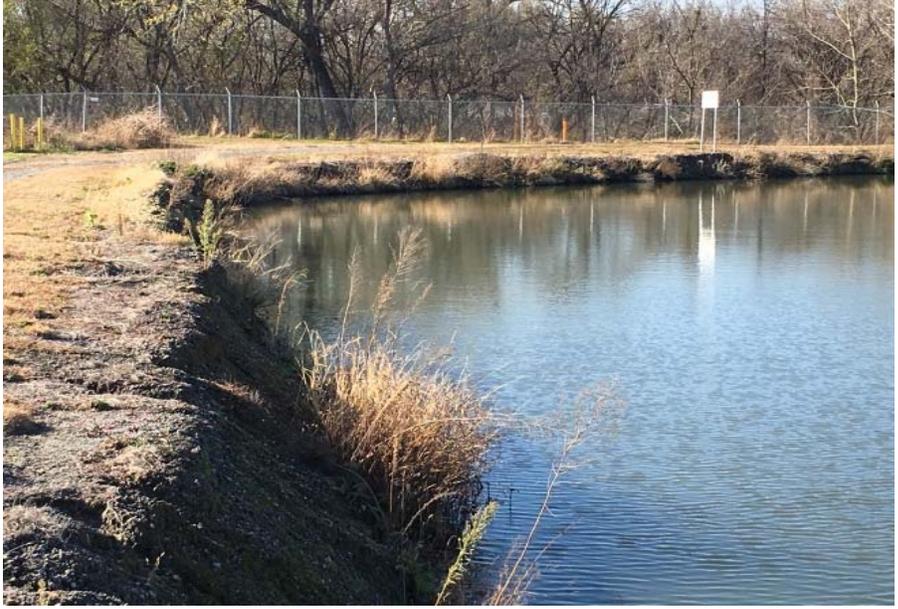
<p><b>Photograph No. 5</b></p> <p><b>Date:</b> November 28, 2016</p> <p><b>Direction:</b> West</p>

<p><b>Description:</b> Observing the South Pond. Minor erosion gullies on inside slope, but is not causing malfunction or impacting stability.</p>

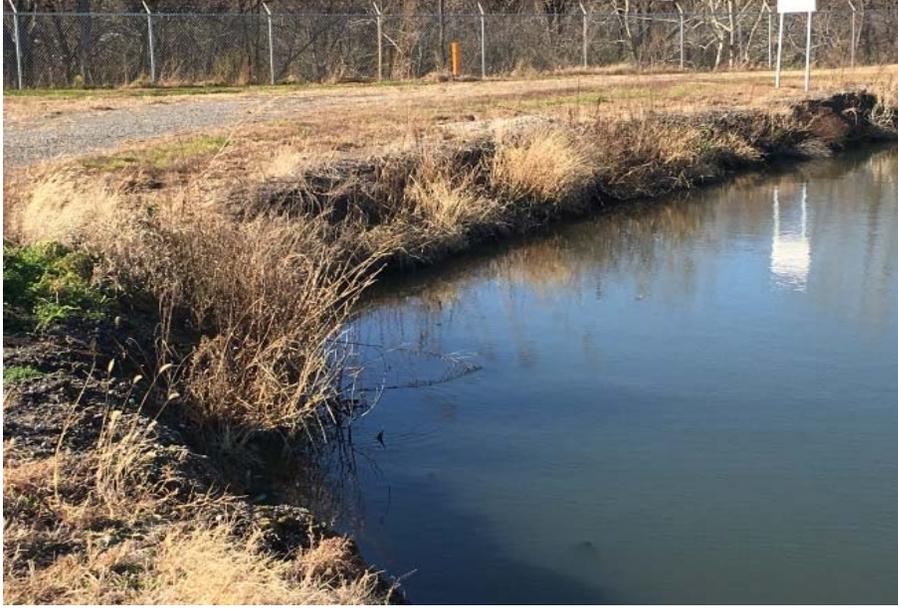
<p><b>Photograph No. 6</b></p> <p><b>Date:</b> November 28, 2016</p> <p><b>Direction:</b> Northwest</p>

<p><b>Description:</b> Observing area of erosion at southwestern corner of the South Pond. Does not impact stability.</p>

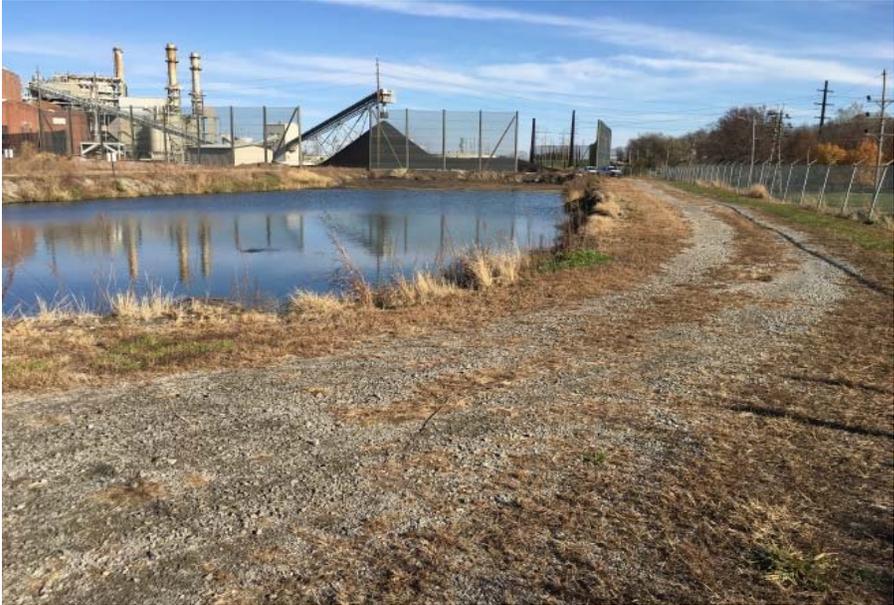
<p><b>Photograph No. 7</b></p> <p><b>Date:</b> November 28, 2016</p> <p><b>Direction:</b> East</p>

During the on-site inspection, slope appearance, slope stability, and overall site conditions were assessed. A low spot was not apparent in the berm crest in the southwest corner of the South Pond as previously reported. No erosion or sloughing was observed along the outside of the Surface Impoundments perimeter berm, with the exception of the base of slope along SE 2<sup>nd</sup> Street within the drainage ditch. This drainage ditch is incising its channels and should be stabilized. Minor erosion was present on the inside slopes of the impoundment, but is not presenting as a stability concern. No animal burrows were observed.

<p><b>Description:</b> Observing the previously identified “low spot” in 2015 report. The depression is nominal and does not present concern.</p>

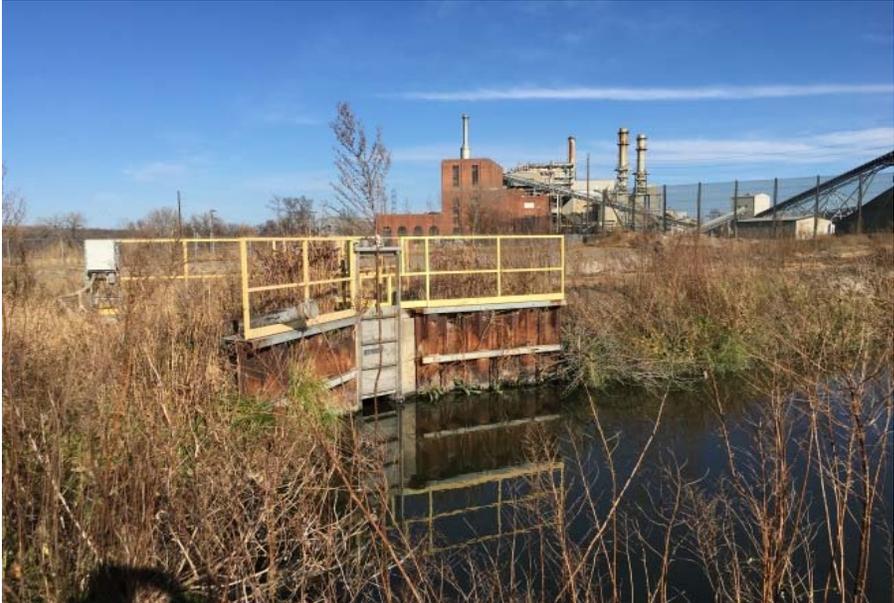
<p><b>Photograph No. 8</b></p> <p><b>Date:</b> November 28, 2016</p> <p><b>Direction:</b> Northeast</p>

<p><b>Description:</b> Observing the weir flow control system between the north and south ponds. Structure is clear of obstructions and free-flowing.</p>

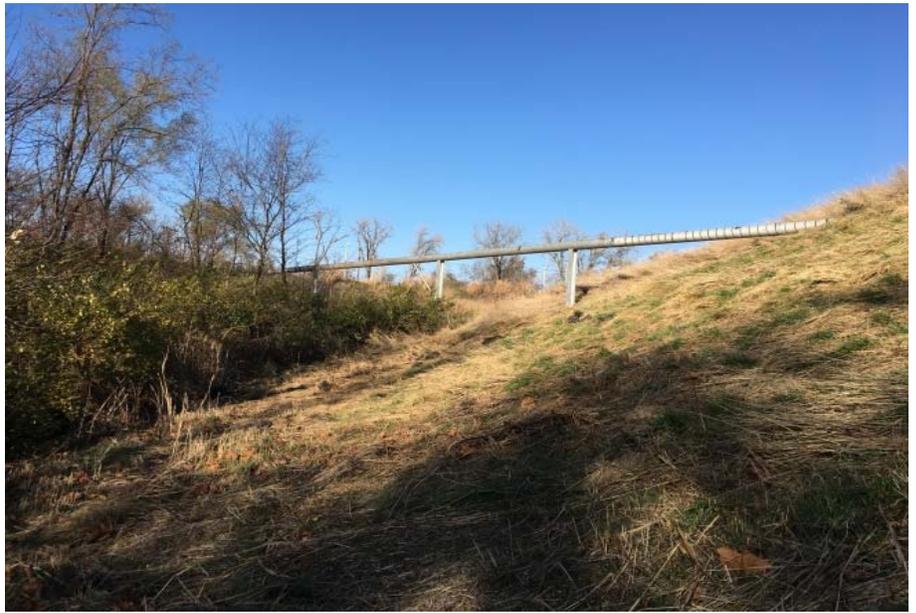
<p><b>Photograph No. 9</b></p> <p><b>Date:</b> November 28, 2016</p> <p><b>Direction:</b> North</p>

<p><b>Description:</b> Observing the west slope. Vegetation is well established and maintained. No evidence of slope stability concerns or erosion despite steep slopes.</p>

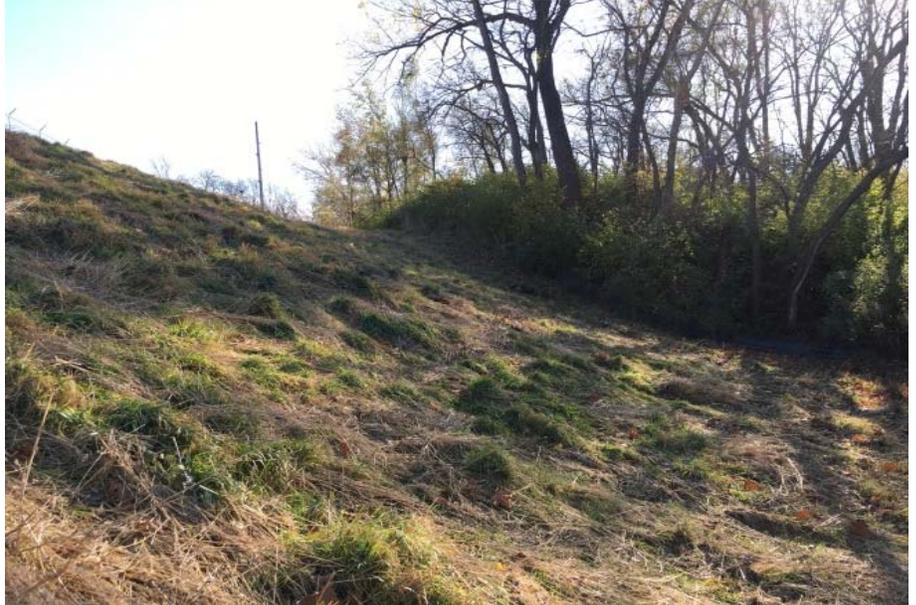
<p><b>Photograph No. 10</b></p> <p><b>Date:</b> November 28, 2016</p> <p><b>Direction:</b> South</p>

<p><b>Description:</b> Observing the west slope. Vegetation is well established and maintained. No evidence of slope stability concerns or erosion despite steep slopes.</p>

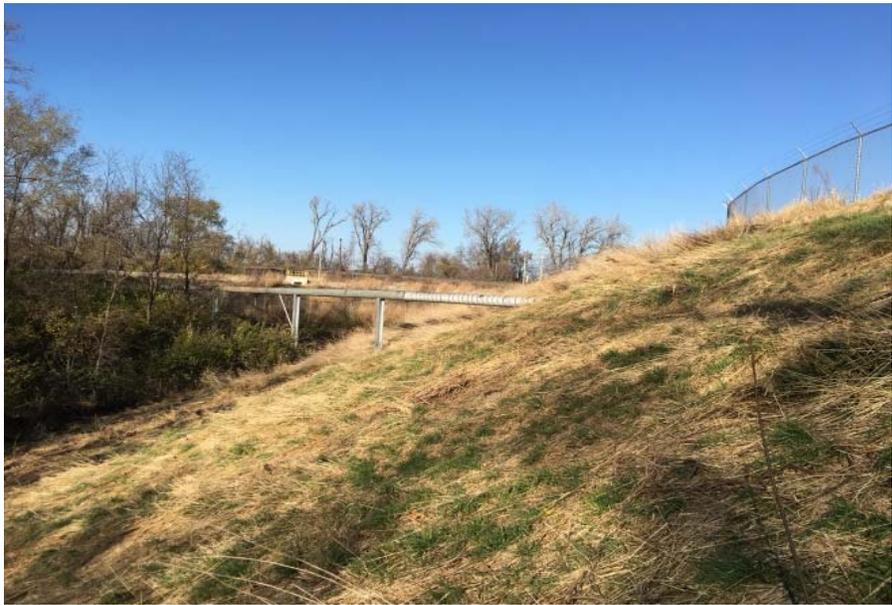
<p><b>Photograph No. 11</b></p> <p><b>Date:</b> November 28, 2016</p> <p><b>Direction:</b> North</p>

<p><b>Description:</b> Observing the west slope. Vegetation is well established and maintained. No evidence of slope stability concerns or erosion despite steep slopes.</p>

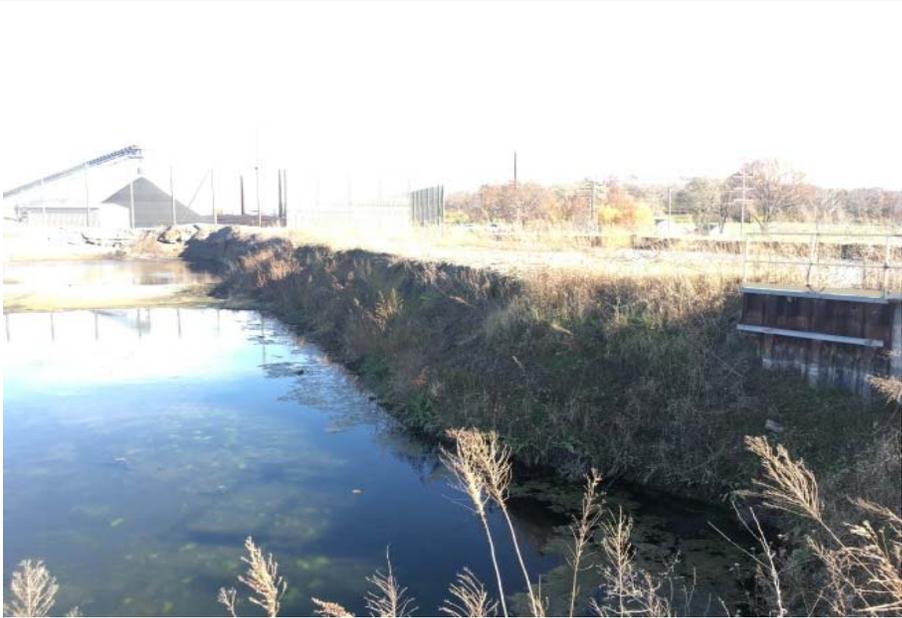
<p><b>Photograph No. 12</b></p> <p><b>Date:</b> November 28, 2016</p> <p><b>Direction:</b> East</p>

<p><b>Description:</b> Observing the North Pond interior.</p>

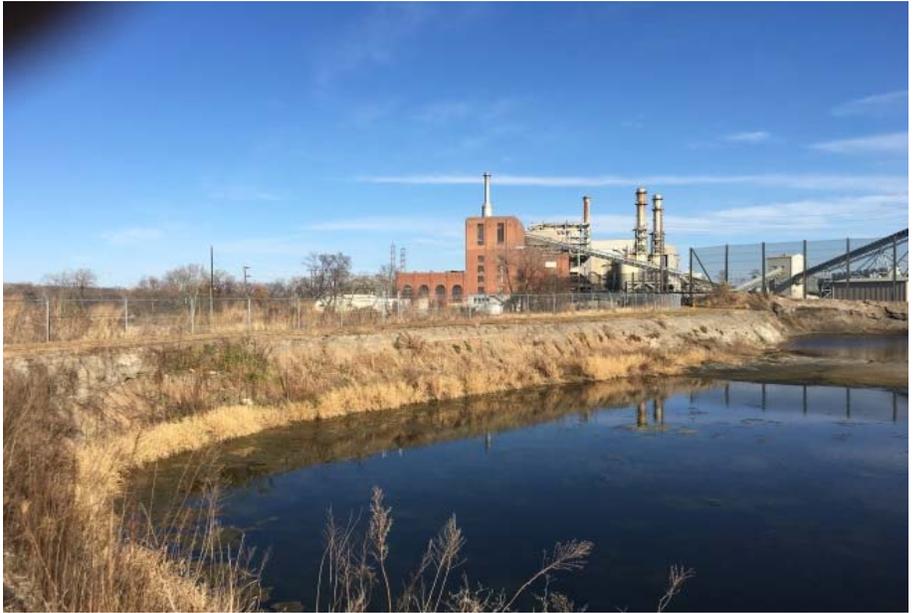
<p><b>Photograph No. 13</b></p> <p><b>Date:</b> November 28, 2016</p> <p><b>Direction:</b> Northeast</p>

<p><b>Description:</b> Observing the North Pond interior. Minor erosion gullies on inside slope, but is not causing malfunction or impacting stability.</p>

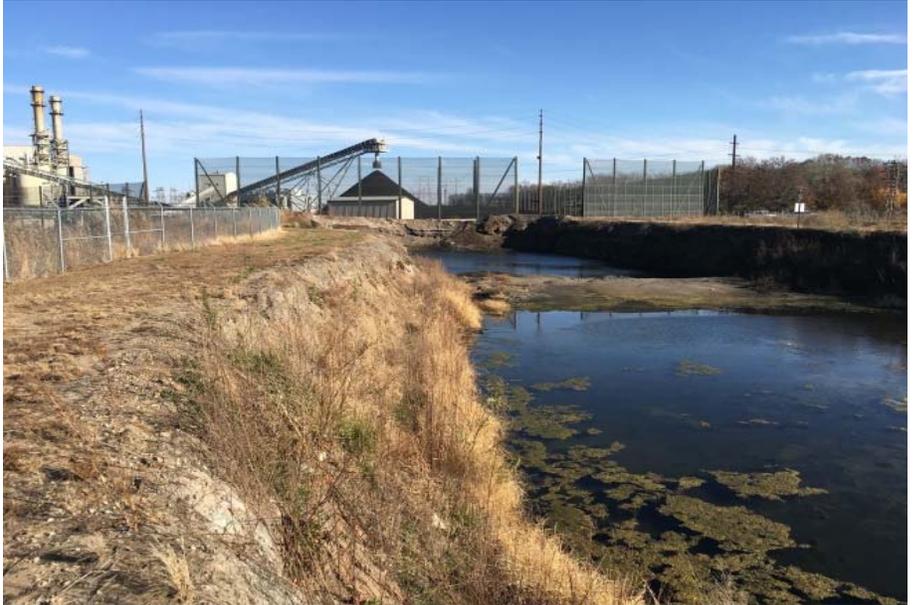
<p><b>Photograph No. 14</b></p> <p><b>Date:</b> November 28, 2016</p> <p><b>Direction:</b> East</p>

<p><b>Description:</b> Observing the North Pond interior. Minor erosion gullies on inside slope, but is not causing malfunction or impacting stability.</p>

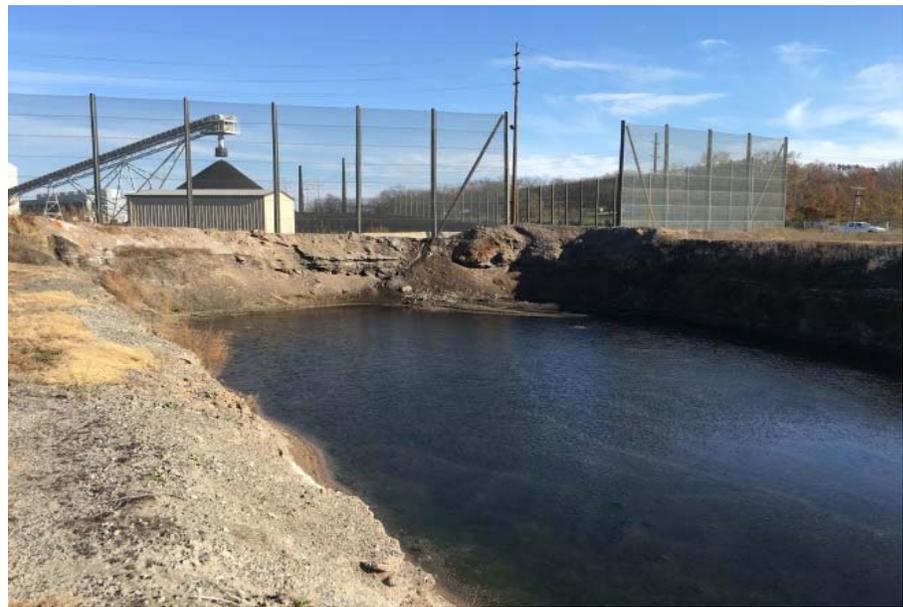
<p><b>Photograph No. 15</b></p> <p><b>Date:</b> November 28, 2016</p> <p><b>Direction:</b> East</p>

<p><b>Description:</b> Observing the North Pond interior. Minor erosion gullies on inside slope, but is not causing malfunction or impacting stability.</p>

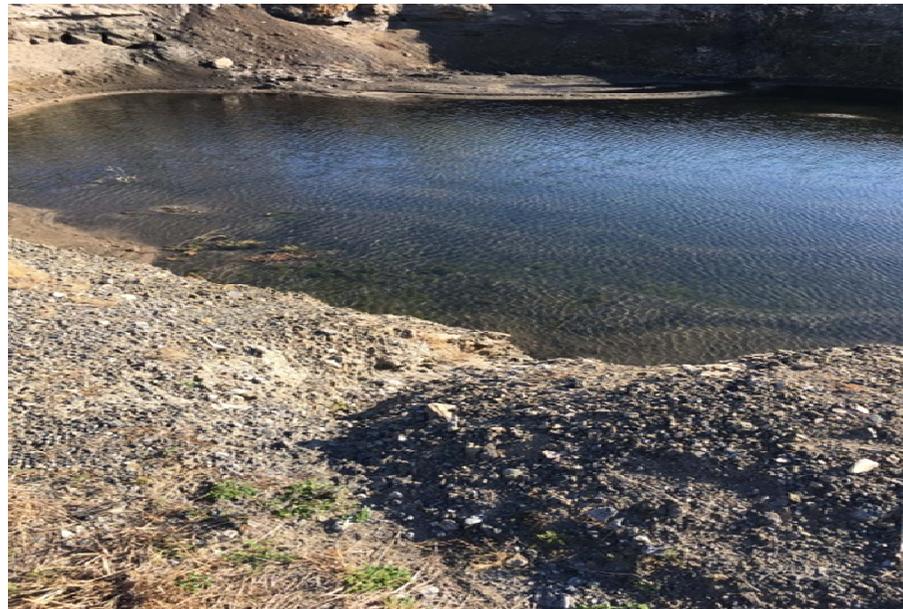
<p><b>Photograph No. 16</b></p> <p><b>Date:</b> November 28, 2016</p> <p><b>Direction:</b> Southeast</p>

<p><b>Description:</b> Observing process water within North Pond.</p>

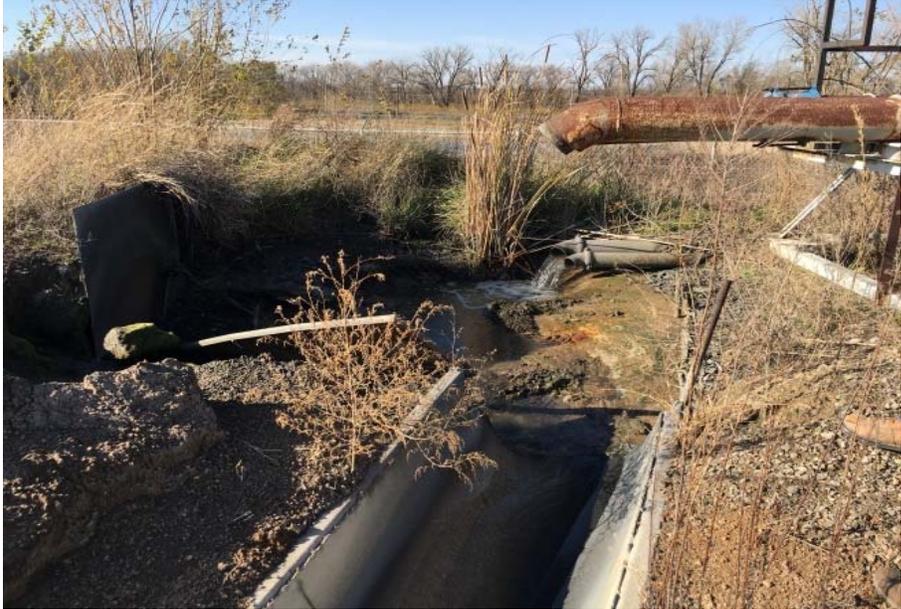
<p><b>Photograph No. 17</b></p> <p><b>Date:</b> November 28, 2016</p> <p><b>Direction:</b> Northwest</p>

<p><b>Description:</b> Process water discharge point into flume that feeds ponds. No evidence of erosion or malfunction. The closed culvert on left travels to north pond when open. Trough flows to south pond.</p>

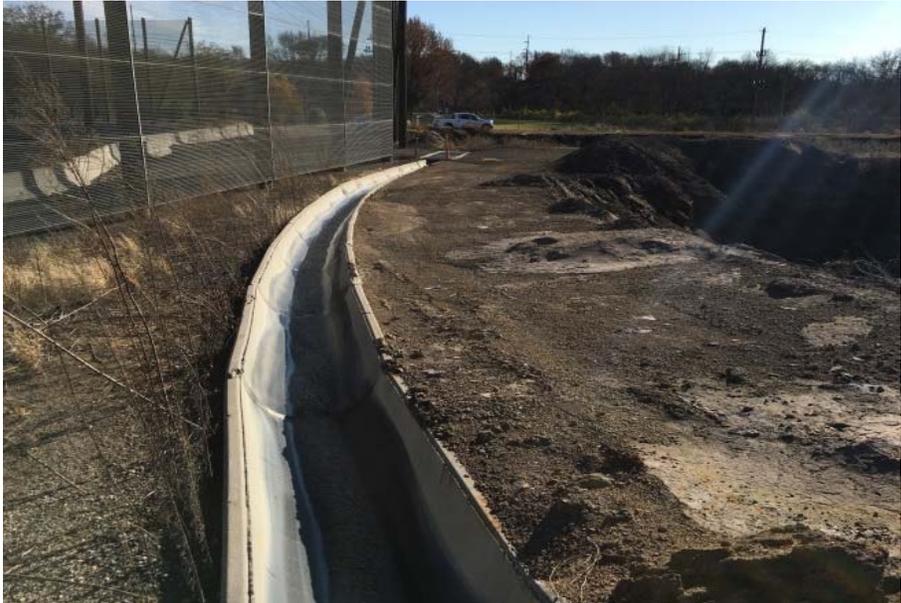
<p><b>Photograph No. 18</b></p> <p><b>Date:</b> November 28, 2016</p> <p><b>Direction:</b> South</p>

<p><b>Description:</b> Observing trough flow to South Pond. No apparent obstructions or malfunctions observed.</p>
