Location Restriction Demonstration Report Fly Ash Landfill Area 2

Jeffrey Energy Center
25905 Jeffrey Rd.
St. Marys, Kansas

Evergy Kansas Central, Inc.

25221157.00 | October 2021

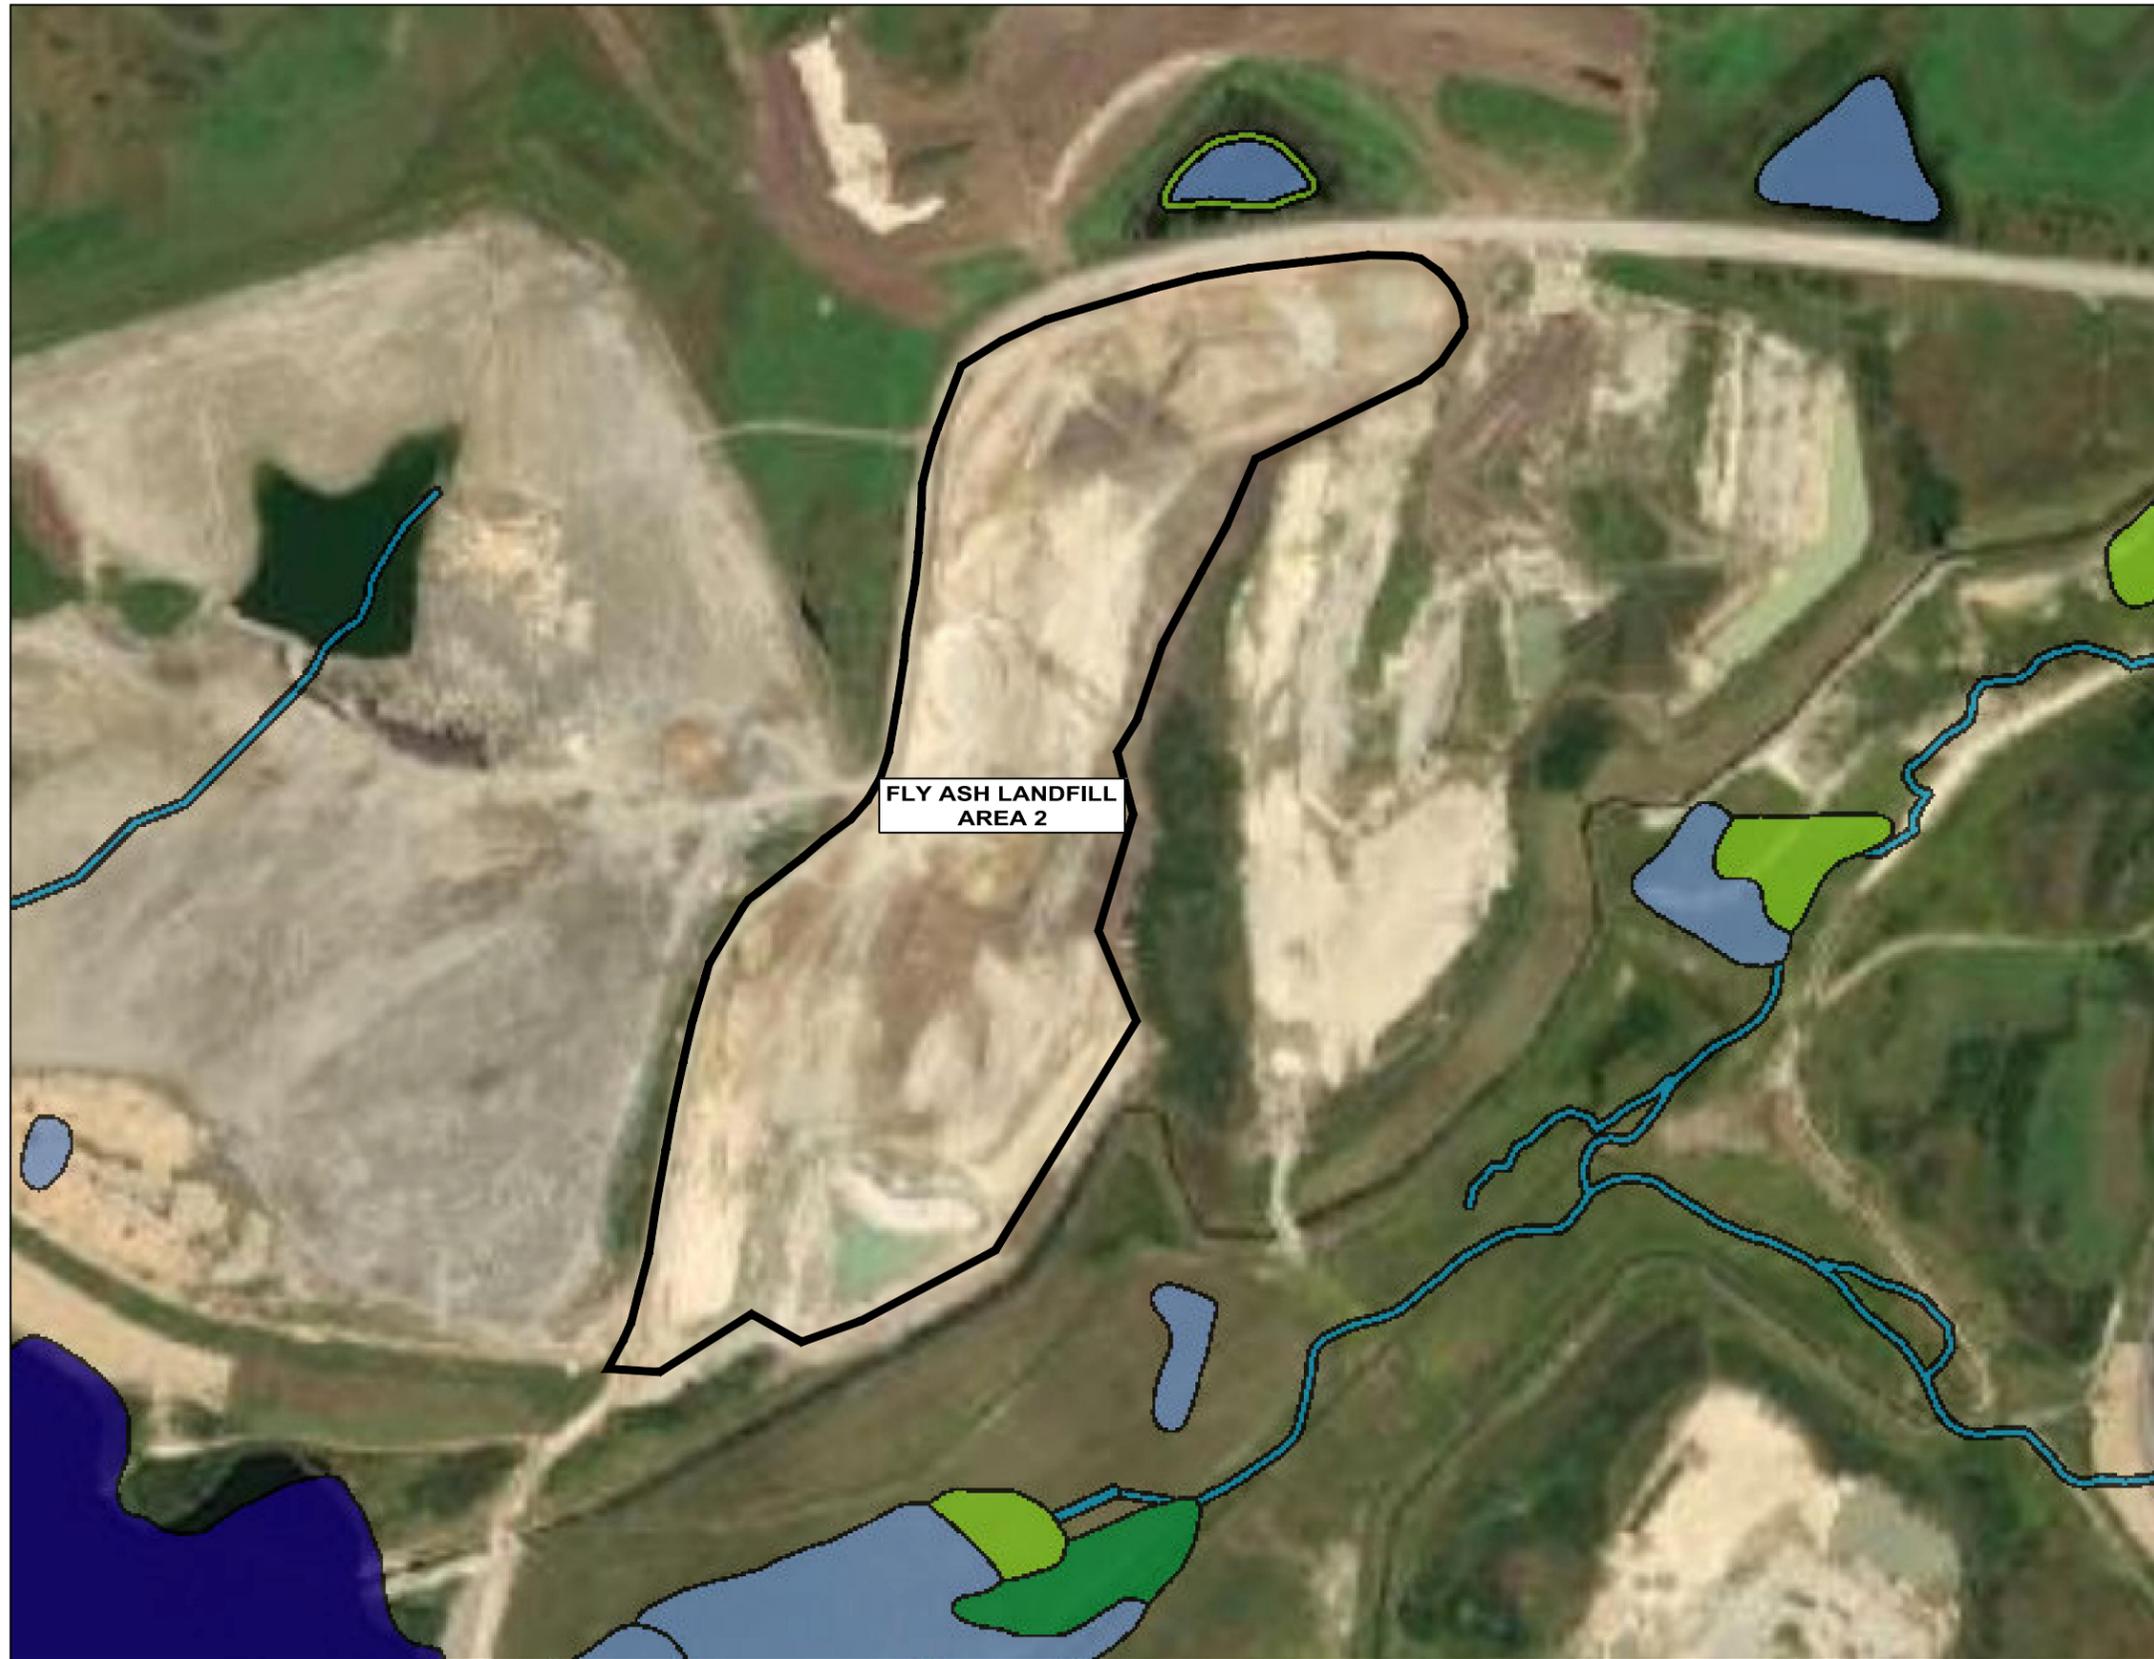
NATIONAL WETLANDS INVENTORY

- A review of the National Wetlands Inventory does not show any areas likely to be a wetland within the proposed Unit boundary.
- A review of historic aerial imagery shows no evidence of ponding, darkened areas that may indicate saturated soils, or hydrophytic vegetation.

The Unit was inspected by a certified wetland scientist in October 2021. The evaluation included a desktop review and field analysis to determine if wetland indicators were present at the Unit. Based on the conclusions drawn in that inspection report, the Unit was not constructed on a wetland, is currently not disturbing a wetland, and is not contributing to the significant degradation of a wetland. The Wetland Evaluation, dated October 2021, can be found in **Appendix B**. Maps showing the National Wetlands Inventory and pre-development topography are included as **Figures 2 and 3**, respectively.

The NWI map indicates no wetlands exist at the landfill. In addition, the area is outside the mapped 100-year floodplain, a less favorable environment for wetlands to develop. The USGS Topo indicates steep slopes as well, which provides for a well-drained area also not conducive to wetland development.

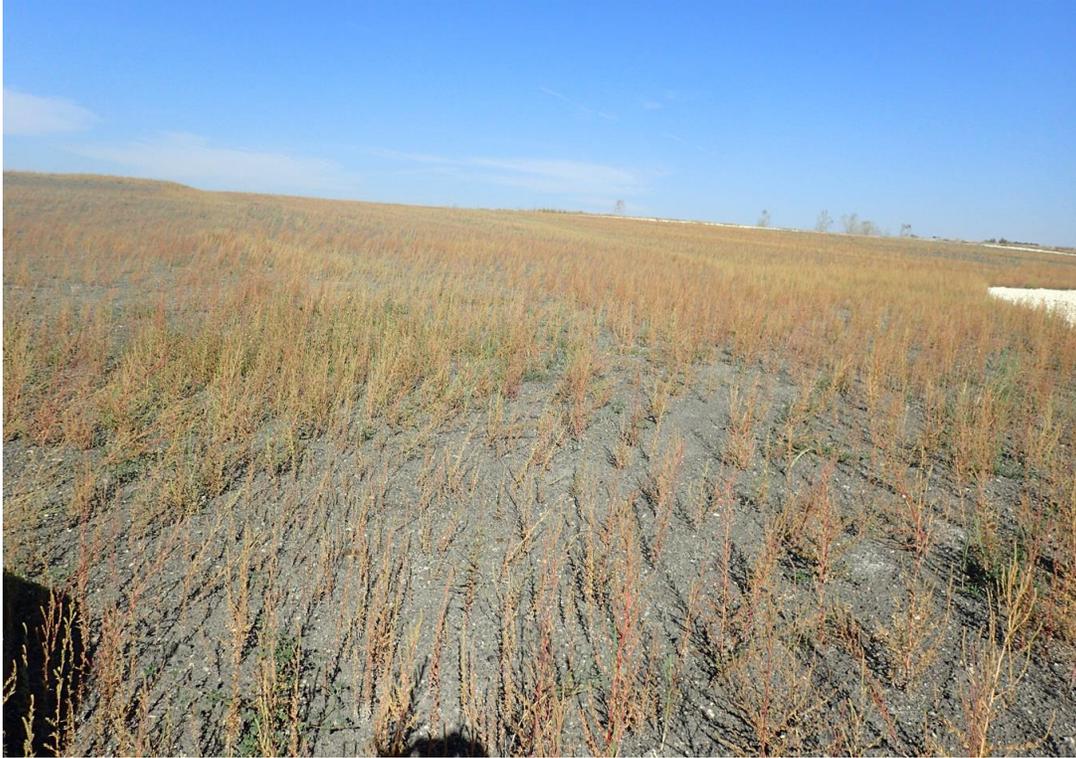
The upland sloped area of was first observed. These areas were well drained, with no wetland vegetation or hydrology. The primary, dominant vegetation was Pigweed, *Amaranthus palmeri*. This species has a wetland indicator of FACU, a Facultative upland plant, therefore is most likely not found in wetlands of the Great Plains Region. Hydrology indicators were absent, there was no surface water, saturation within the upper 12", water marks sediment deposits, drift lines

Upland slope area of landfill, Sampling Pt A, Pigweed, *Amaranthus palmeri* dominant
