Structural Stability Assessment Jeffrey Energy Center Inactive Bottom Ash Pond

Prepared for:
Westar Energy
Jeffrey Energy Center
St. Marys, Kansas

Prepared by:
APTIM Environmental & Infrastructure, Inc.

April 2018

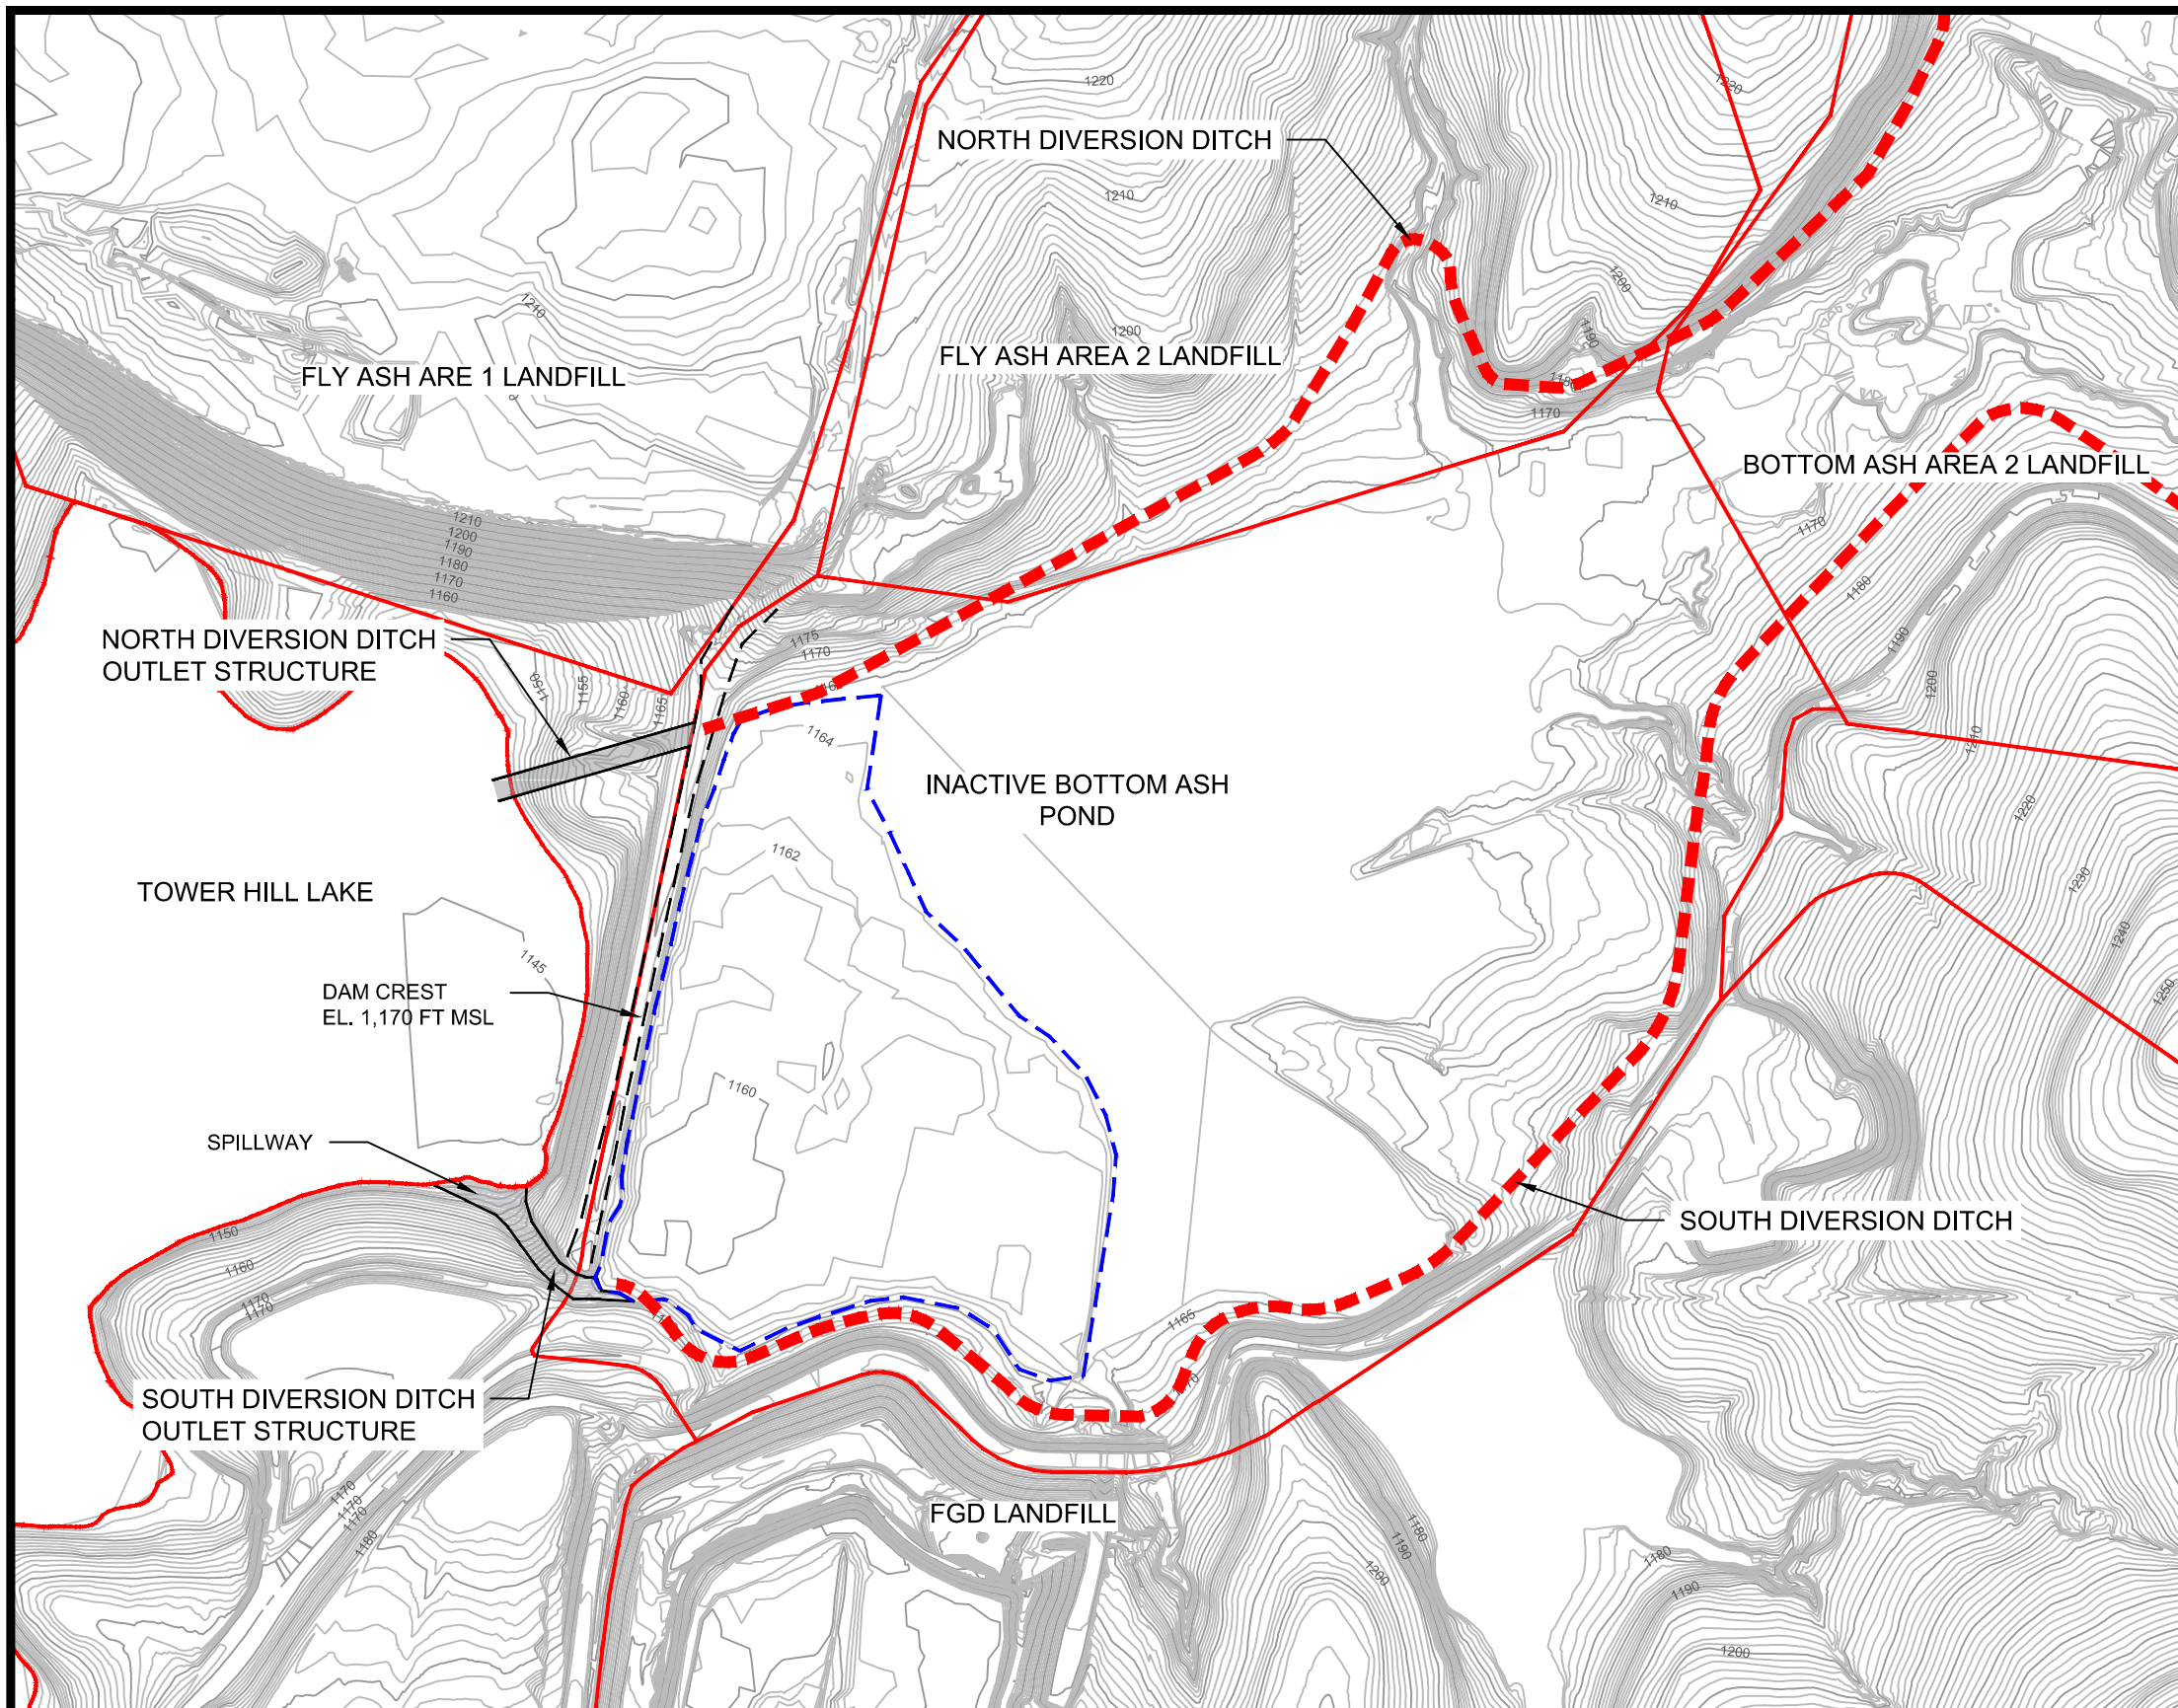
FIGURE 2
INACTIVE BOTTOM ASH POND
SITE TOPOGRAPHY PRIOR TO CLOSURE

The Pond is currently undergoing closure and has been dewatered. Historically, the typical impounded water volume within the Pond was determined to be approximately 62,680 cubic yards (cy), as described in the 2017 Annual Inspection Report. The CCR depths within the Pond have varied through time due to the continual deposit and discharge of water and CCR materials, and whether the fines have settled out in the alluvial fan/ravine (elevation higher than 1,164 ft MSL). The remaining CCR material storage capacity within the Pond was calculated in the 2017 Annual Inspection Report and was determined to be approximately 138,232 cy. The total CCR volume is unknown due to a range of ash material sources historically being routed to the Pond. Site topography prior to closure is depicted in **Figure 2**.
