15 January 2016
File No. 41938-008

Subject: Annual CCR Surface Impoundment PE Inspection
Area 1 Pond
Tecumseh Energy Center
Tecumseh, Kansas

**REPORT ON
INITIAL ANNUAL CCR SURFACE IMPOUNDMENT PE
INSPECTION
AREA 1 POND
TECUMSEH ENERGY CENTER
TECUMSEH, KANSAS**

for Westar Energy, Inc.
Tecumseh, Kansas

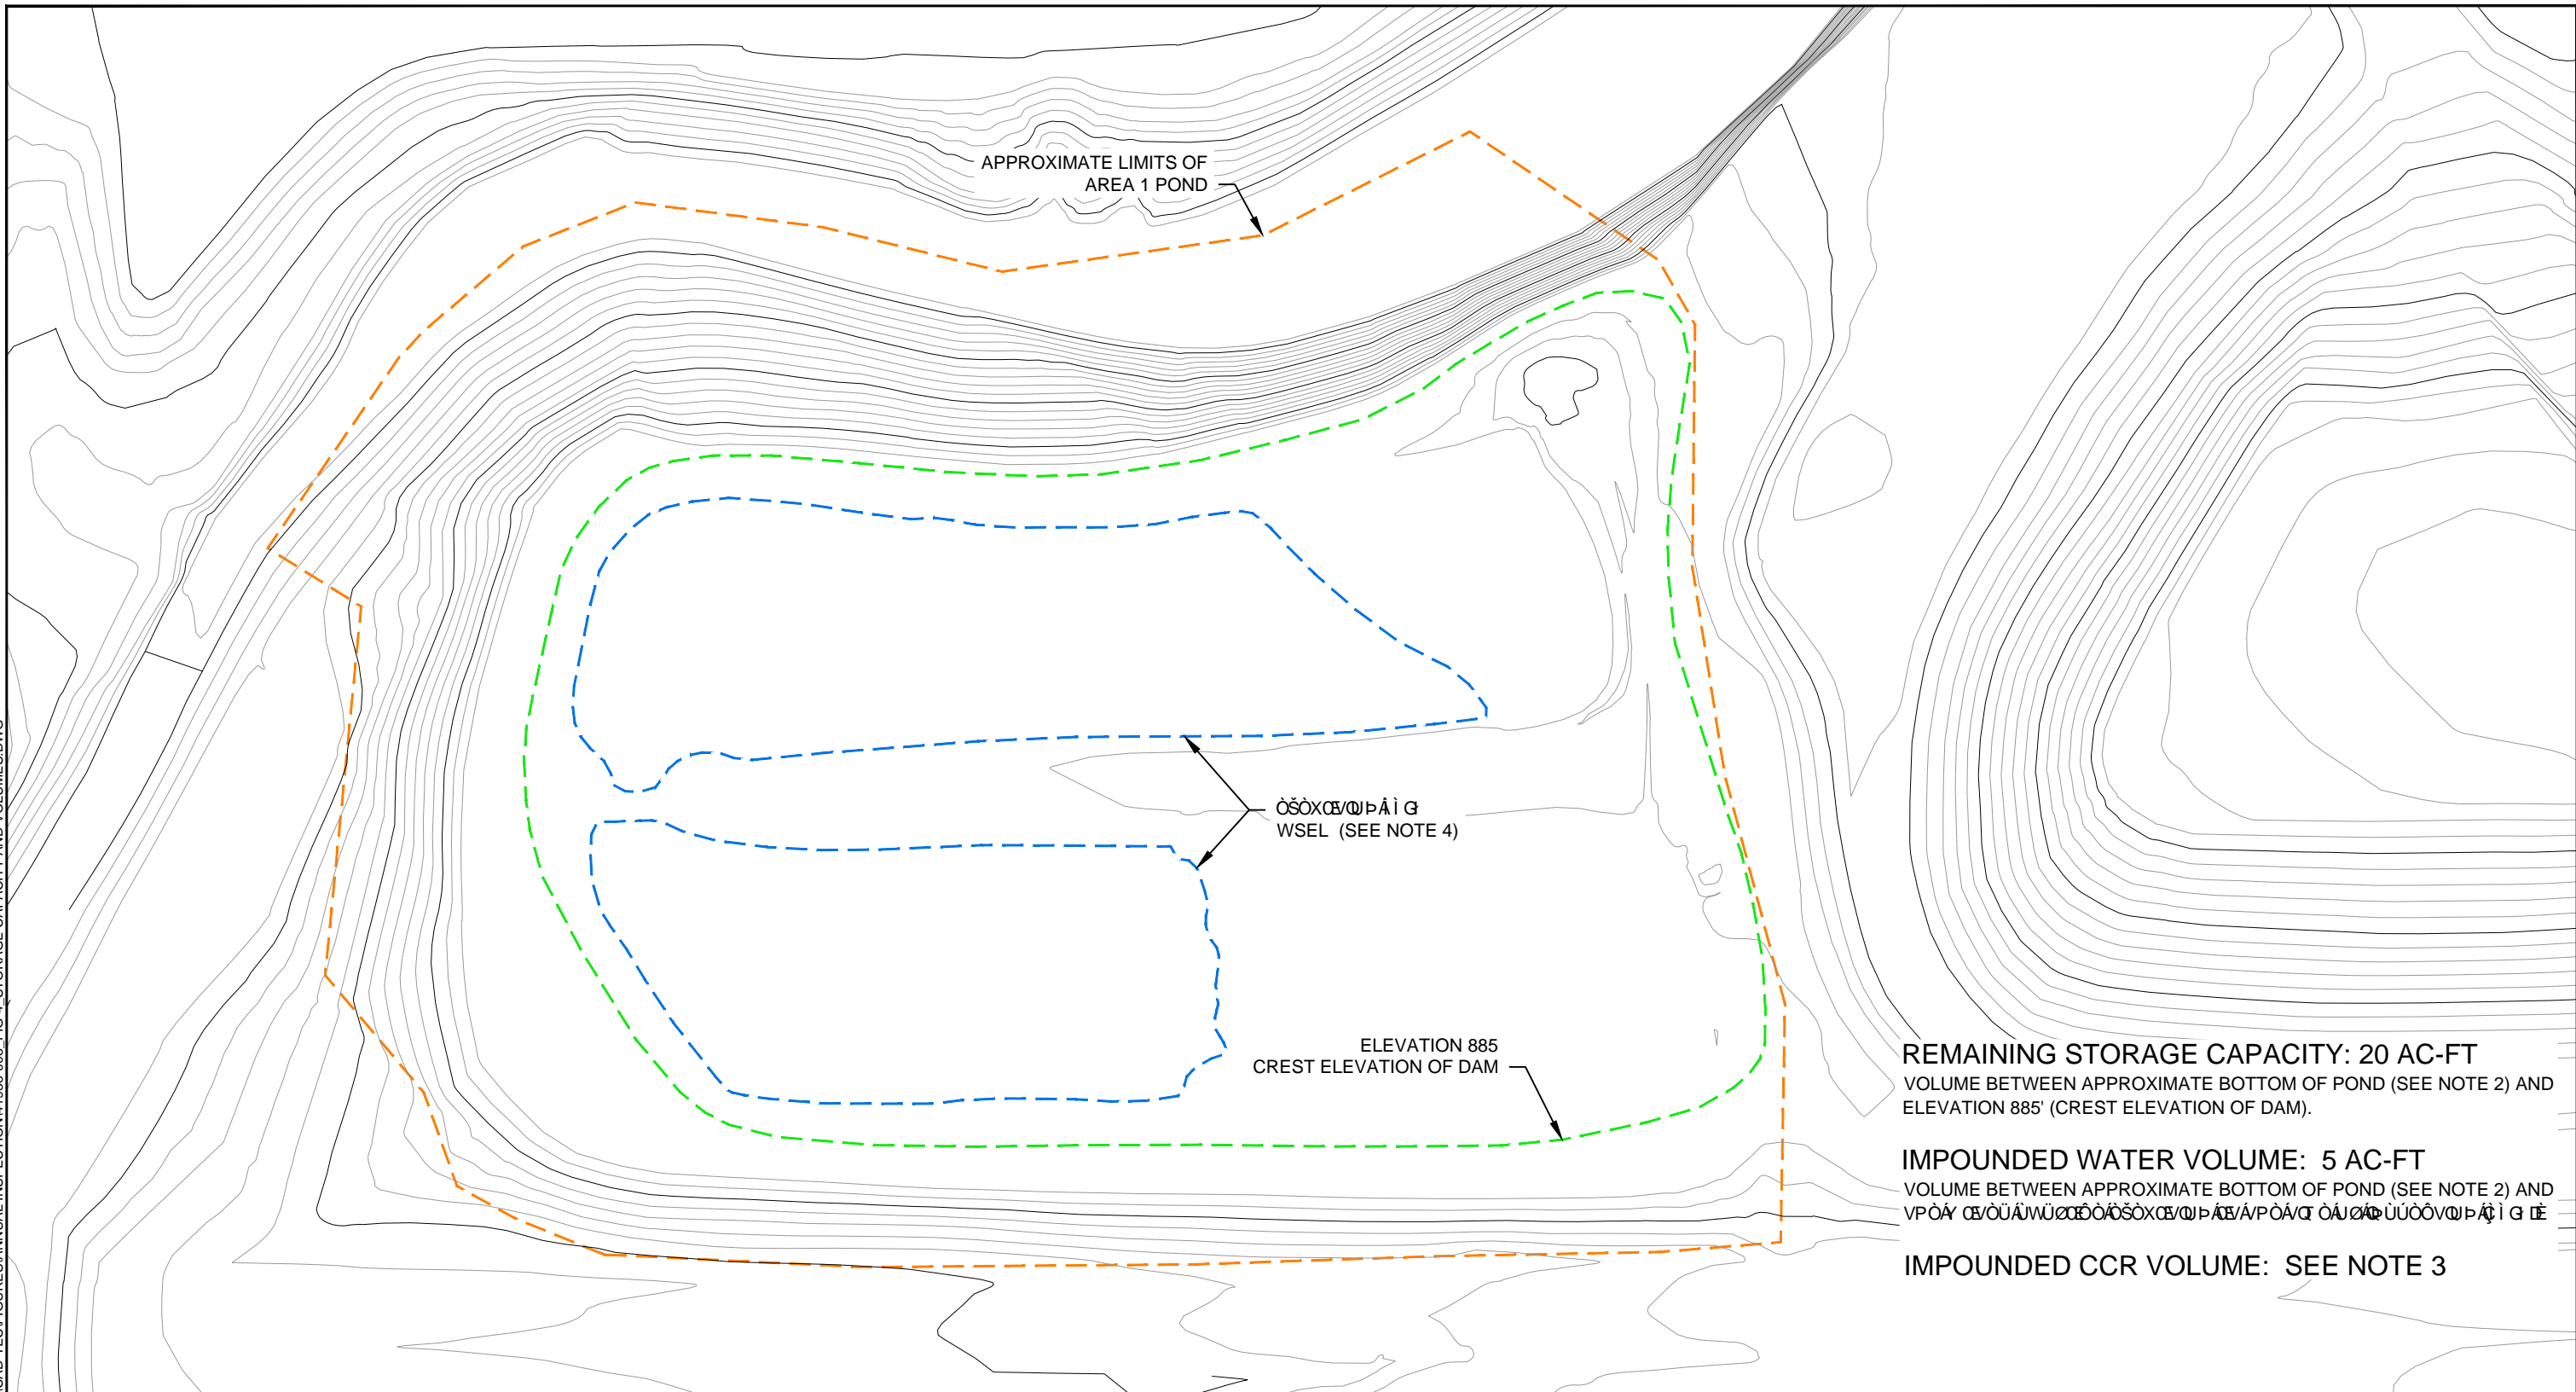
FIGURE 4

At the time of the inspection, the storage capacity of the Area 1 Pond is estimated to be approximately 20 acre-ft. As described in Figure 4, the remaining storage capacity was approximated by determining the volume of the impoundment (as of the most recent survey Western Air Maps and PEC) below El. 885, which is the elevation of the berm crest on the inspection date. Because no bathymetric data was available, the bottom of the pond was approximated to be at El. 877.

The impounded water volume was approximated to be 5 acre-ft. As described in Figure 4, the volume of impounded water was approximated by determining the volume of the impoundment (as of the most recent survey by Western Air Maps and PEC) below El. 882. Because no bathymetric data was available, the bottom of the pond was approximated to be at El. 877.
