# Annual Inspection Report Jeffrey Energy Center Bottom Ash Area Surface Impoundment

Westar Energy

Jeffrey Energy Center

January 2017

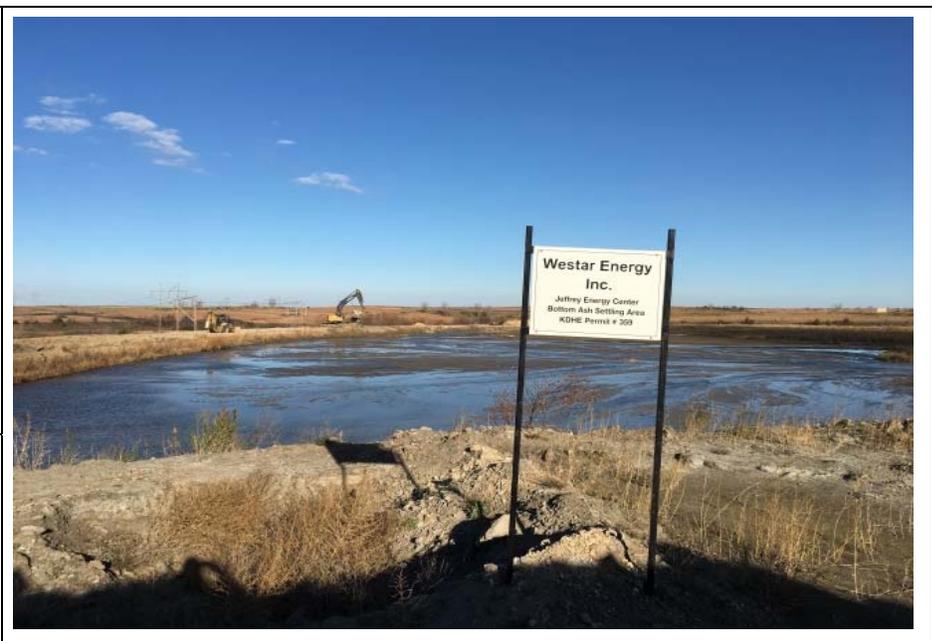
<p><b>Photograph No. 12</b></p> <p><b>Date:</b> November 29, 2016</p> <p><b>Direction:</b> North</p>

<p><b>Description:</b> Observing the Bottom Ash Area 1 and surface impoundment signage.</p>
